REPORT No 75  
September, 1953

THE COLLEGE OF AERONAUTICS  
CRANFIELD

Note on the development of a trailing-edge flap  
as a stall-detector.

C.F.BETHWAITE, B.Sc., A.F.R.Ae.S.

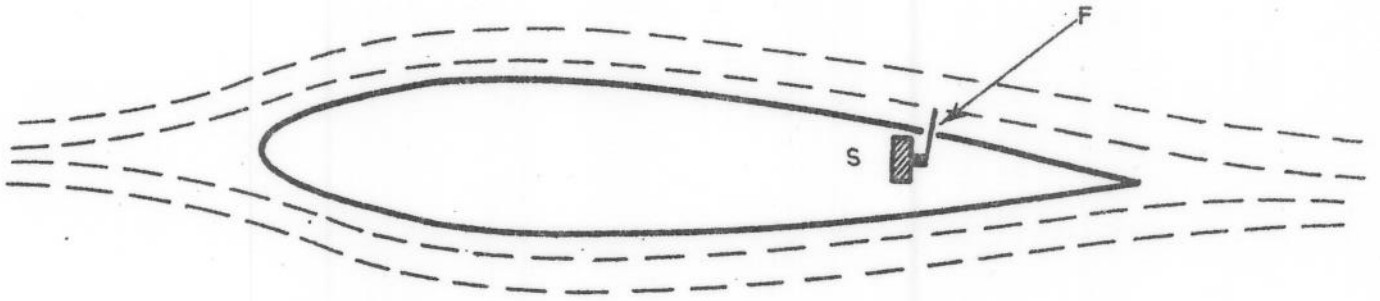
- (a) WING AT LOW INCIDENCE. FLAP "F" IS FORCED BACKWARDS AND DEPRESSES SPRING-LOADED PLUNGER OF MICRO-SWITCH "S", BREAKING CONTINUITY.

PRINCIPLE OF TRAILING-EDGE STALL DETECTOR.

A small metal flap was mounted near the trailing-edge of the wing so that it protruded outside the wing profile normal to the airstream. The flap was free to rotate against the spring-loaded plunger of a "break" micro-switch, i.e. continuity in the switch was broken when the plunger was depressed. The flap was mass-balanced about its axis of rotation. At low angles of incidence the aerodynamic load on the flap pressed it backwards, depressing the plunger of the switch. At incidences near the stall when a break-away occurred near the trailing-edge with a corresponding loss of total head, the aerodynamic loads on the flap were reduced, until, finally, the spring-loaded plunger was released and continuity was completed within the switch. This was connected in series with a suitable stall-indicator. The incidence at which this occurred- the "warning incidence"- could be adjusted either by adjusting the leverage of the plunger about the axis of rotation of the flap or by adjusting the length of flap protruding outside the wing profile. The principle of the stall-detector is illustrated in fig.1, and figs. 3 and 4 show the unit mounted on the Anson and Provost respectively. An obvious criticism of the system described is that the warning circuit was completed when the aircraft was taxiing or at rest, since the aerodynamic loads on the flap were then low (or zero). This defect was eliminated by including an undercarriage micro-switch in the warning circuit, so that the system was not energised when the wheels were on the ground.

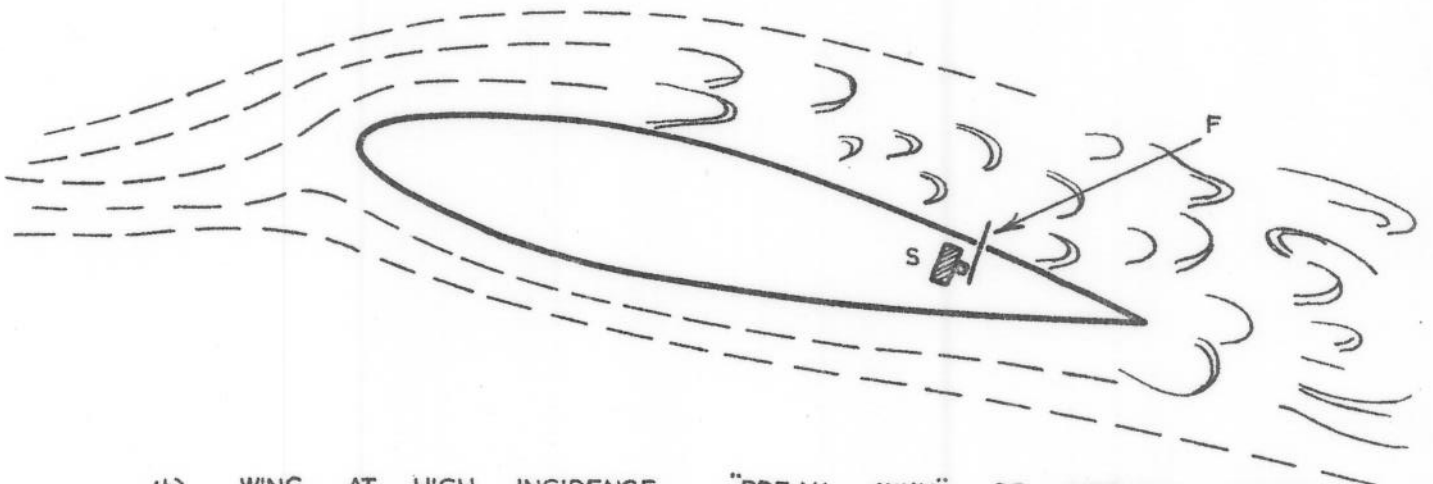
- (b) WING AT HIGH INCIDENCE. "BREAK AWAY" OF AIRFLOW OCCURS NEAR TRAILING EDGE, FLAP "F" IS MOVED FORWARD, RELEASING PLUNGER OF SWITCH AND CONTINUITY IS MADE.

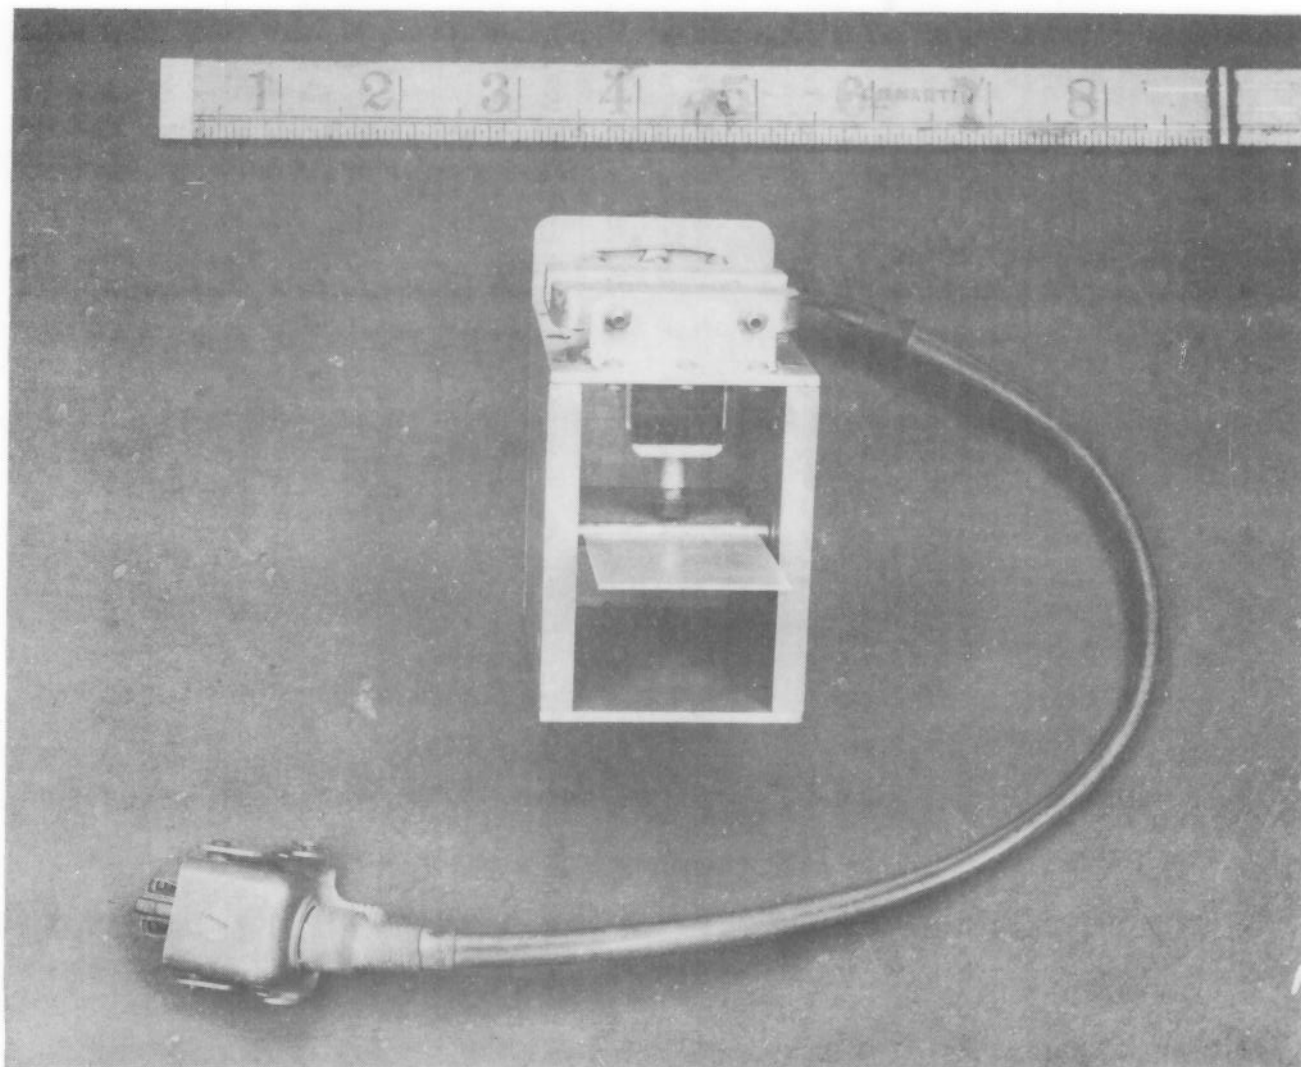
FIG 2

"The unit is mounted near the trailing edge of the wing so that the main part is inside the wing with the detector flap protruding outside the wing profile. The photograph illustrates the prototype unit; a much neater production version has now been manufactured."

STALL DETECTOR UNIT

The detector unit is illustrated in fig.2, but it should be remembered that this particular unit is a prototype and a version properly designed for production would be much neater.

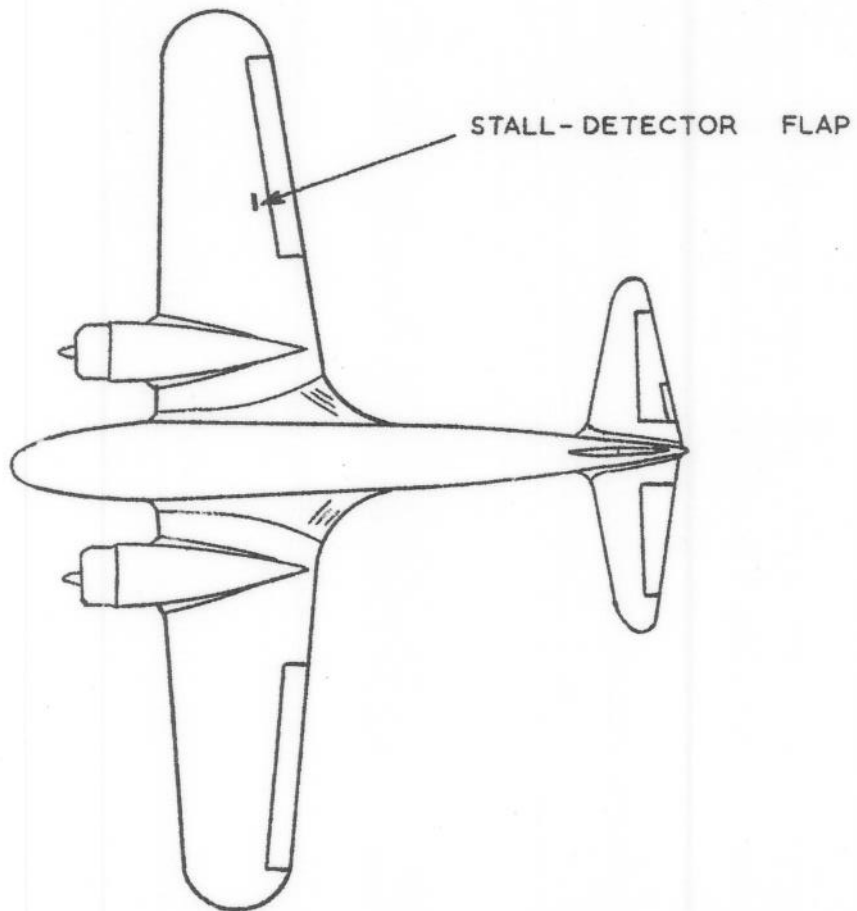
ANSON I.

The stall-detector was fitted to an Anson Mark I in a spanwise position just outboard of the landing flaps and propeller disc where wool tufts indicated a flow breakaway just before the stall. The detector was located at 75% of the local wing chord aft of the leading-edge (fig.3) and was connected in series with the stick-shaker described in ref.1. The effects of adjusting the length of the detector-flap protruding outside the wing profile are illustrated in fig.5 for various configurations of landing flaps and throttle setting. Fig.6 illustrates the similar effects of adjusting the micro-switch plunger in relation to the axis of rotation of the detector

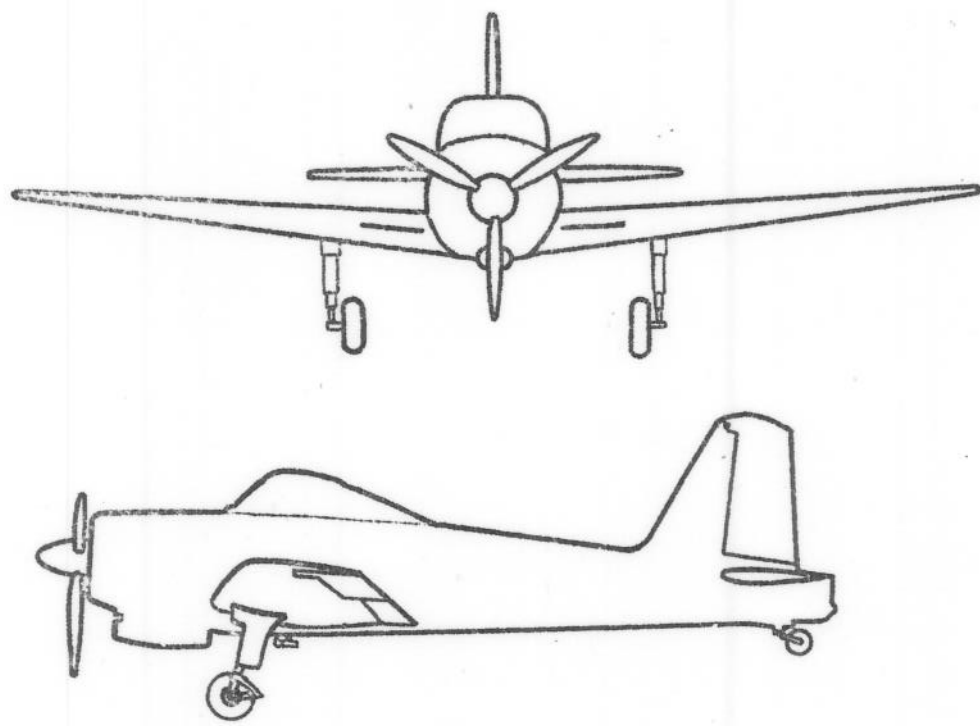
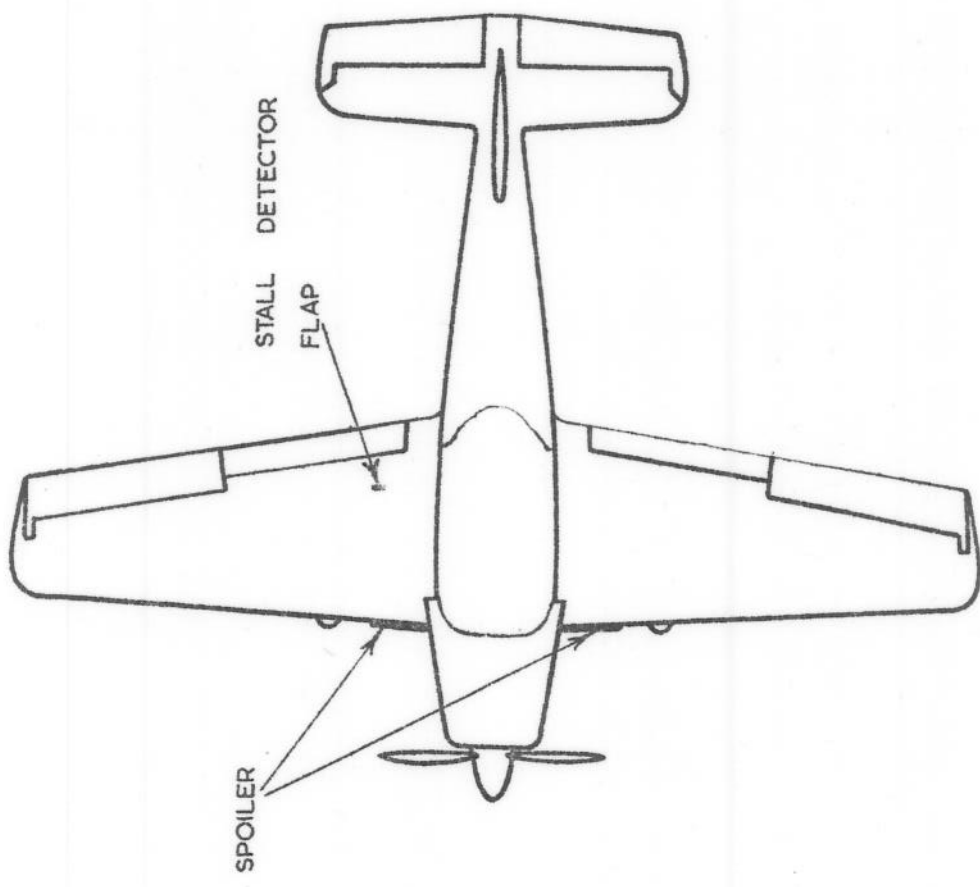
PERCIVAL "PROVOST"

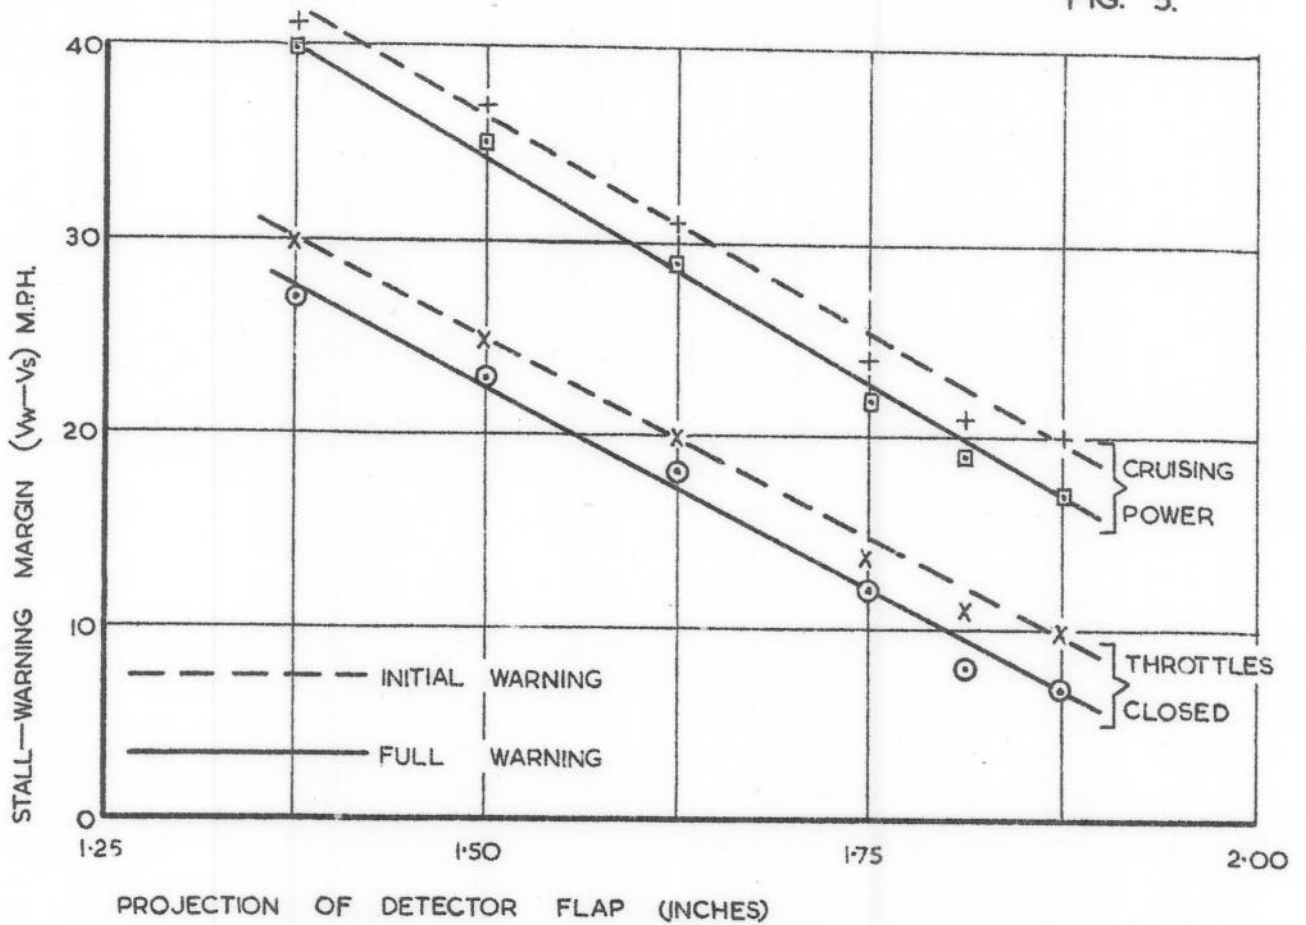
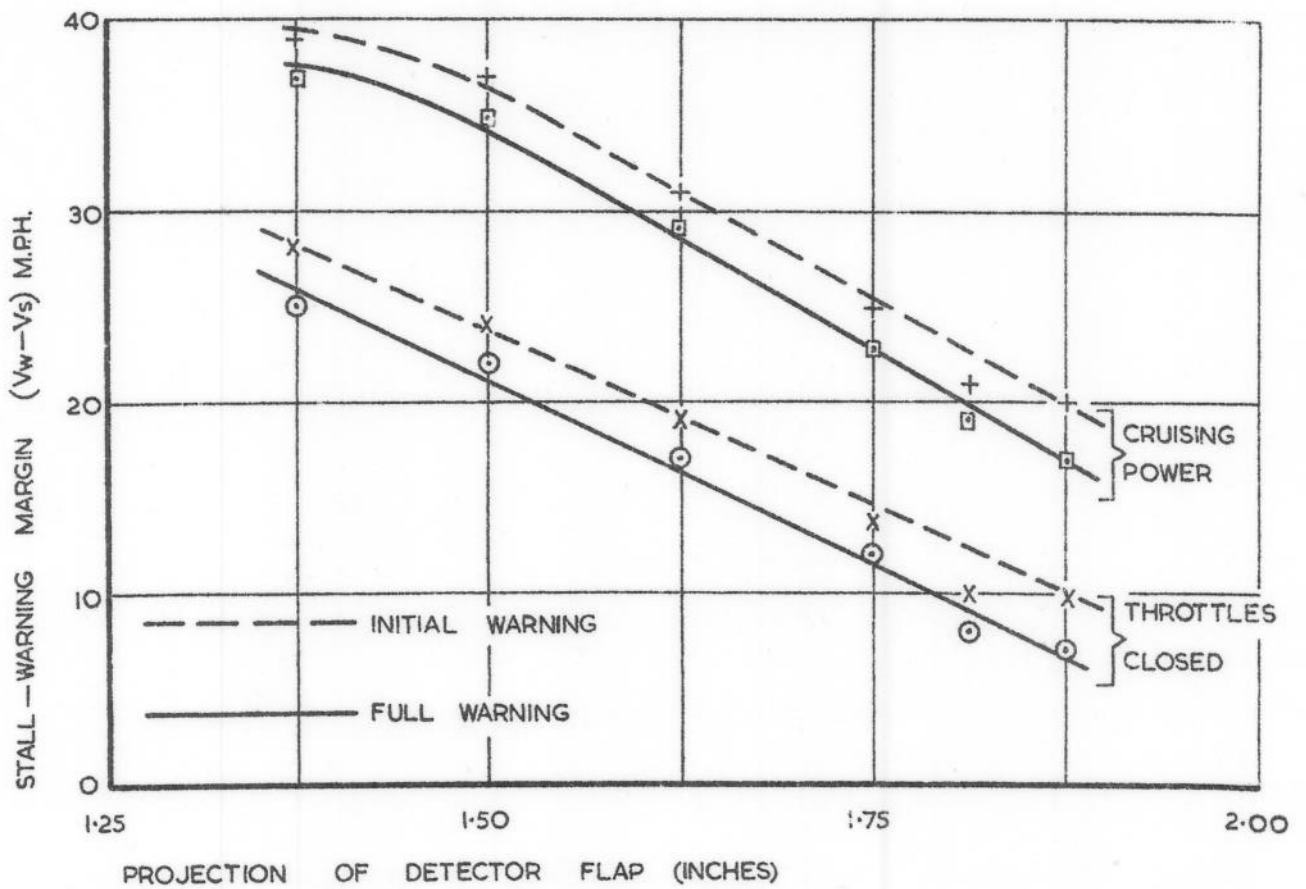
FIG. 5.

(a) LANDING FLAPS UP

(b) LANDING FLAPS 60° DOWN

EFFECT OF LENGTH OF STRAIGHT DETECTOR FLAP ON STALL—  
WARNING MARGIN — "ANSON"  
(MICRO—SWITCH POSITION = 0 I.E. AT DATUM POINT)

flap. Comparing the individual curves of figures 5 & 6 it can be seen that the warning margin (expressed in m.p.h. as excess of warning-speed over stalling-speed) was reasonably independent of landing flap position, but the margin was greater in the case of a powered stall. This was not considered undesirable since the powered stall on the Anson is more violent than the power-off stall and a greater warning margin may be an asset. This particular feature was probably associated with the spanwise location of the detector. The salient point, however, is that for any configuration the margin was adequate without being embarrassingly large.

It is clear from fig.5 and 6 that this type of detector can easily be adjusted to operate over a wide range of speeds. Movement of the micro-switch through 8 mms. relative to the axis of rotation of the flap caused a change in warning speed of about 15 m.p.h. so that it should be possible to adjust warning speed to an accuracy of about 1 m.p.h. Trimming the length of flap may be useful as a preliminary adjustment.

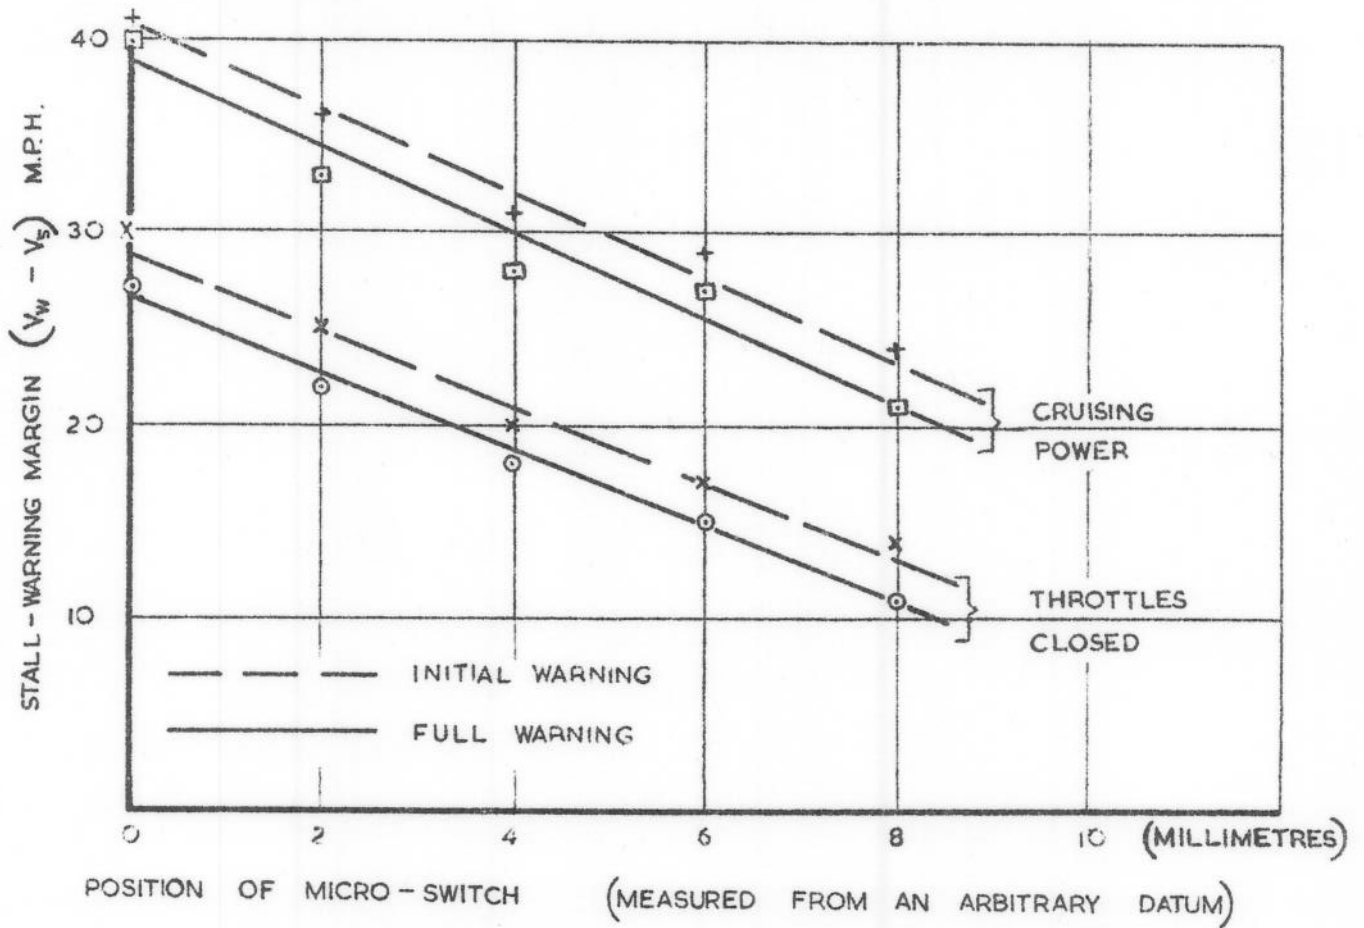
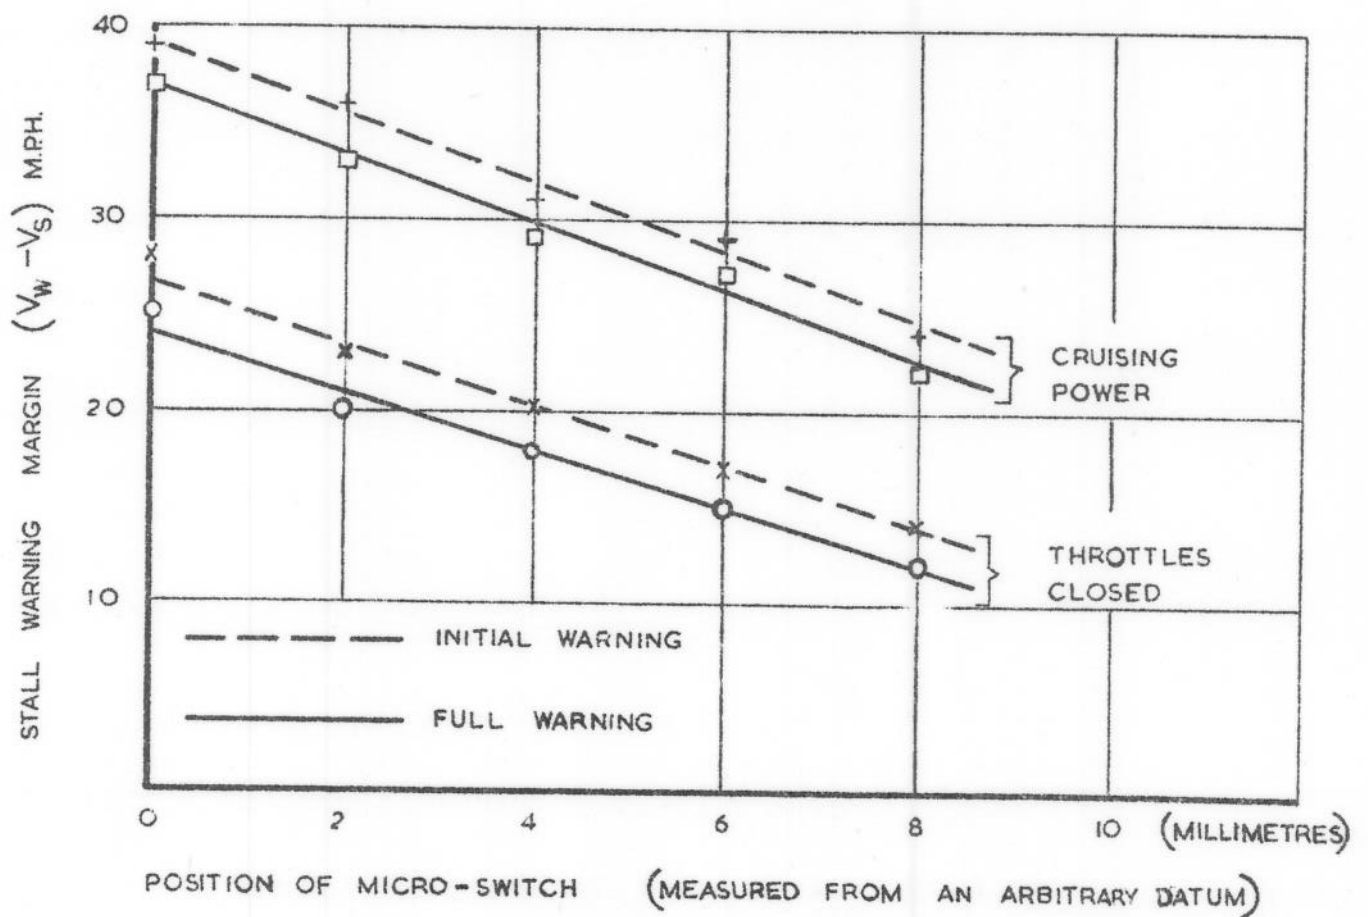
(a) LANDING FLAPS UP

(b) LANDING FLAPS 60° DOWN

EFFECT OF MICRO-SWITCH ADJUSTMENT ON  
STALL-WARNING MARGIN — "ANSON"  
(PROJECTION OF STRAIGHT STALL DETECTOR FLAP = 1 3/8")

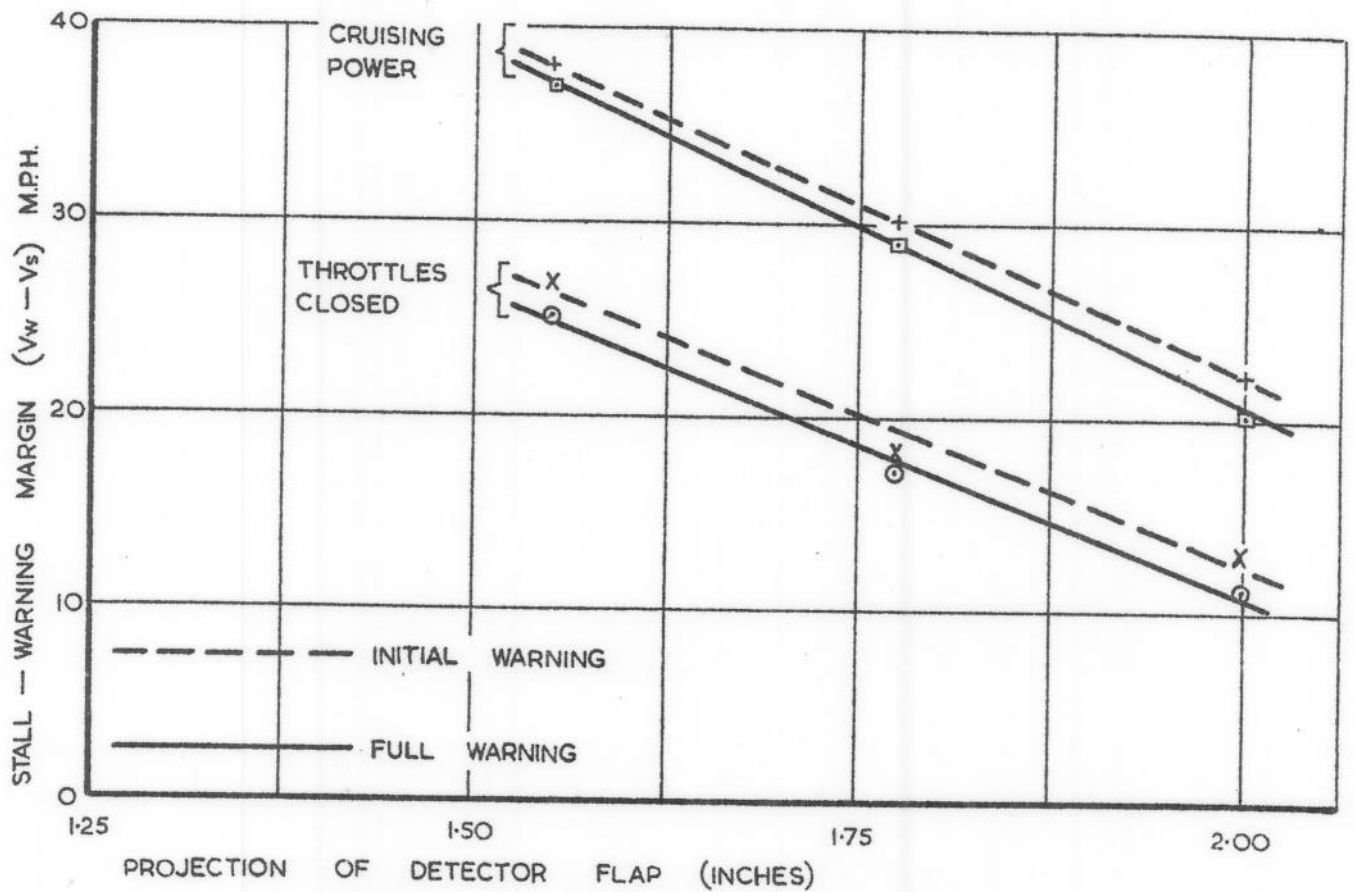
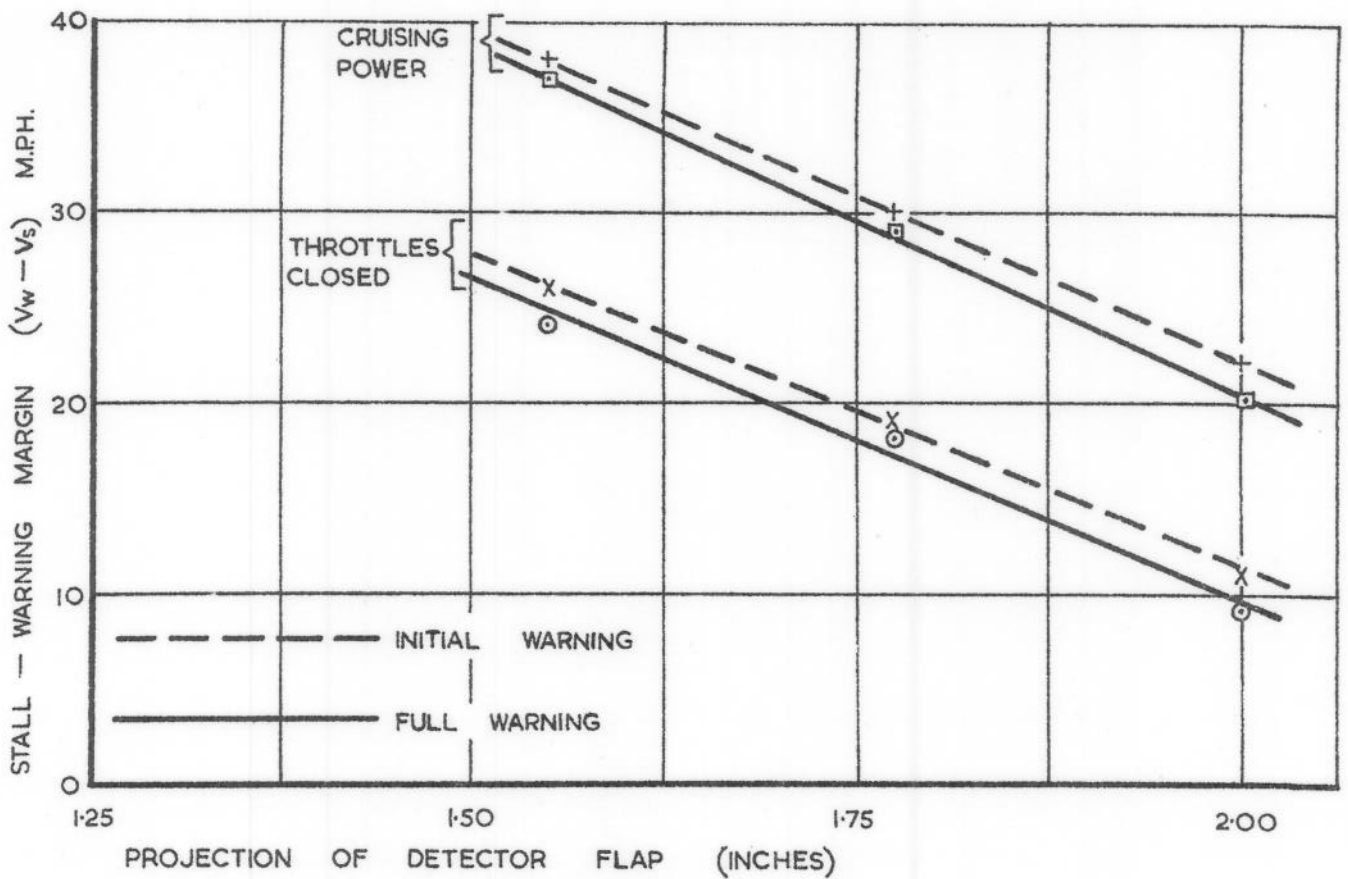
(a) LANDING FLAPS UP

(b) LANDING FLAPS 60° DOWN

EFFECT OF LENGTH OF 30° BENT DETECTOR FLAP ON STALL - WARNING MARGIN — "ANSON"  
 (MICRO-SWITCH POSITION = O, I.E. AT DATUM POINT)

It was suggested that a less objectionable excrescence on the wing would be presented if the detector flap was bent backwards rather than sticking out normally to the wing profile. Fig.7 illustrates the results obtained when the protruding flap of the stall-detector was bent backwards through  $30^\circ$ . For any particular length of flap the warning speed achieved with the bent flap was higher than that obtained with the straight flap; the effect of bending the flap is comparable with the effect of trimming the straight flap. Detailed comparison of fig.5 and 7 indicates that the warning margin achieved with a flap of length "1" bent backwards through  $30^\circ$  is approximately equal to that achieved with a straight flap of length " $1 \cos 30^\circ$ ". In other respects the bent flap worked in the same way as the straight flap.

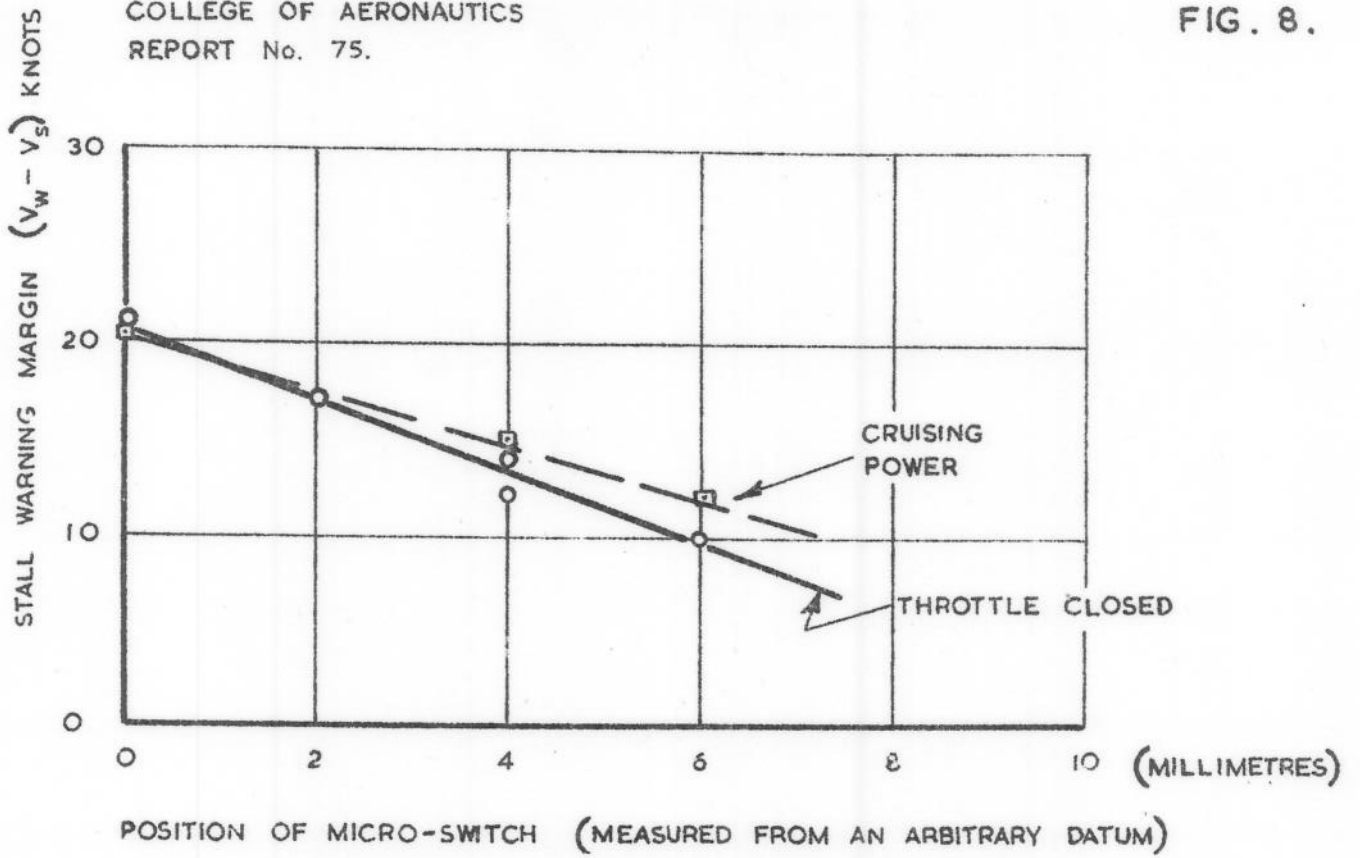
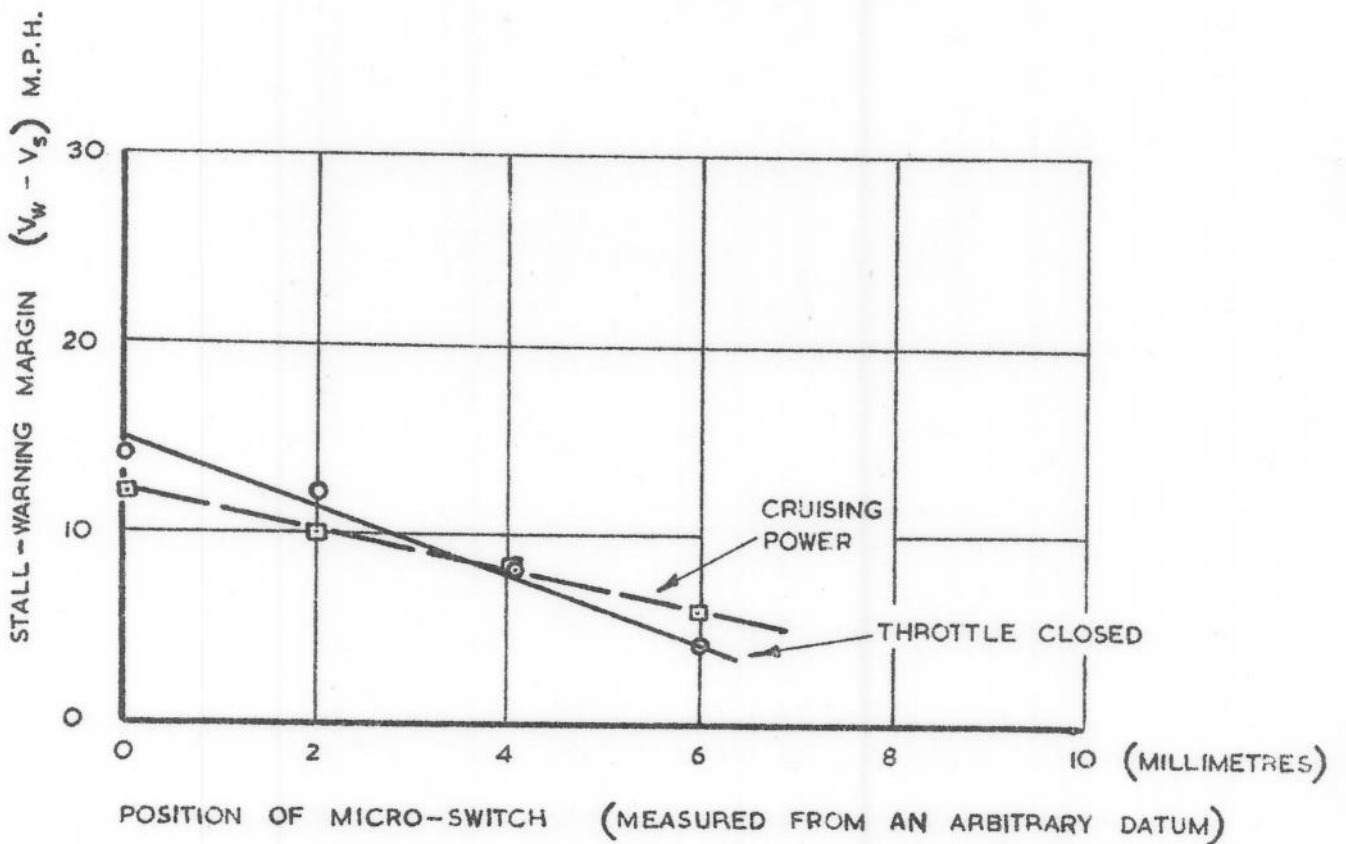
(a) LANDING FLAPS CLOSED

(b) LANDING FLAPS FULLY DOWN

EFFECT OF MICRO-SWITCH ADJUSTMENT ON  
STALL WARNING MARGINS - "PROVOST"  
(PROJECTION OF STALL DETECTOR =  $1\frac{7}{16}$ " )

Comprehensive flight trials of the detector were carried out on an Anson aircraft, followed by brief check trials on a Percival Provost. The results are given in fig. 5 to 9 and are discussed below.

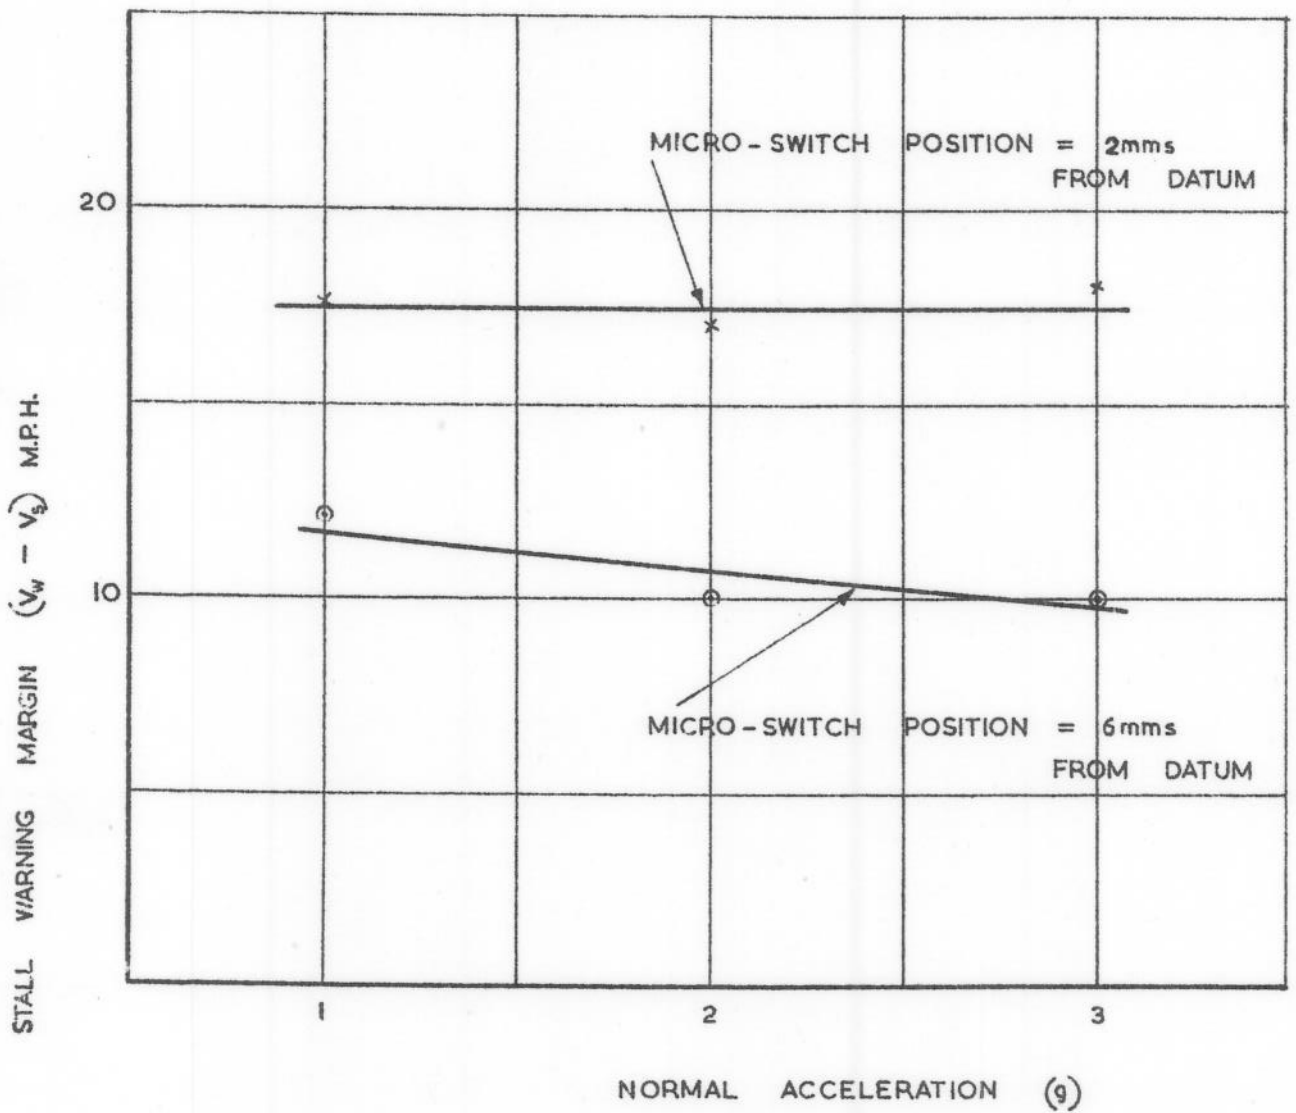
EFFECT OF NORMAL ACCELERATION  
ON STALL - WARNING MARGIN  
PERCIVAL "PROVOST"  
(FLAPS CLOSED)

(STALLS WERE CARRIED OUT AT CRUISING POWER  
IN STEADY FLIGHT AND IN STEEP TURNS  
AT STEADY "g")
