# Recent experiences of helicopter main rotor blade damage

## Abstract

### **Survey results**

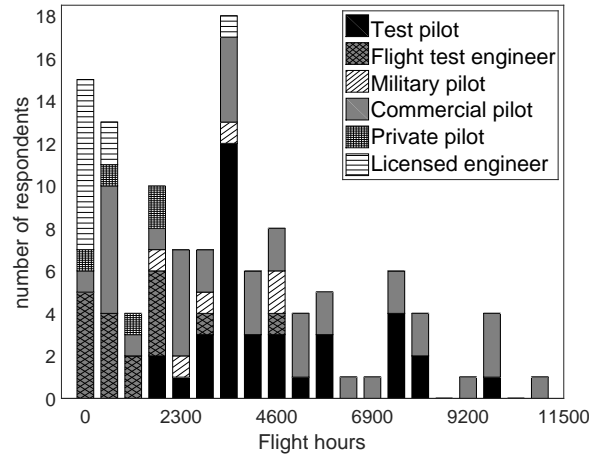
**Fig. 1** Respondents flying experience.

In total 115 participants worldwide consisting of test pilots (30 %), flight test engineers (14 %), military pilots (5 %), commercial pilots (36 %), private pilots (4 %) and licensed engineers (11 %) answered the survey. Figure 1 show the distribution of the participants and their respective experience in terms of flight hours. Each target group provides valuable input based on their extensive flying experience, different operational tasks, maintenance expertise, and their ability to evaluate the helicopter’s performance and behaviour in a practical way. The participants cover a large variety of helicopters, ranging from a maximum take off weight (MTOW) of 600 kg up to 18,000 kg. Some of these pilots have flown over 100 different types of helicopters.

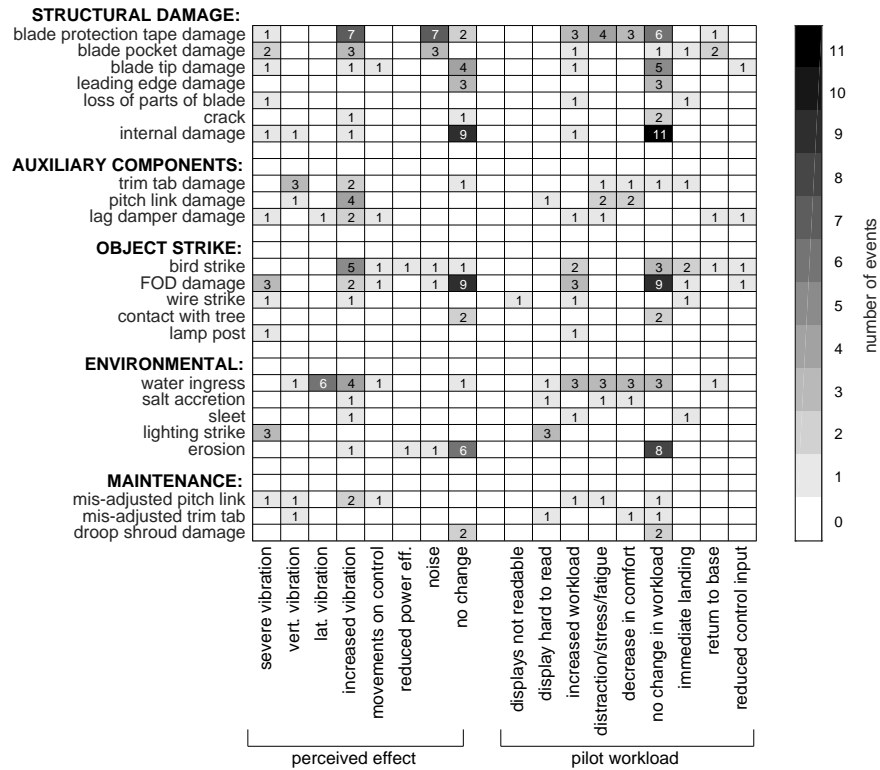
Fig. 3 Damage linked to perceived effects and pilot workload.

The results of the survey have been arranged into different groups relating to pilot perception and workload (Fig. 3). It can be seen that most of the damage is immediately felt by the pilot either through increased vibration or noise. The relationship of how damage affects pilot workload highlights that most internal damage and all erosion type damage resulted in no additional workload even though vibration was evident.
