Recent experiences of helicopter main rotor blade damage

Abstract

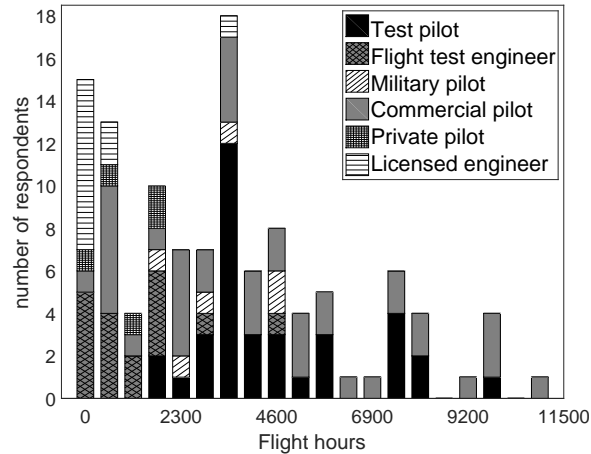
Fig. 1 Respondents flying experience.

In total 115 participants worldwide consisting of test pilots (30 %), flight test engineers (14 %), military pilots (5 %), commercial pilots (36 %), private pilots (4 %) and licensed engineers (11 %) answered the survey. Figure 1 show the distribution of the participants and their respective experience in terms of flight hours. Each target group provides valuable input based on their extensive flying experience, different operational tasks, maintenance expertise, and their ability to evaluate the helicopter’s performance and behaviour in a practical way. The participants cover a large variety of helicopters, ranging from a maximum take off weight (MTOW) of 600 kg up to 18,000 kg. Some of these pilots have flown over 100 different types of helicopters.
