Strain and damage monitoring in CFRP fuselage panels using fiber Bragg grating sensors. Part I: Design, manufacturing and impact testing

This is the first paper of a two-paper series describing design, implementation and validation of a strain and damage monitoring system for CFRP fuselage stiffened panels based on fiber optic Bragg grating sensors. The monitoring system was developed and tested on the basis of three load-scenarios: compression to failure of the undamaged panel, compression to failure of the impacted panel and compression to failure of the impacted and fatigued panel. This paper focuses on the design of the fuselage panel, the design of the monitoring system, the embedment of fiber sensors in the panel during manufacturing and the impact testing. The network of the sensors was designed based on a numerical buckling analysis from which the strain field of the panel was computed as a function of the applied compressive load. Embedment of fiber sensors in the panel was done so as to minimize risk of fiber breaking during manufacturing and impact testing and to effectively capture strains that are representative of damage developed in the panel due to compressive load

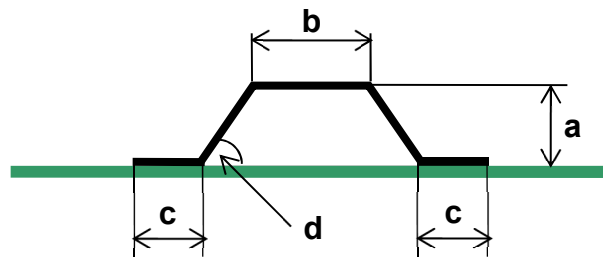
Fig.1

- Fig.1: Schematic and dimensions of the omega stringer.
- Fig.2: FE mesh of the fuselage barrel.
- Fig.3: Variation of design variables with respect to design cycles: a. number of stringers, stringer layup, stringer thickness, skin thickness.

- a:** stringer's height
- b:** stringer's upper cap width
- c:** stringer's lower feet width
- d:** angle of stringer's webs

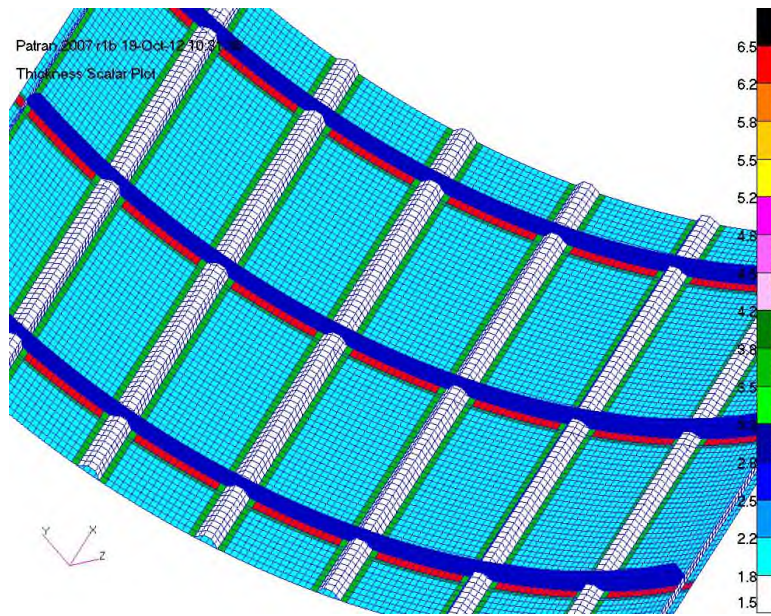
Fig.4

- Fig.4: Variation of skin thickness in the FE model of the curved barrel.
- Fig.5: Schematic of the flat CFRP stiffened panel.
- Fig.6: Schematic of the panel including dimensions, locations of impact damage and artificial delamination.

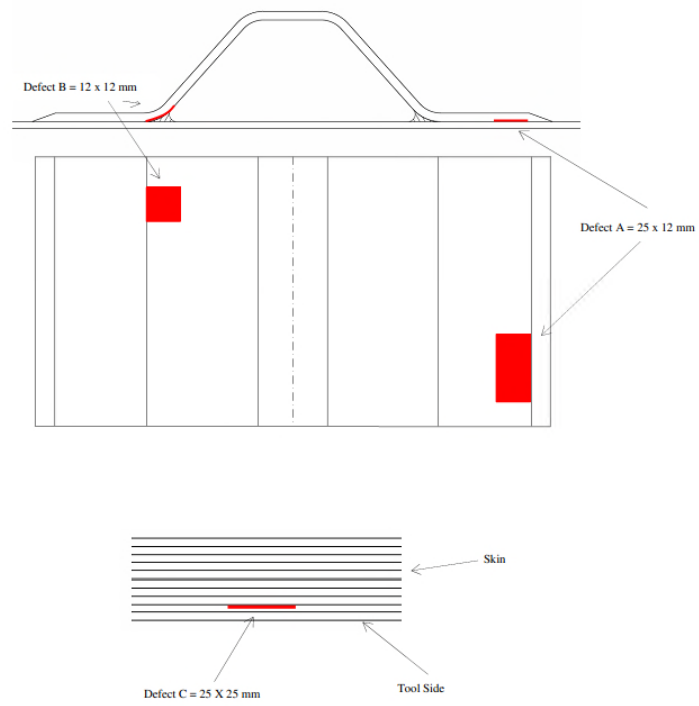
Fig.7

- Fig.7: Schematic illustrating locations of artificial delaminations.
- Fig.8: FE mesh of the flat panel used for buckling analysis.
- Fig.9: Schematic of the boundary conditions applied to the model of the panel.

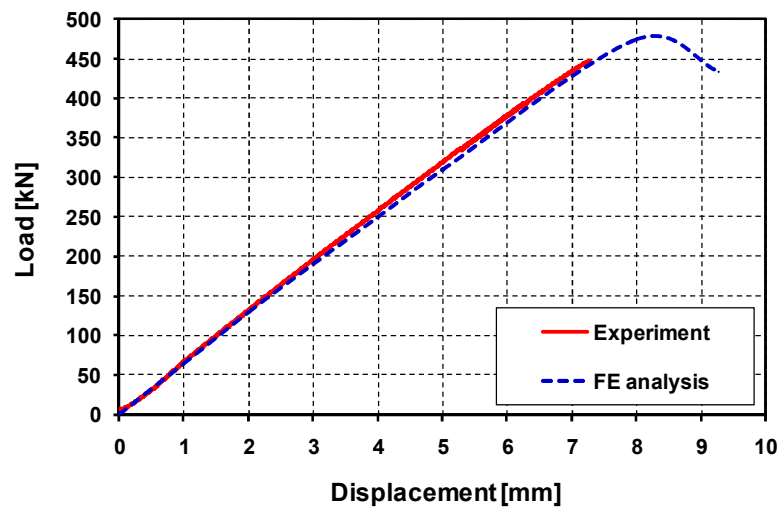
Fig.10

- Fig.10: Comparison between numerical and experimental [24] load-displacement curve of the panel.
- Fig.11: Predicted contour of normal displacement (in mm) and deformed shape of the panel at a. 70 kN and b. 475 kN.

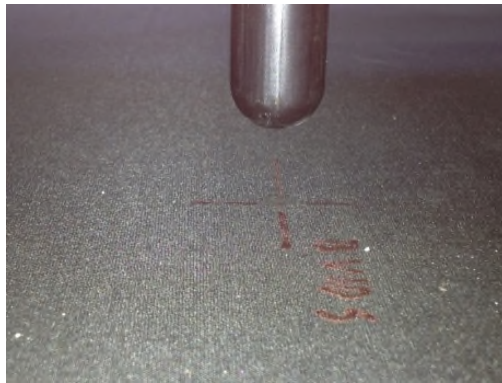
Fig.15

- Fig.15: Photo of the impactor above BVID5 location.
- Fig.16: Photo of the panel supported by the metallic device just before subjected to impact testing.

Impact damage was created in panel_2 and panel_3 using an INSTRON Dynatup 9250 HV drop tower. Several experiments were conducted to create BVID and VID sites at the specified locations indicated in Fig.6 using a semi-circular impactor with a diameter of 16 mm (Fig.15). During testing force and energy versus time and deflection were recorded. A full lateral support at the large sides of the panels was applied during impact. To apply these boundary conditions, the special metallic device shown in Fig.16 was built.

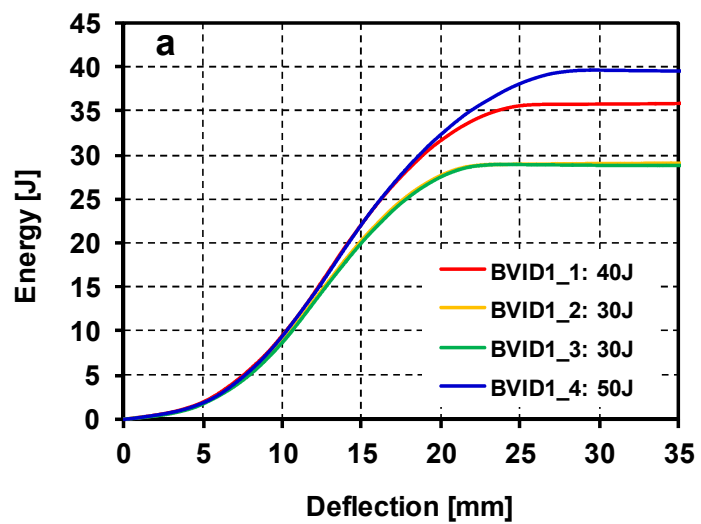
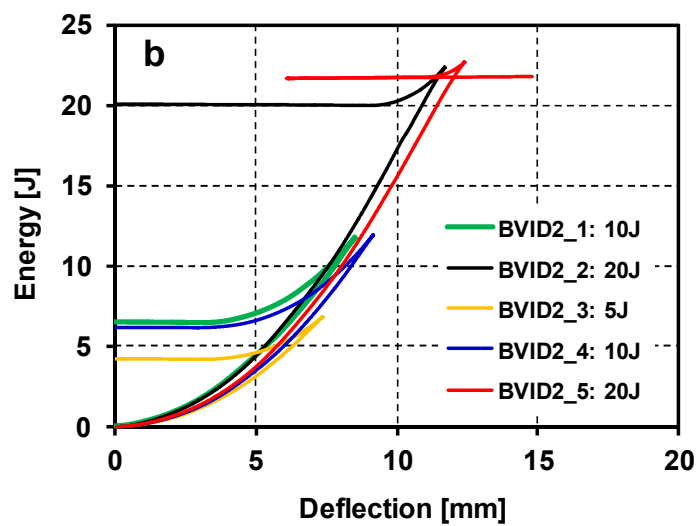
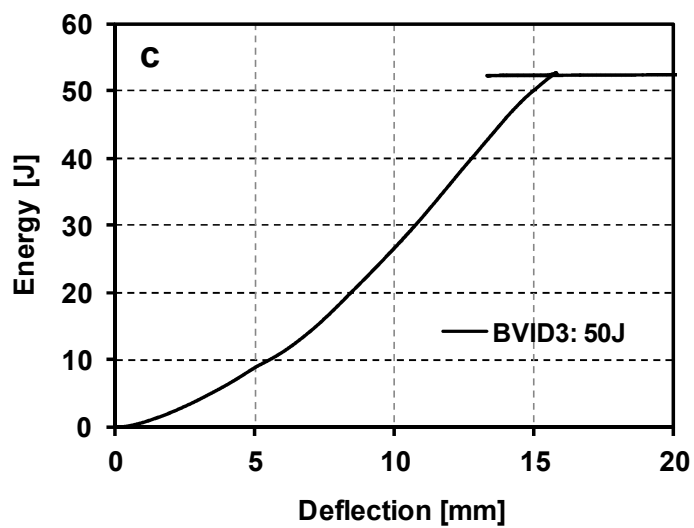
Fig.17

- Fig.17: Plots of energy versus deflection recorded during a. BVID1 test, b. BVID2 test and c. BVID3 test.
- Fig.18: a. Close view of the impact damage at BVID5 location and b. C-scan of the area around BVID5 location.

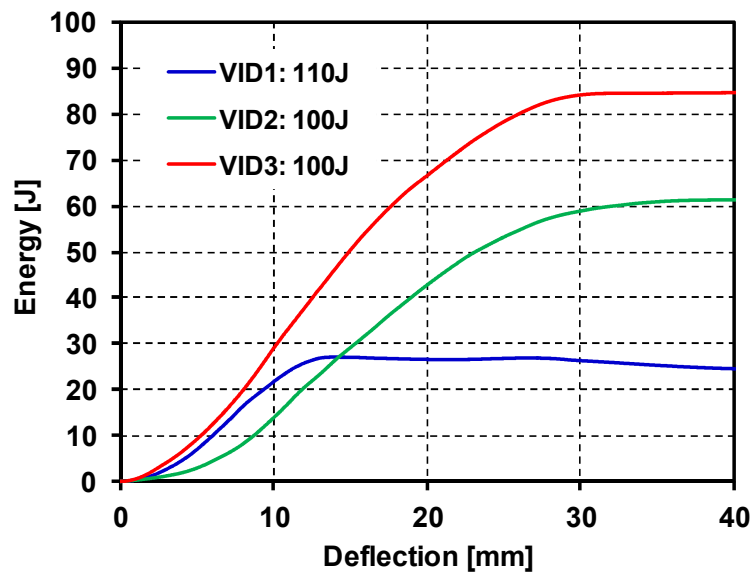
Fig.19

- Fig.19: Plot of energy versus deflection recorded during VID tests.
- Fig.20: Hole created due to impact at VID4 location: a. impacted side and b. opposite side. c. C-scan around VID4 location.

The variation of energy with respect to the deflection for the VID1, VID2 and VID3 locations is plotted in Fig.19. In this case, much larger impact energies were applied as practically there is no threshold for the developed impact damage. In most VID tests, a hole was created in the panel. This is also the case for VID4 shown in Fig.20. The C-scan of the impacted area (Fig.20c) shows the amount of delamination and matrix cracking accumulated around the hole.
