The response of aluminium/GLARE hybrid materials to impact and to in-plane fatigue

Keywords: Bonded hybrids; Damage tolerance; Fatigue crack growth; Fibre Metal Laminates; Impact

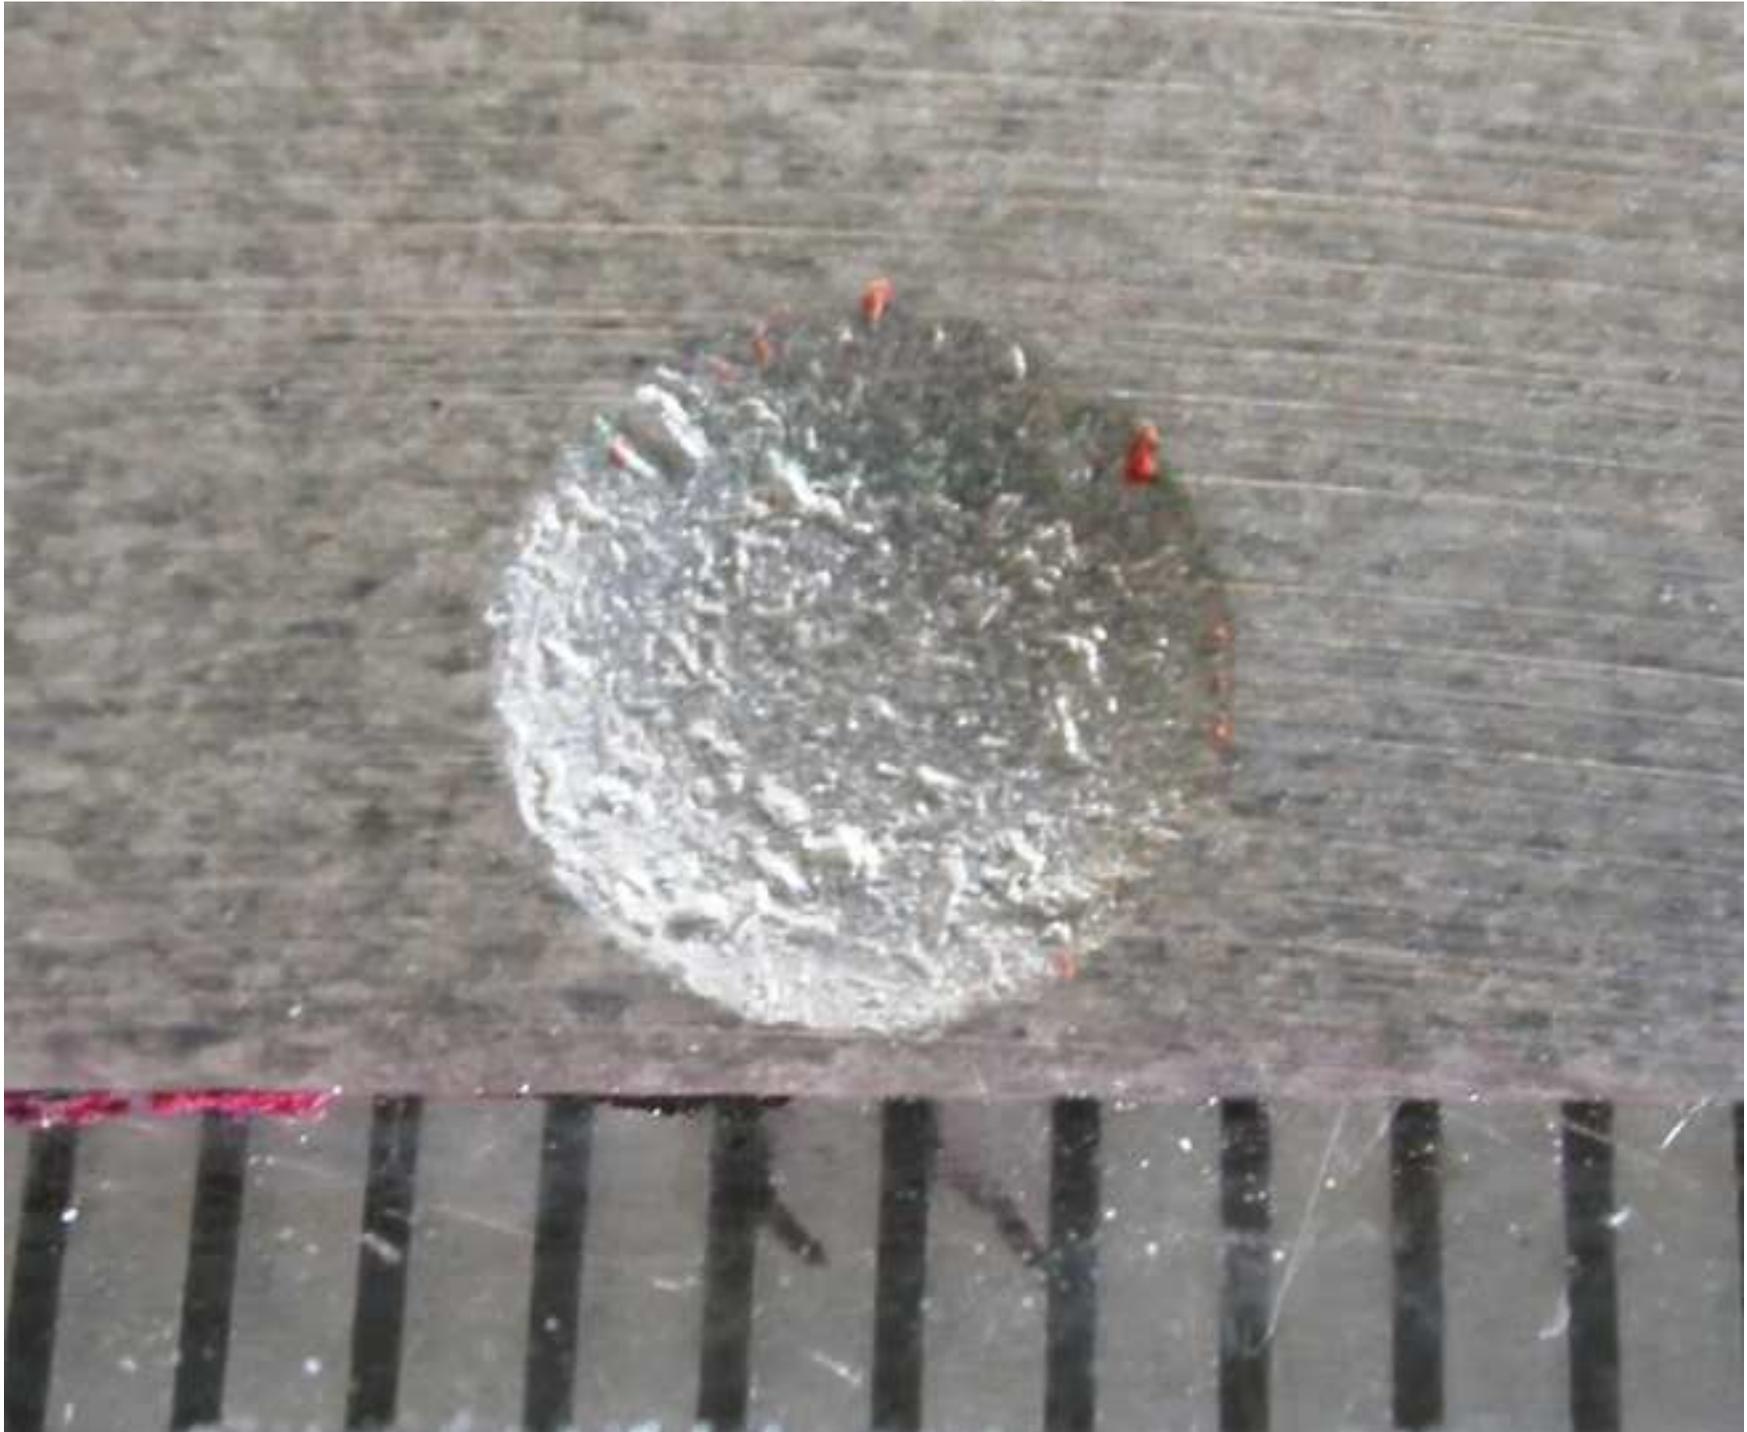
figure 8

- Figure 7 Indentation produced on substrate after impact at 50 J
- Figure 8 Phased array C scan image of delamination damage produced after 30 J impact on to the aluminium substrate.

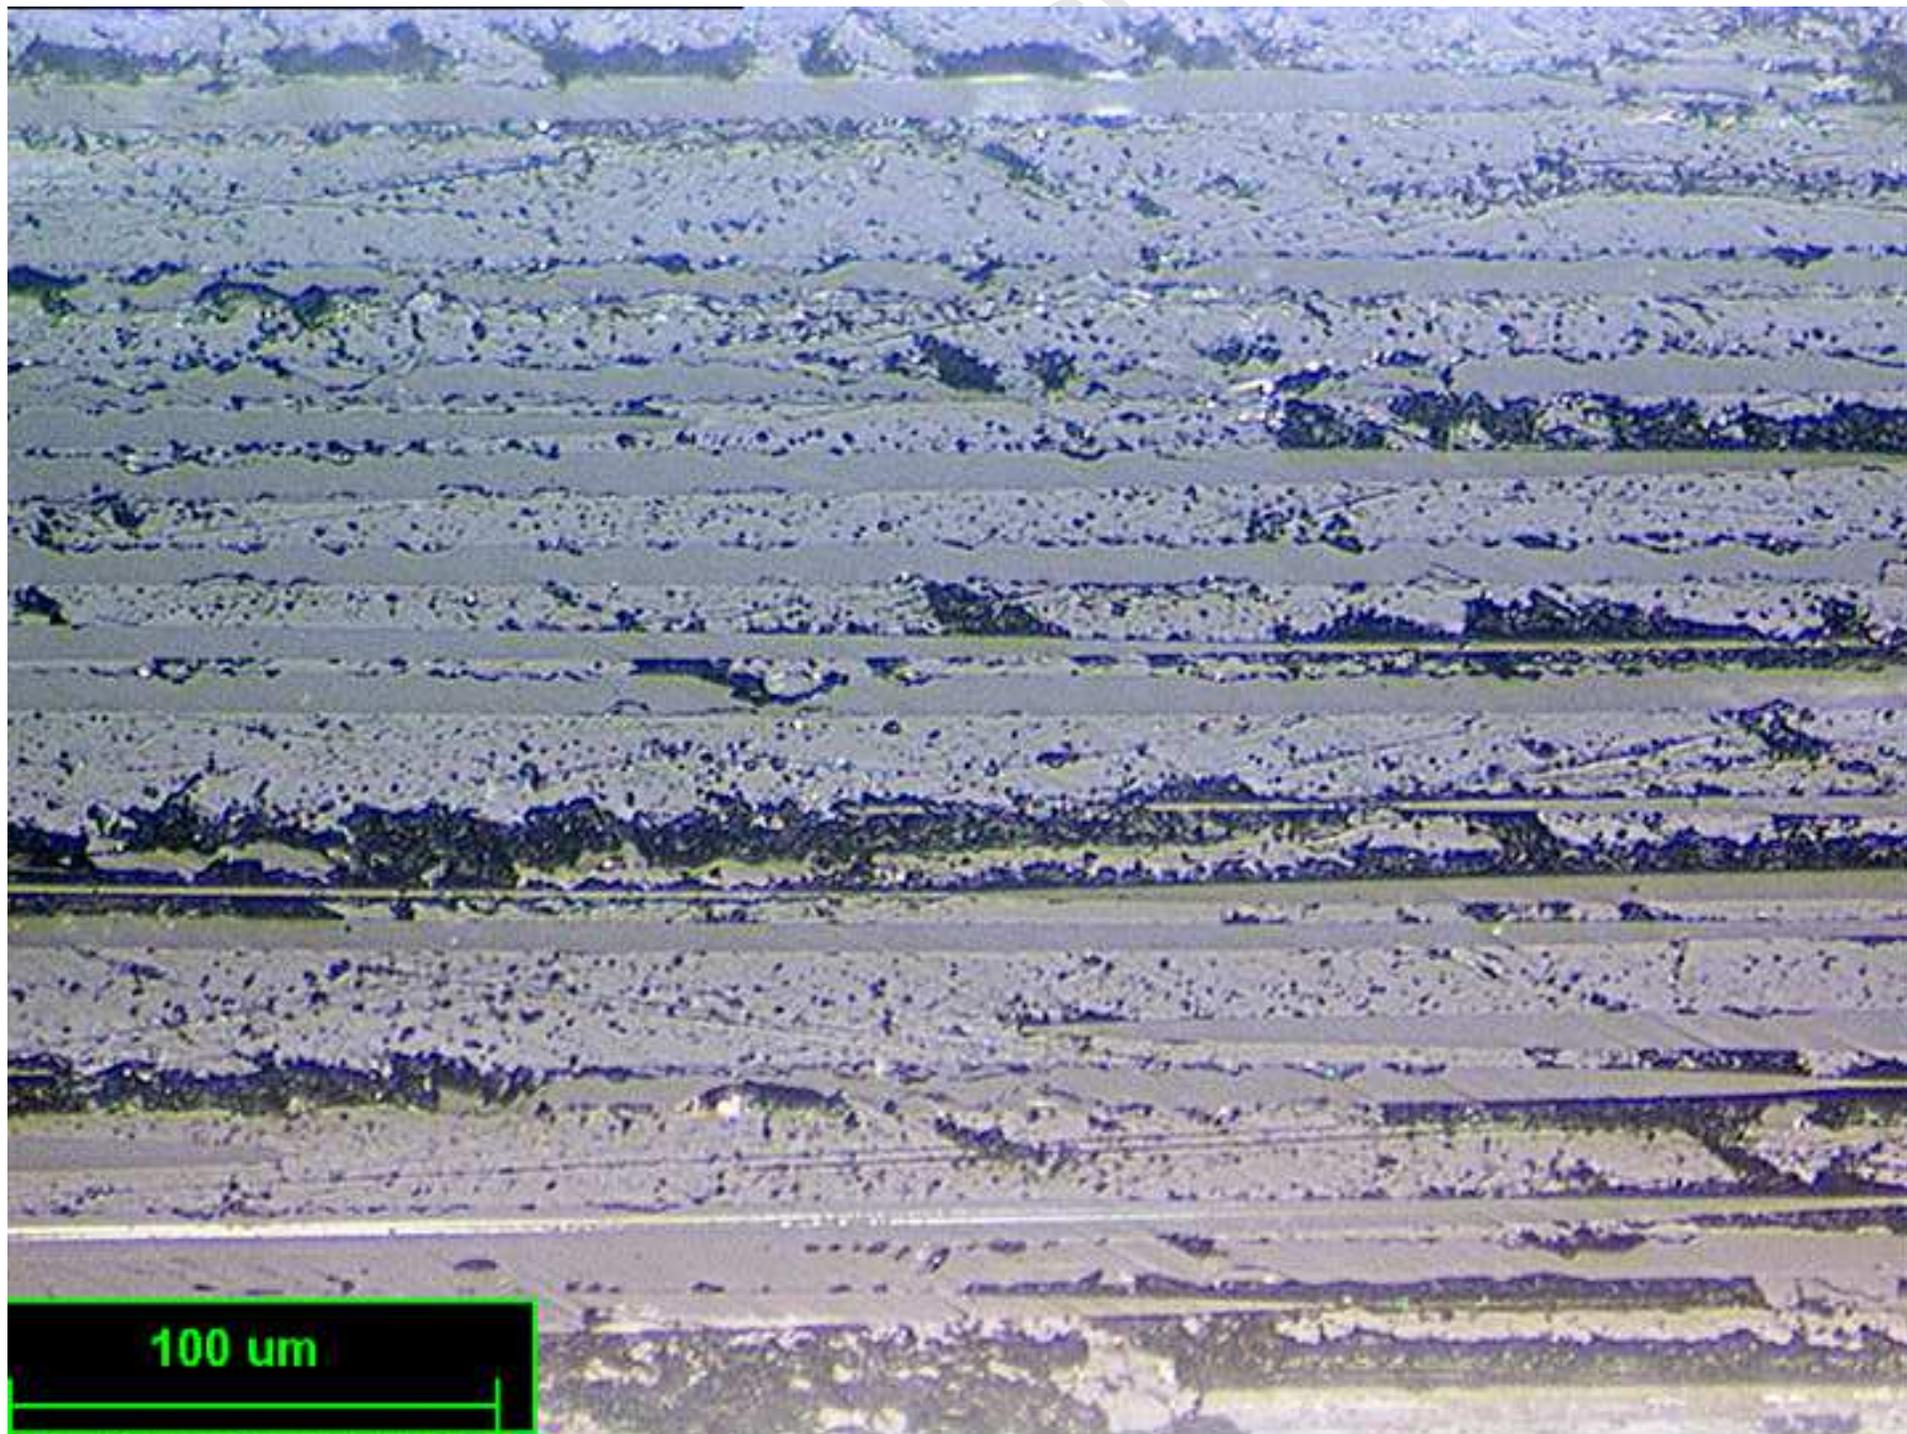
figure 12

- Figure 12 Optical micrograph showing cracks in the glass fibres at 45° (see arrows) with respect to the fibre axis in second glass layer within GLARE after 50 J impact on the substrate.
