The Fourth International Conference on Through-life Engineering Services

Degradation Assessment of Industrial Composites using Thermography

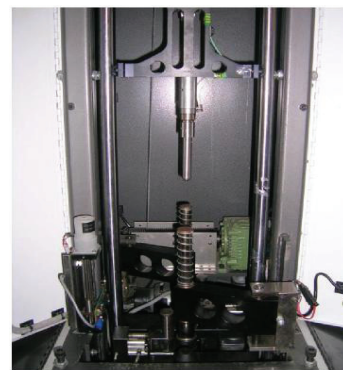
Fig. 3. Drop-weight tower.

Six plates were impacted in the middle with different energy levels using a drop-weight machine. The impactor of this

machine, as shown in Fig. 3, was semi-spherical, 16mm diameter and 2.281kg weight.

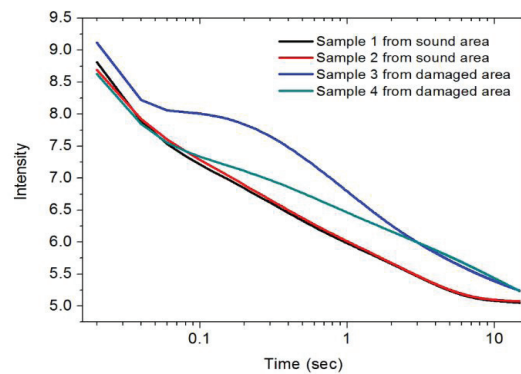
Fig. 7. Time-temperature profiles for 4 selected samples, the first two of which were from the sound area and other two were from the damaged area.

In the proposed method, the time-temperature profile for each pixel of the thermal image is considered to determine the sound areas and damaged areas. Consider four sampled pixels from the image, two of which were from the sound area and other two were from the damaged area. The $\log(t)$ vs $\log(\Delta T)$ profiles for these four samples are shown in Fig. 7. The value of ΔT was calculated by subtracting the initial temperature before the flash from the current temperature for the considered pixel. Inspection of this figure shows that for sampled pixels from the sound area the temperature cooling curves are close to linear, which is not the case for ones from the damaged area. The new method utilises this characteristics to classify the pixels from sound areas and damaged areas by measuring the similarity between the observed temperature cooling curve and its linear fitting.

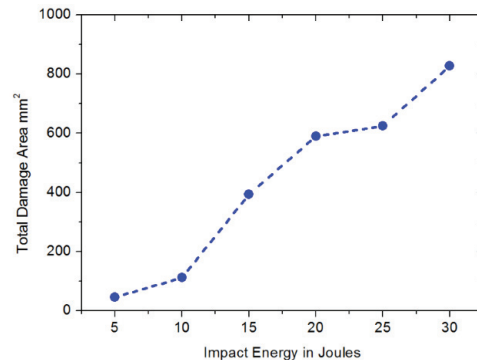
Fig. 13. Measured total areas of damage for all 6 specimens.

All six specimens have been analysed by the proposed routine. The visualisation results are shown in Fig. 12 and measured total damage area in mm² versus the impact factor is shown in Fig. 13 with the same thresholds. Inspection of Fig. 12 shows that the secondary damages were detected for all specimens, while the primary damages were detected for specimens with impact energy no less than 10 joules. For the specimen 5J, the primary damage probably is too weak to be detected by thermal inspection. Figure 13 obviously shows that the higher the impact energy, the larger the delamination area detected.
