## Bearing Damage Characteristics of Fibre-reinforced Countersunk Composite Bolted Joints Subjected to Quasi-static Shear Loading

This paper studies the progression of damage in carbon fibre-reinforced polymer (CFRP) countersunk composite bolted joints (CBJs) with neat-fit clearance, subjected to quasi-static loading. Damage mechanisms, comprising of fibre buckling and breakage, matrix damage, shear damage and inter-laminar delamination within the CFRP composite parts of the joints have been studied. Load-displacement curves, X-ray and optical microscopic images in single- and three-bolt CBJs were used to investigate damage and deformation characteristics. The observations were then employed to further investigate the type of failure and the extent of damage. The evolution of damage within the composite parts was correlated to the failure characteristics of the joints: It was found that the type and extension of damage is strongly correlated with the ultimate failure load point of the joint in single-bolt CBJs. A combined inter/intra-laminar damage consisting of fibre cluster breakage, extensive fibre buckling, debonding and delamination was observed at the ultimate failure load.

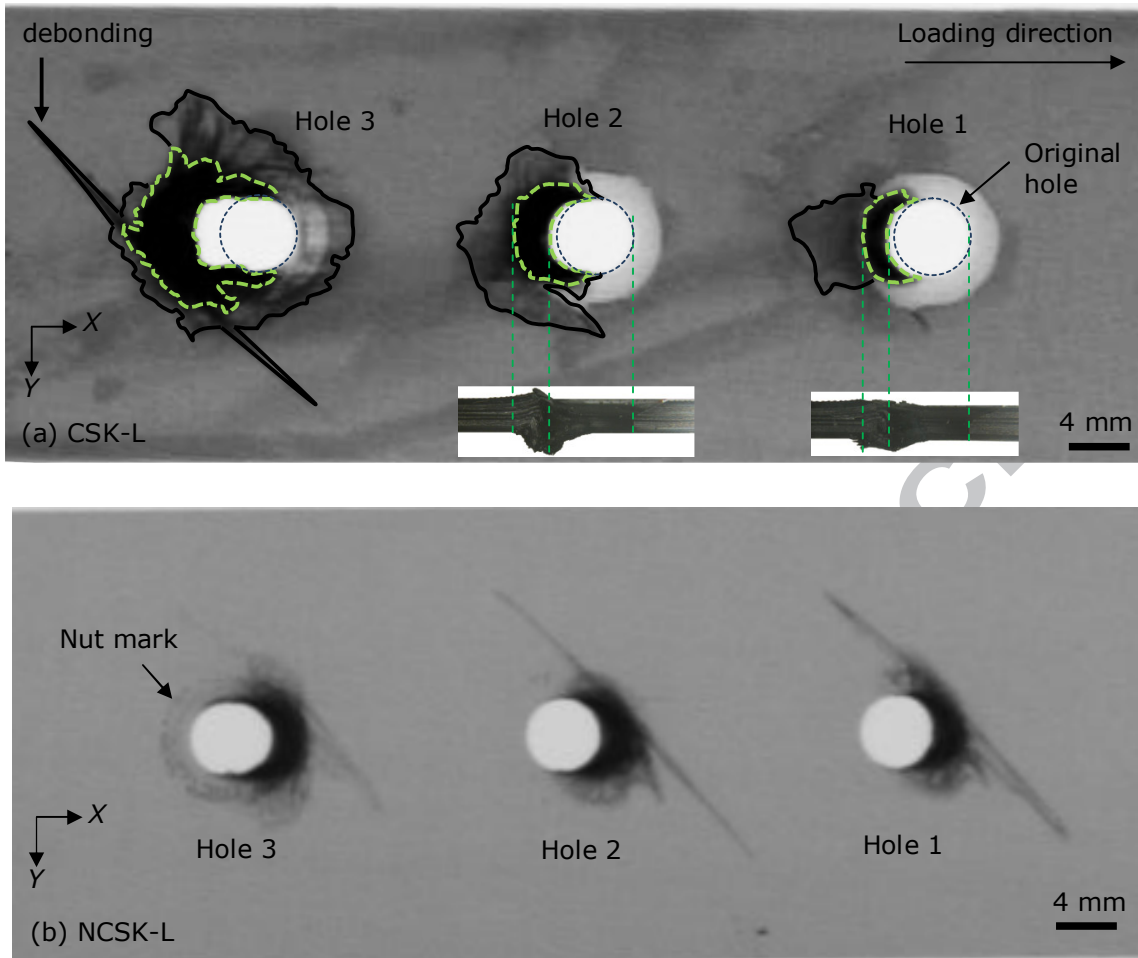
Figure 9: X-ray image of three-bolt CBJ using X-ray, (a) CSK-L, (b) NCSK-L

three-bolt joint, however, the images highlight the occurrence of in-plane damage as the dominant mechanism. The region surrounding hole 3 was severely damaged and could not provide any meaningful results, and so was not presented. For comparison, the X-ray image of the three-bolt CBJ is shown in Figure 9.

As seen in Figure 9(a), damage area in the CSK part is largest at Hole 3 and smallest at Hole 1, while damage at each bolt-hole in the NCSK laminate in Figure 9(b) is almost identical. This difference in damage area is attributed to the presence of countersunk head crushing into the top surface of the CSK laminate, as was clearly observed during testing. This observation is in stark contrast to what is observed in protruding head bolted joints, where damage is anti-symmetric, meaning that damage at Hole 1 in one joint member is normally equal to damage at Hole 3 in the opposite joint member [16, 17]. This loss of anti-symmetry means that countersunk bolted joints must be analysed fully at each bolt-hole, and that simplifying extrapolations derived from single-bolted joint tests must be used with caution. We thus now offer a new method to predict the damage growth in CSK joints based on the concept of damage areas.
