Air Traffic Control Radiotelephony Safety:  
Investigating the English Second Language Users' Perspective

School of Engineering

PhD

October 2007

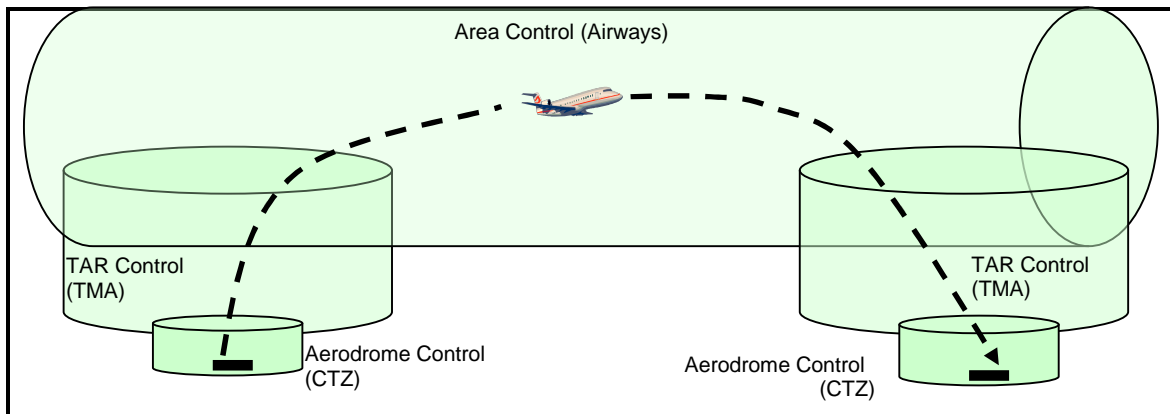
Figure 2-1: ATC Airspace Structure

Figure 2-1 illustrates an aircraft passage through a simplified airspace structure with the relevant ATC units having jurisdiction of the airspace portions. The flight will begin and end at an aerodrome where the tower/ aerodrome controller is responsible for flight movements. In the TMA the approach radar control directs and positions a flight onto the en-route phase. Once joining the intended airways, the area control takes charge of an aircraft flight until descend phase in preparation for arrival. At this point, the flight once again enters the TAR control airspace. Landing and gate-in at the end of a flight will be under the responsibility of the aerodrome controller.

Terminal Control Area (TMA) which could be compared to city areas, are more congested as many airways confluence here for traffic movements into and out of an airport. The airspace surrounding an airport is known as the control zone (CTZ). These segments of control areas, control zones, airways, terminal areas and aerodrome traffic zones are structured for the efficient and smooth control of traffic flow.

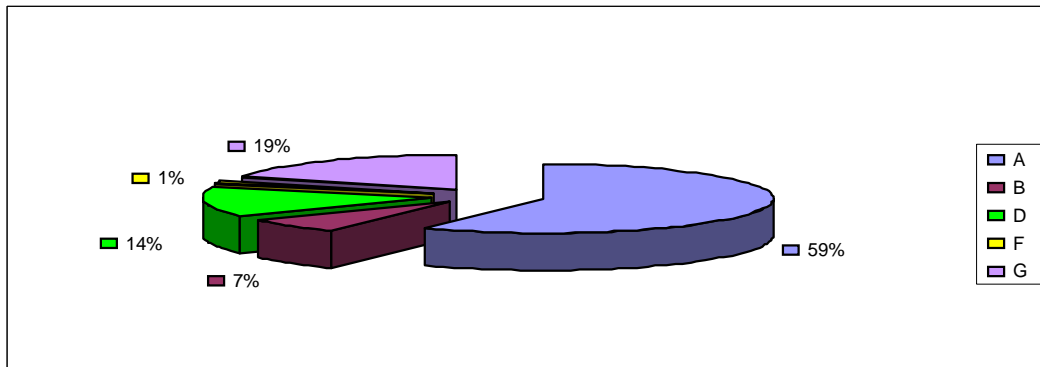
**Figure 3-5: Airprox by Airspace Classification**

Figure 3-5 show the percentages of discrepancies per airspace class. It was noted that discrepancies took place more often (59%) in class A airspace which is busier and under positive control at all times, compared to other classes of airspace. 7% were in Class B airspace, which increased the percentage of discrepancies in positive control airspace to 66%.

In uncontrolled airspace, Classes F and G where flights receive only flight information, about 20% communication discrepancies were observed. Class D is advisory airspace and responsibility for separation is shared between pilots and controllers. This airspace recorded 14% of the discrepancies. There is very little Class E airspace in the UK and no language or communications discrepancies were recorded in it.

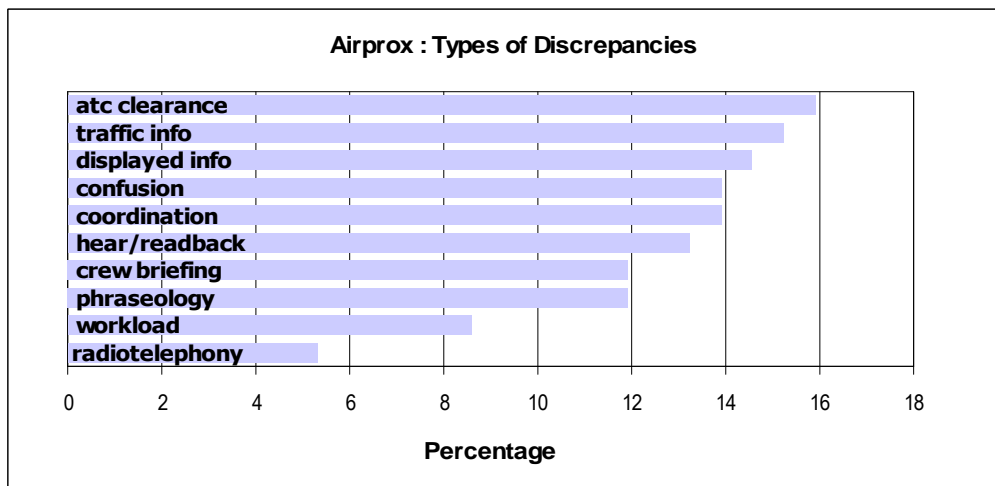
**Figure 3-6: Types of Discrepancies**

Figure 3-6 shows the types of discrepancies. The lowest percentage, at about 5%, was for 'radiotelephony technique and equipment problem'. This may be due to advanced and more reliable telecommunication systems now. ATC clearance (unclear or misleading) made up 16% of discrepancies.

Workload totalled to about 9%, suggesting that problems may have occurred during high, complex traffic situations. Other discrepancies showed between 12 to 15% occurrence, suggesting that problems between controller-pilot (ATC clearance, hear/readback and phraseology) and controller-controller (displayed information, coordination and crew briefing) are seen to be equally significant as Airprox causal factors. 'Traffic info' and 'confusion' type of discrepancies could occur in either pilot-controller or controller-controller communications.

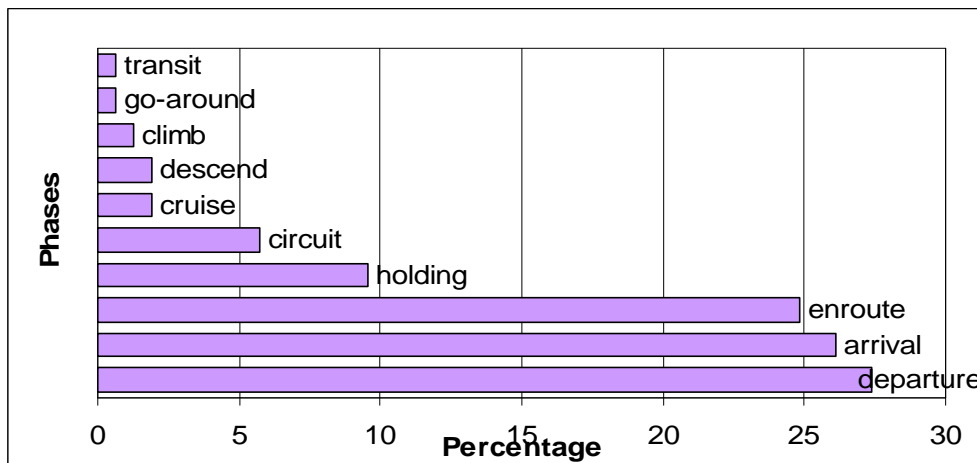
Figure 3-7: Airprox by Flight Phase

An analysis of the flight phase (Figure 3-7) indicated that the departure, arrival and enroute phases show high percentages of communication discrepancies. This could be attributed to high workload and similarly high communication events between pilots and controller as these phases involved movements of aircraft within the terminal control area (TMA).

Aircraft in transit, on cruise and on a missed approach (go-around) usually follow fixed routings and standard procedures where minimum communication is required. The phases categorised as climb and descend in the data source are those at higher flight levels, where navigational and level changes are less frequent. Circuits and holding showed higher discrepancies as these involved more congested airspace and the possibility of conflict is greater, while communications needs are more frequent.

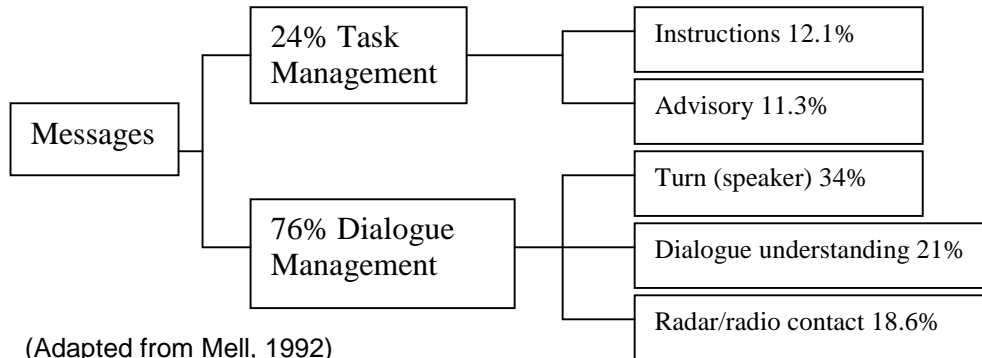
**Figure 4-1: Messages type in abnormal situations dialogue**

In a second radiotelephony study by Mell () involving ESL controllers, the focus was on discourse analysis of dialogue in abnormal situations. Mell considered that the understanding of non-standard dialogue in terms of pragmatic and discursive characters is critically important in maintaining the safety margin of civil aviation. In this study, only 24 % of messages were found to be associated with task management, in which 12.1% was issuing of instructions and 11.3% was information advisory (refer Figure 4-1). Dialogue management occupied

76% of communication, with 34% for turn management, 21% for dialogue understanding and 18.6% associated with radar/radio contact.

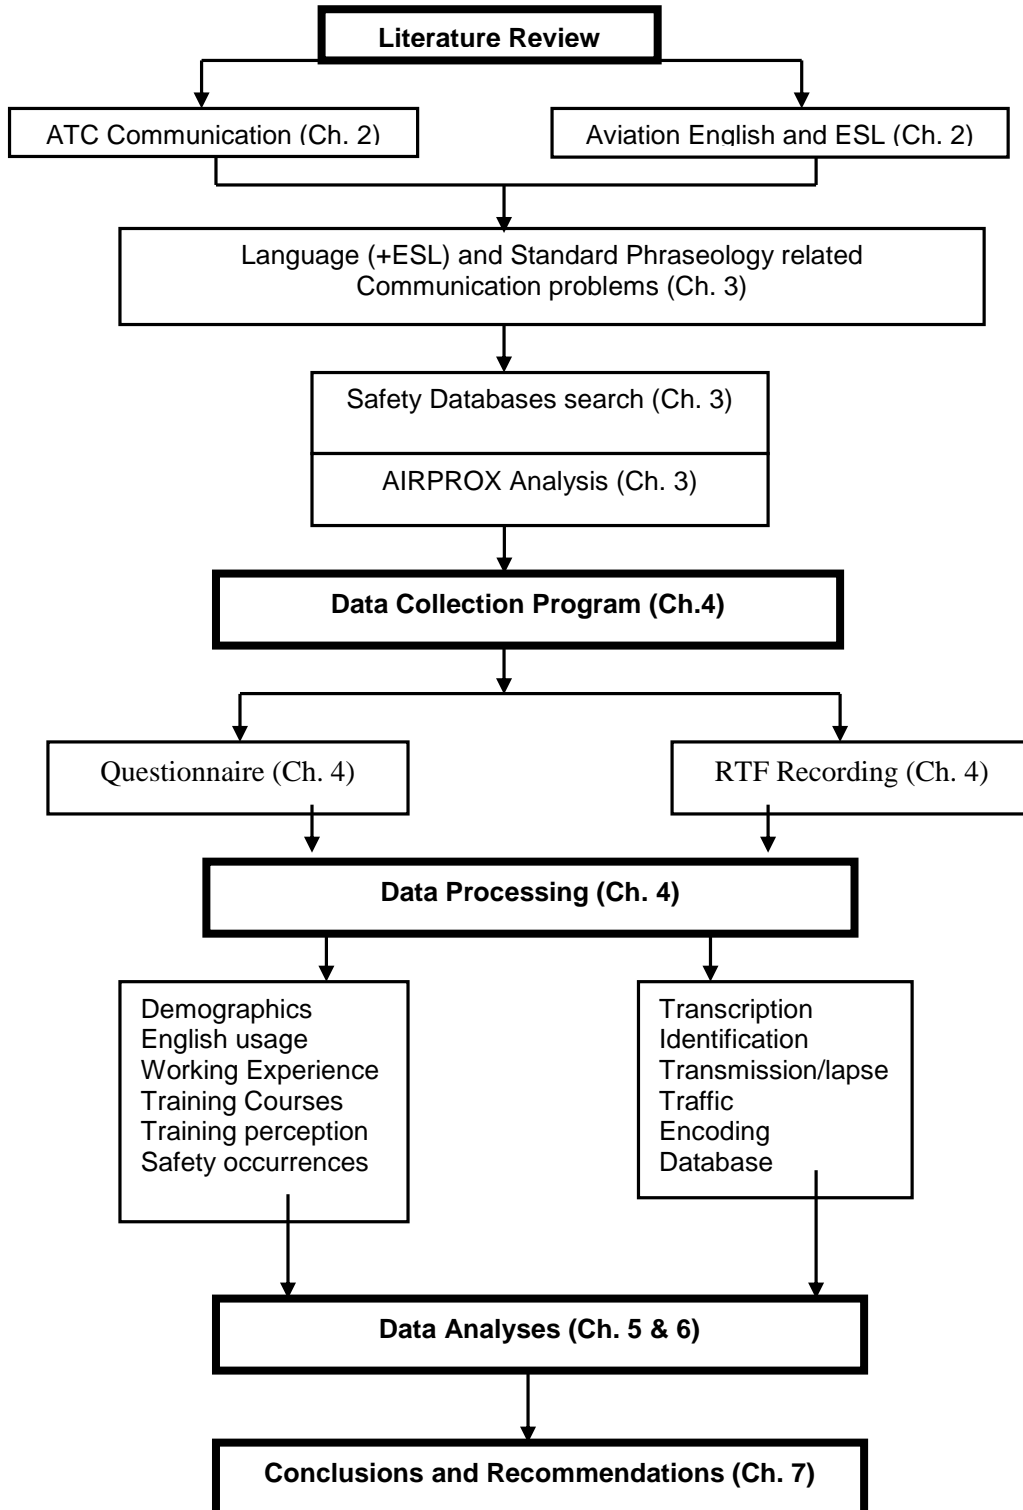
Figure 4-2: Research Work Flowchart

extensive than expected. Figure 4-2 summarised the work flow involved in the research and show the proposed chapters for the thesis writing.

The thesis is presented in 7 chapters. Chapter 2 briefly explains about ATC operations, radiotelephony and its related problems. Chapter 3 approaches the research area from the language perspective and also discuss ESL related problems. Research methodology is explained in Chapter 4, detailing the methods, the data collection program, data processing and encoding phase. As there were two data sources, data analyses results are presented in two separate chapters. Demographics and respondents' perception of language training and usage is presented in Chapter 5 while ATC radiotelephony analysis in Chapter 6. Chapter 7 presents the conclusion, summarising the knowledge contributed by this research, commenting on the overall undertaking of the task and possible areas for related researches to widen the knowledge map of this subject matter. For a detailed research work flowchart refer to Figure 4-2 on page 89.

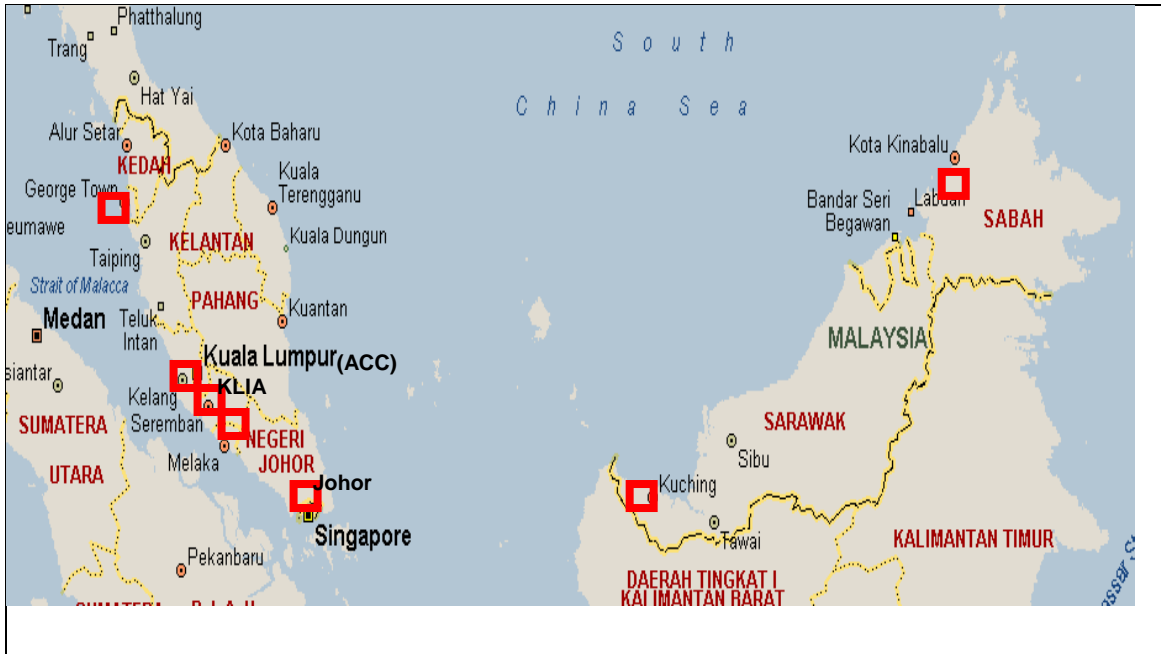
**Figure 4-3: Locations of Radiotelephony Recordings**

Kuala Lumpur Air Traffic Control Centre. Two approach radar and three area radar control positions were involved in the data collection. The locations are shown in Figure 4-3.
