# Non-destructive evaluation of localised heat damage occurring in carbon composites using thermography and thermal diffusivity measurement

Sri Addepalli \*, Yifan Zhao, Rajkumar Roy, Wathsala Galhenege, Marine Colle, Jingjing Yu, Aziz Ucur

Through-life Engineering Services Centre, Cranfield Manufacturing, Cranfield University, Cranfield MK43 0AL, United Kingdom

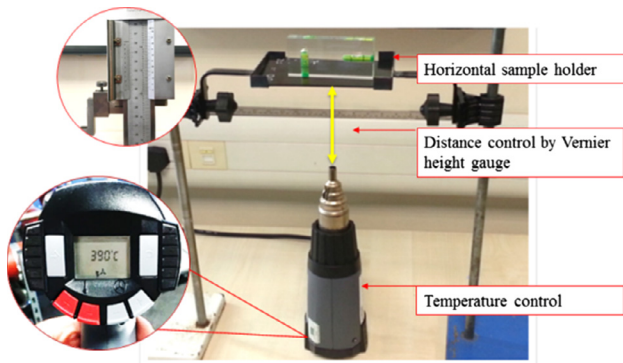
**Fig. 1.** Heat exposure test rig.

In order to maintain repeated presentation of the part, the rig was setup as seen in Fig. 1. The setup consisted of a heat gun with electronic temperature controller; two custom made holders set on the stand, the height of which was set using a Vernier height gauge with an accuracy of  $\pm 0.02$  mm. The holder was designed to match the precise location of the sample and maintain repeatability. For the selection of a suitable heat source a range of heat sources were explored during the research and included systems that used laser, infrared and resistive heating methods. With an approach to represent an in-field scenario, a hot air gun was finalised as the heat source.
