Laser array spots thermography for detection of cracks in curved structures

Abstract. The laser array spot thermography (LAST) is a fully non-contact and non-destructive method for the inspection of surface cracks with high efficiency. In this study, the detection capability of this method for the inspection of surface cracks in structures with curved surfaces is experimentally studied. The influence of the inspection angle on the crack imaging results is also investigated. The experiment results show that cracks in surface of the pipes with different dimeters can be detected and imaged by LAST.

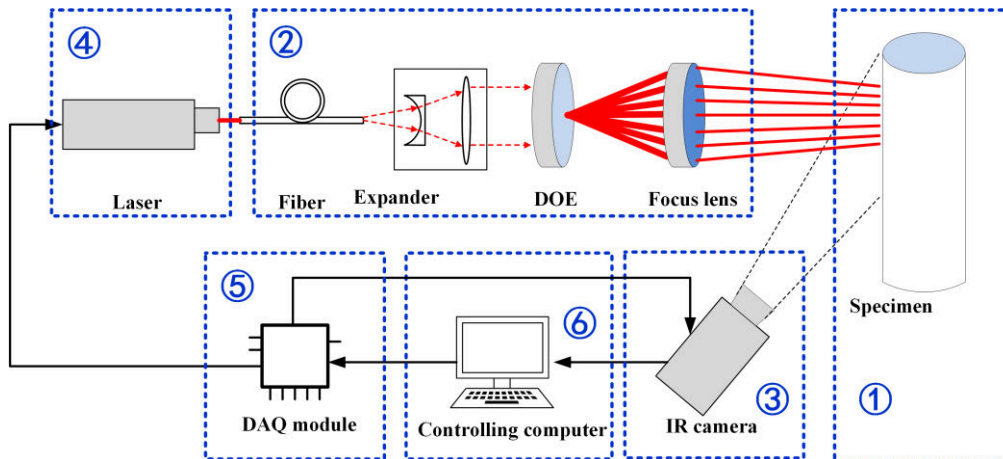
Fig. 1. Picture of laser array spot thermography experiment system. The system contains (1) specimen and holder; (2) optical components, comprise of a laser expander, a DOE and a PCL; (3) IR camera; (4) continuous-wave laser; (5) DAQ model; (6) controlling computer.

The established LAST system for inspection of surface cracks is shown in Fig. 1. The experimental setup includes a continuous heat source, an infrared camera, a data acquisition (DAQ) module and a set of optical components. The heat source is a continuous-wave (CW) laser with 1064 nm wavelength and maximum power of 100W. The thermal images were acquired by a mid-wave infrared thermal camera with a resolution of 512×640 pixel and frame frequency of 60Hz. The laser output power and duration are controlled by a DAQ module of ARM, which also output camera trigger signal to synchronize the capture of infrared images and laser turn on. The optical components contain a diffractive optical element (DOE) and a plano-convex lens (PCL) laser to split the single point laser beam into a 9×9 laser array.

The working principle of the system is as follows. First, the controlling computer sends out a trigger signal to the DAQ module to activate the inspection procedure. Then, a periodic voltage signal is generated by DAQ module and transmit to laser driver. This voltage signal is amplified and then drive the laser to generate laser beam. At the same time, another periodic voltage signal generated by the DAQ module is also transmitted to the IR camera to synchronize data acquisition with the laser excitation. Once generated, the initial single laser beam is split into a laser beam array by the optical components. Finally, the laser spots array is exerted onto the target surface of interest, generating thermal waves and finally reveal the surface cracks. The technical specifications of equipment and details of the optical components designing have been carefully discussed in [7].

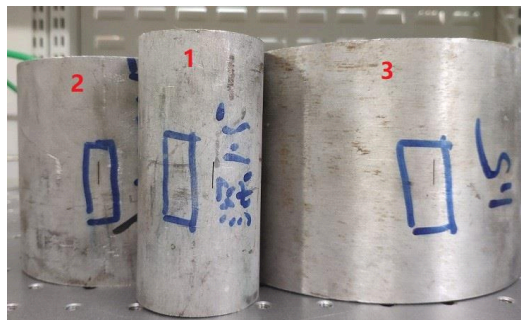
Fig. 2. Picture of SUS pipes specimens with diameters of 50mm, 100mm, 150mm.

To examine the performance of the LAST technique, experimental evaluation is performed. As shown in Fig. 2, the specimen used in experiments are three pipes made of SUS 304. Small notches were respectively

introduced in the outer surface of three pipes using a wire-cut electric discharge machining (EDM) to simulate the surface cracks. The specifications of specimens and cracks are shown in Table 1.

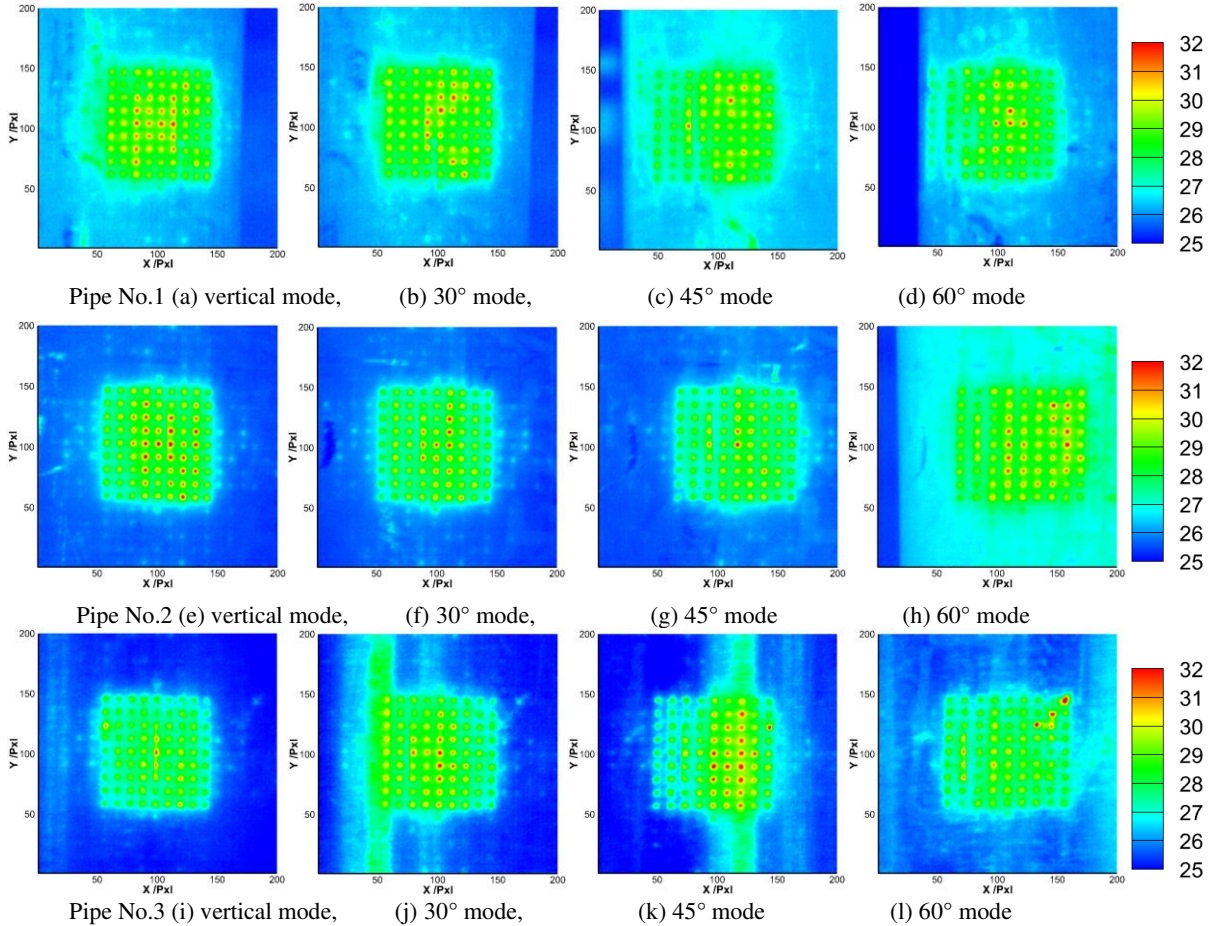
Fig. 5 Representative thermal images of pipes obtained at 2s

Fig. 5 shows the measured temperature distribution on the pipe surface after irradiated by the 9×9 laser spots array after 2 s. Although the resolution of full image is 512×640 pixels only a 200×200 pixels region near the laser source heating area is selected as the region of interest (ROI). The results show that the unsymmetrical distribution of surface temperature caused by the crack can be witnessed although the curved surface reflects parts of the laser energy and cause the uneven heating effect on the surface. With the increase of laser heating angle, the crack become less clearly in original thermal images. Then the image processing procedure discussed in section 3 is applied to the raw images. Fig. 6 illustrates the results of main steps in the image processing of ROI in Fig. 5a. Final results of all the six images are shown in Fig. 7. As we expected the laser heating patterns are greatly eliminated and all the cracks are clearly revealed. Finally, the crack length is evaluated by counting the amount of pixels that visualized the crack (1 pixel sees 0.22mm).
