Article Defects Recognition Algorithm Development from Visual UAV Inspections

Nicolas P. Avdelidis ^{1,*}, Antonios Tsourdos ¹, Pasquale Lafiosca ¹, Richard Plaster ², Anna Plaster ² and Mark Droznika ³

Abstract: Aircraft maintenance plays a key role in the safety of air transport. One of its most significant procedures is the visual inspection of the aircraft skin for defects. This is mainly carried out manually and involves a high skilled human walking around the aircraft. It is very time consuming, costly, stressful and the outcome heavily depends on the skills of the inspector. In this paper, we propose a two-step process for automating the defect recognition and classification from visual images. The visual inspection can be carried out with the use of an unmanned aerial vehicle (UAV) carrying an image sensor to fully automate the procedure and eliminate any human error. With our proposed method in the first step, we perform the crucial part of recognizing the defect. If a defect is found, the image is fed to an ensemble of classifiers for identifying the type. The classifiers are a combination of different pretrained convolution neural network (CNN) models, which we retrain

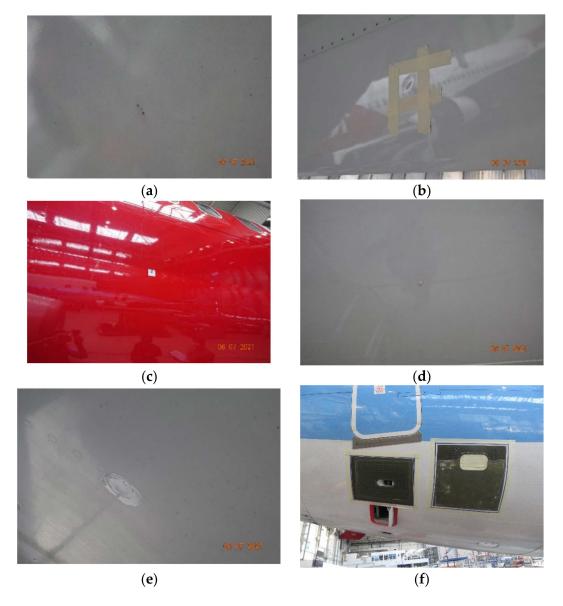
Figure 1. Images of different types of defects in aircraft structures. (a) Missing paint, (b) dents, (c) lighting strike damage, (d) lighting strike fastener repair, (e) blend/rework repair (material removed and then re-protected with exterior paint); (f) double patch repair.

In Figure 1, images of the defects are presented. Most of the obtained images contained several defects, together with other elements such as screws, etc. In order to create the two different datasets, further processing was needed to extract only the objects that we were interested in from each of the images.

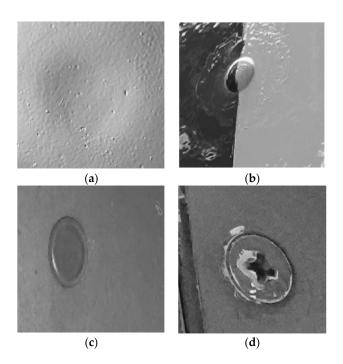
Figure 2. Sample images from the two datasets created for training the classifiers. (**a**) An image of a dent, (**b**) a lighting strike fastener repair; (**c**,**d**) are images with objects that are not defects.

The objects of interest were cropped through a semi-automated procedure to create the datasets for the training. A Python script was developed so the user can select and crop the area with the object of interest. The cropped image was saved in the new image file. The name of the file was indicative of the category of the defect. This provided us the capability to extract multiple images of interest from only one image, with and without defects. The cropped images were grayscaled because we did not want the classifiers to associate color with any defects during training. This was carried out because defects are not color related and aircrafts are painted in different colors, depending on the company. Images of the datasets can be observed in Figure 2.

Following the above procedure, two datasets were created, one containing images from each category of the defects described above and one contains images with and without defects. The second dataset in the no-defect category has images of screws, gaps, small plates etc., objects that the classifier will need to distinguish from the defects. Figure 2 shows images from the two datasets with and without defects.
