Severn Trent Region: River Sence, Hilton Brook

Annex of R&D Note 456

R&D Project Record 317/18/ST

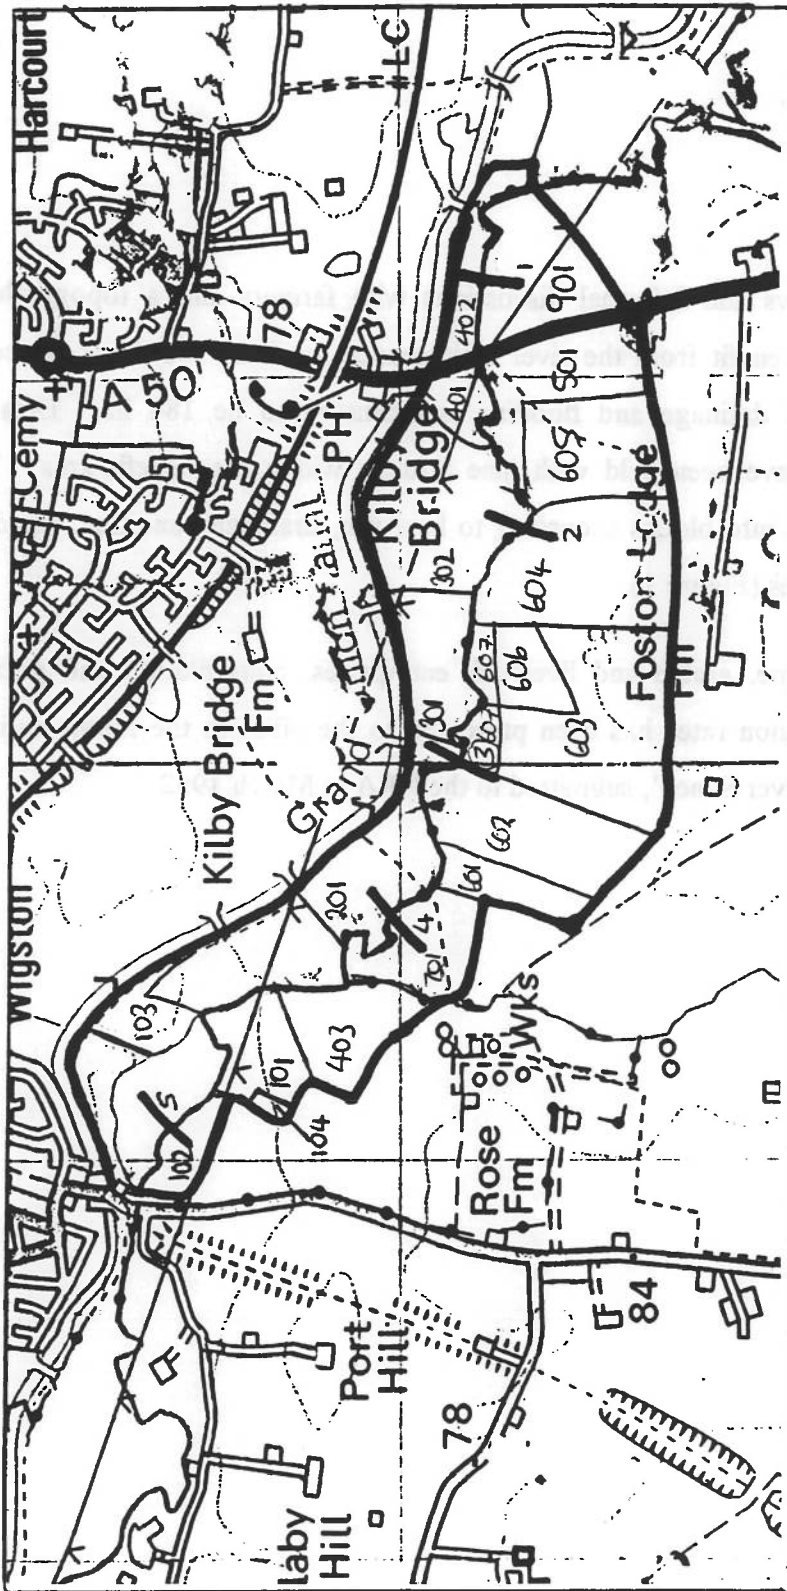
Through structured interviews and informal discussions with farmers and a topographical survey, the area deriving a benefit from the river maintenance work on the River Sence in terms of its impact on land drainage and flooding is estimated to be 184 ha. Detailed interviews and discussions have been held with nine farmers within the benefit area. The benefit area has been divided into blocks according to land use, drainage condition, flooding and land management practices (Figure 1).

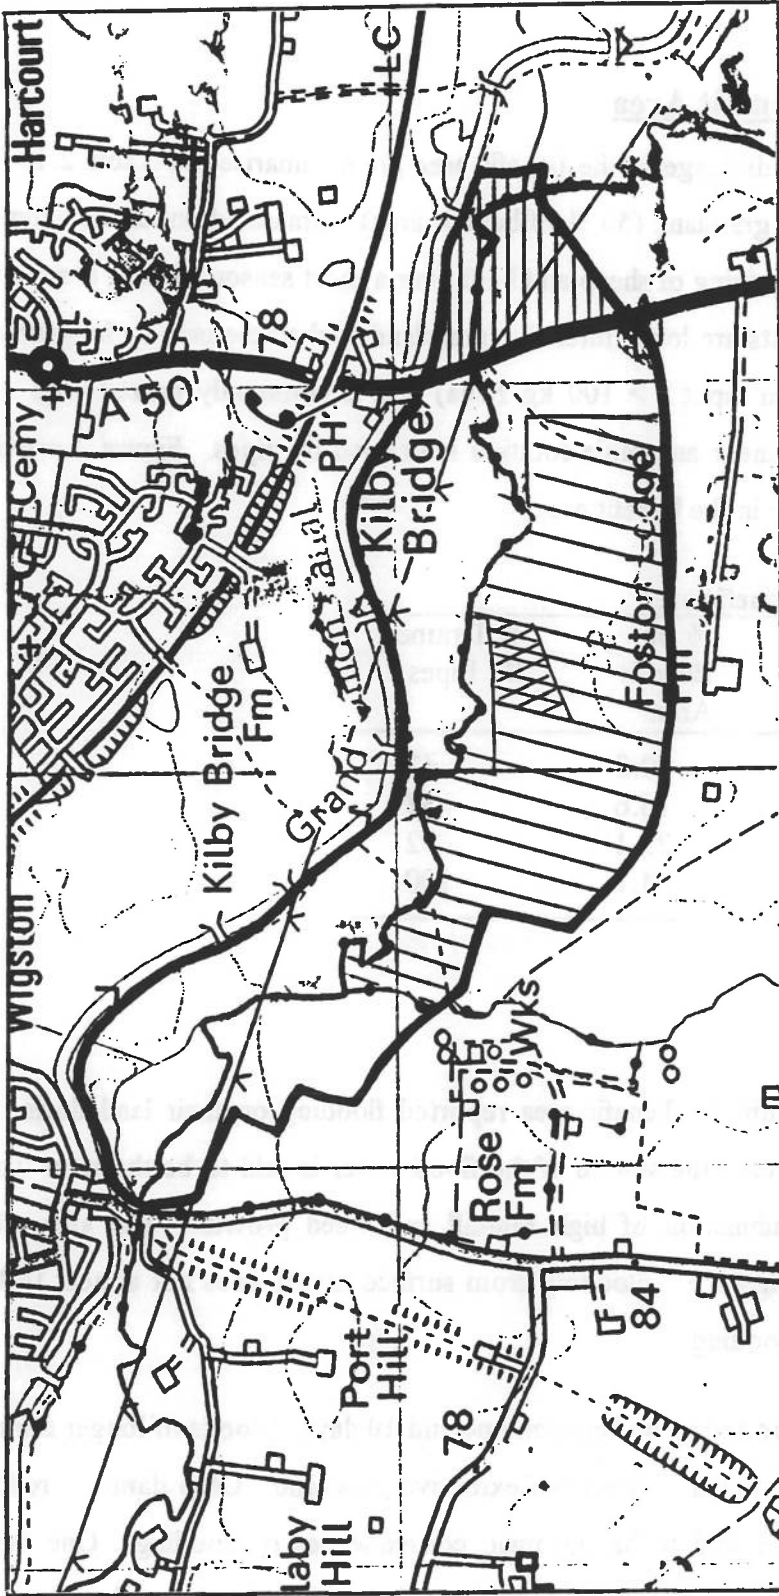
Eight of the nine farmers within the benefit area reported flooding on their land during the course of this study. In each case the source of the flood water is said to be the river whose high levels are due to a combination of high rainfall and weed growth. The area which typically floods is shown in Figure 3. Flooding from surface runoff does not appear to be a major contributory factor to flooding.

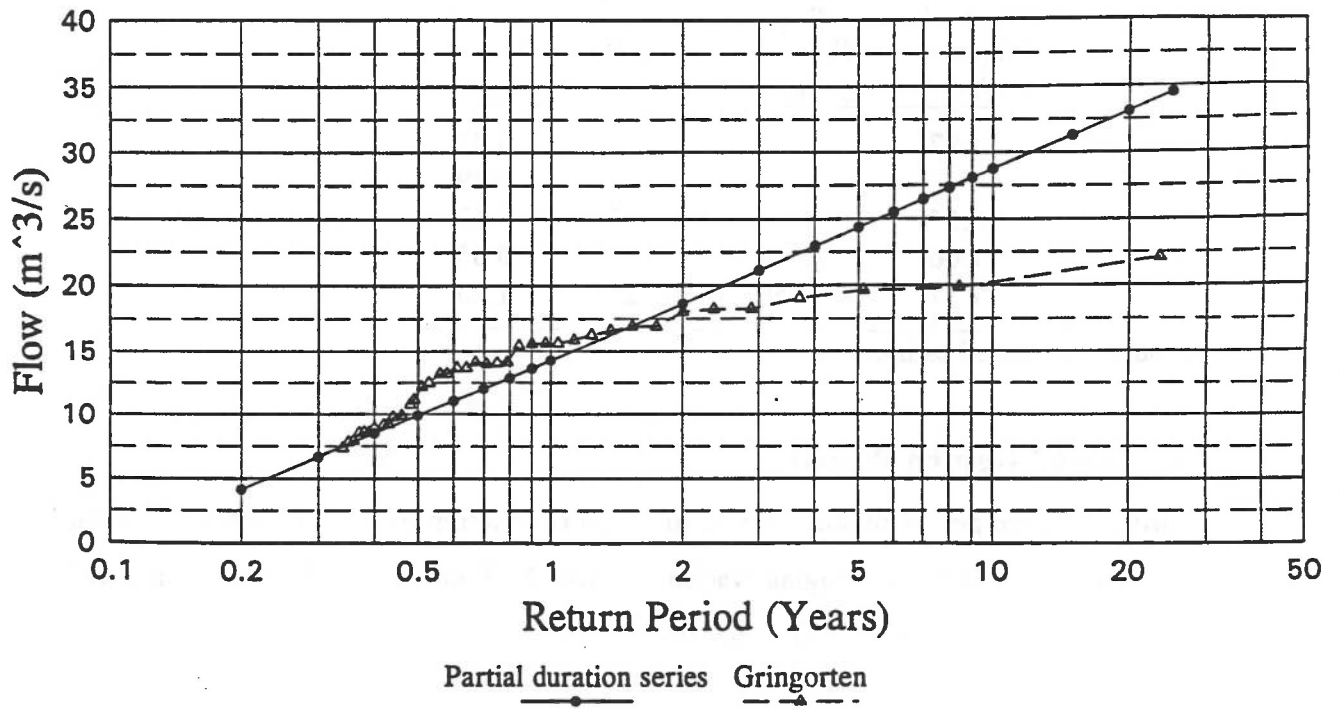
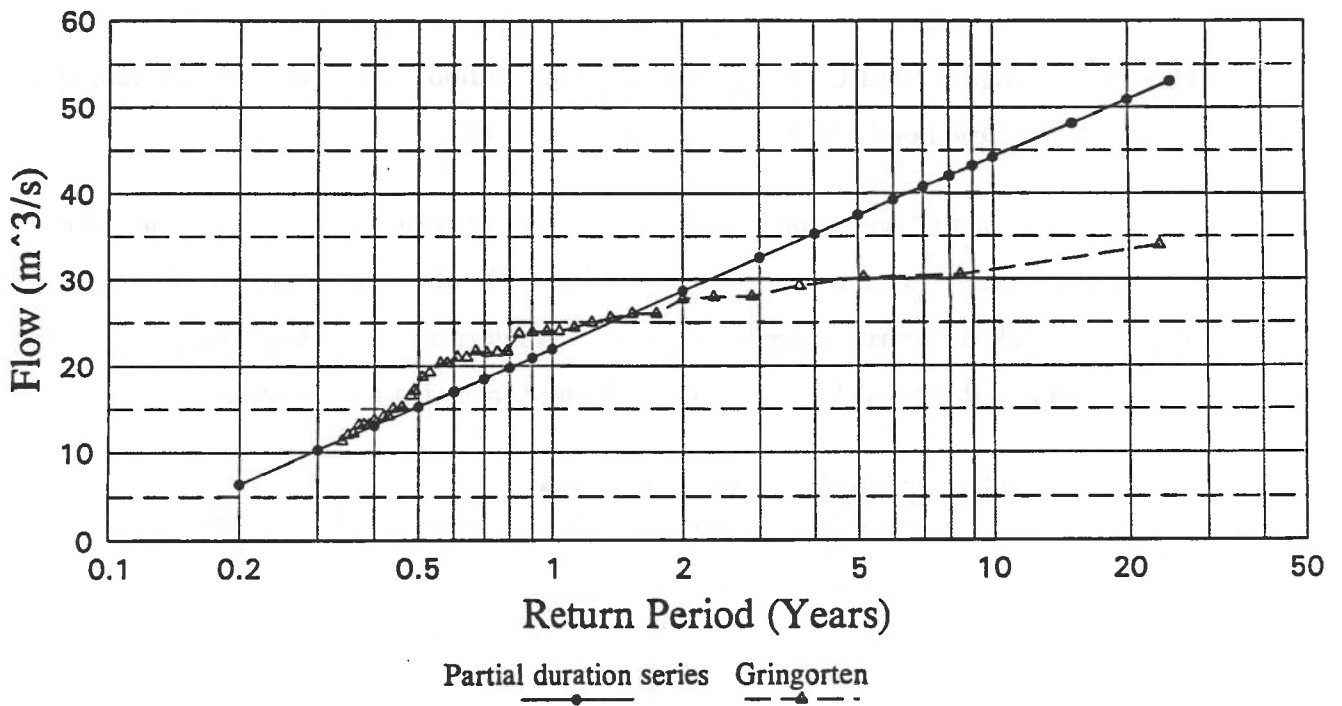
Figure 4 Flood return period

For cross-sections upstream of confluence

For cross-sections downstream of confluence

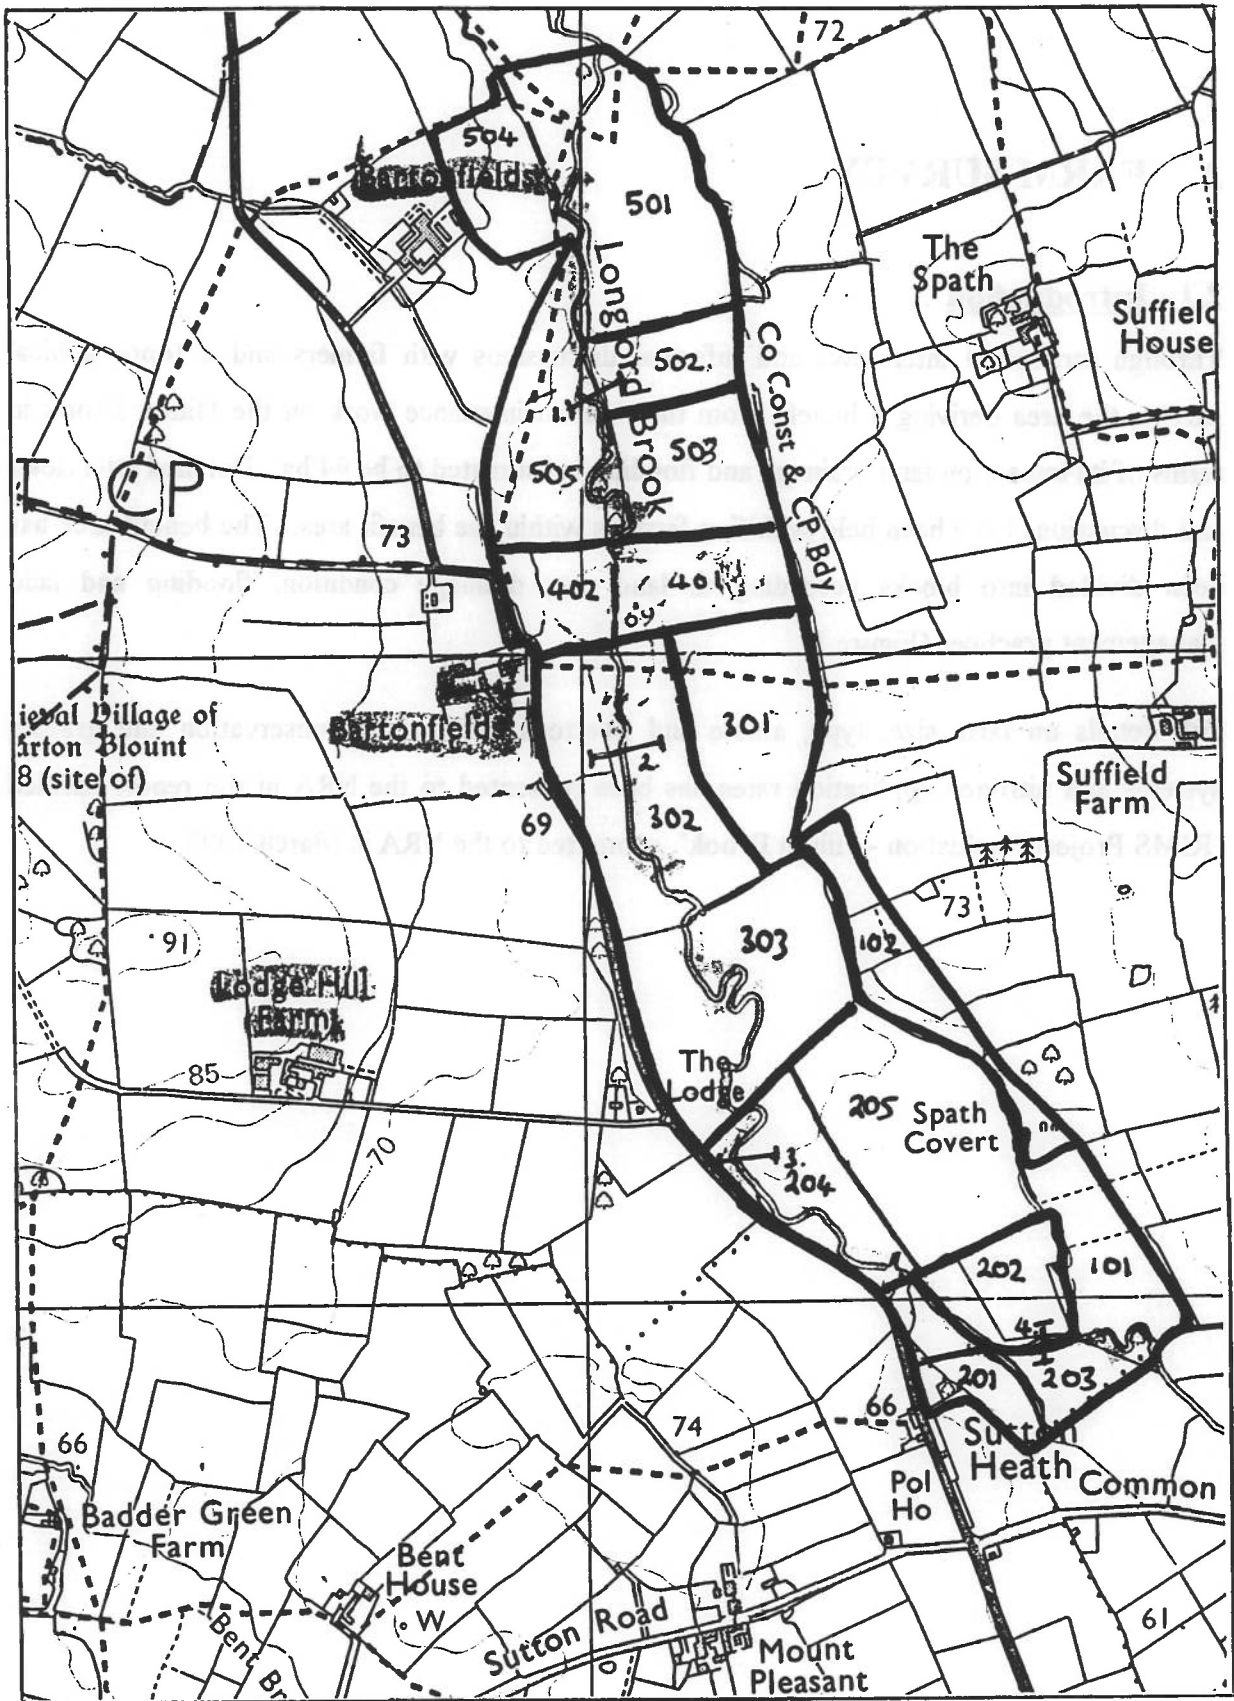
Through structured interviews and informal discussions with farmers and a topographical survey, the area deriving a benefit from the river maintenance work on the Hilton Brook in terms of its impact on land drainage and flooding is estimated to be 94 ha. Detailed interviews and discussions have been held with five farmers within the benefit area. The benefit area has been divided into blocks according to land use, drainage condition, flooding and land management practices (Figure 1).

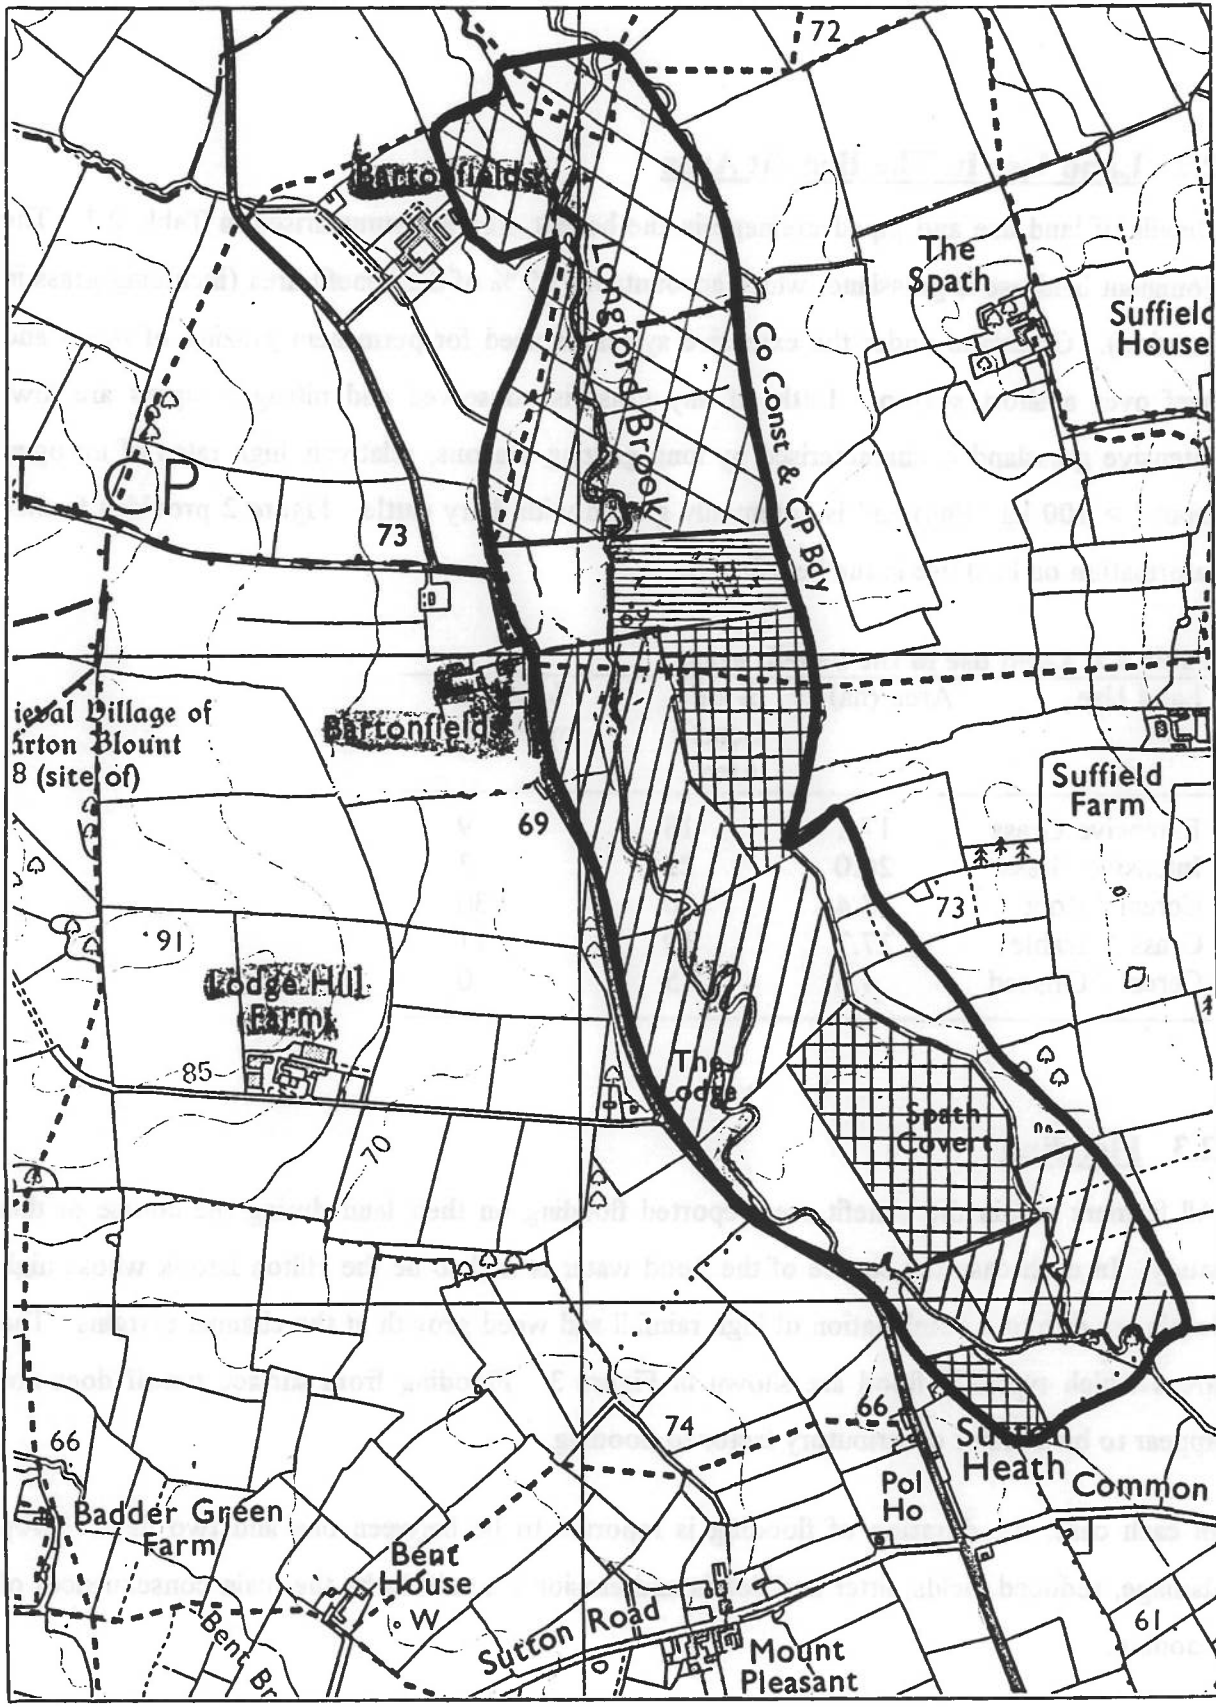
All farmers within the benefit area reported flooding on their land during the course of this study. In each case the source of the flood water is said to be the Hilton Brook whose high levels are due to a combination of high rainfall and weed growth at the channel margins. The areas which typically flood are shown in Figure 3. Flooding from surface runoff does not appear to be a major contributory factor to flooding.

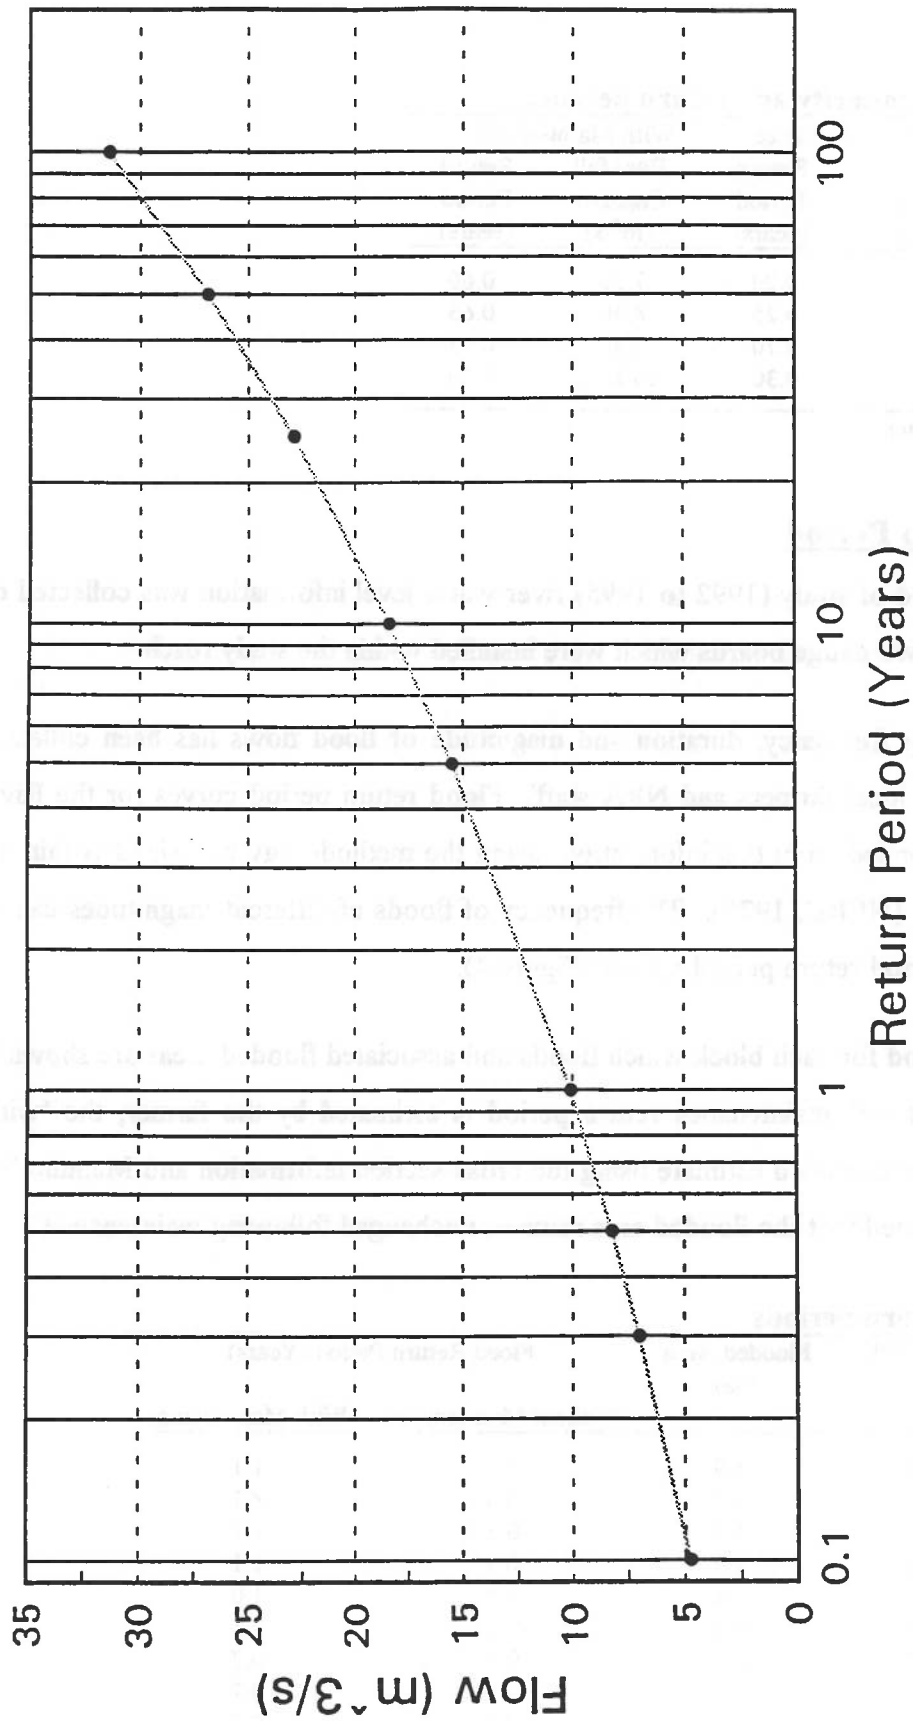
Figure 4 Flood return period curve

NB: Flood Studies Report methodology
