REPORT NO. 51

THE COLLEGE OF AERONAUTICS

Stress Distribution near a Rectangular Cut-out
in a Reinforced Circular Cylinder due to Direct
Shear Loading and Torque

Part I: Test Results

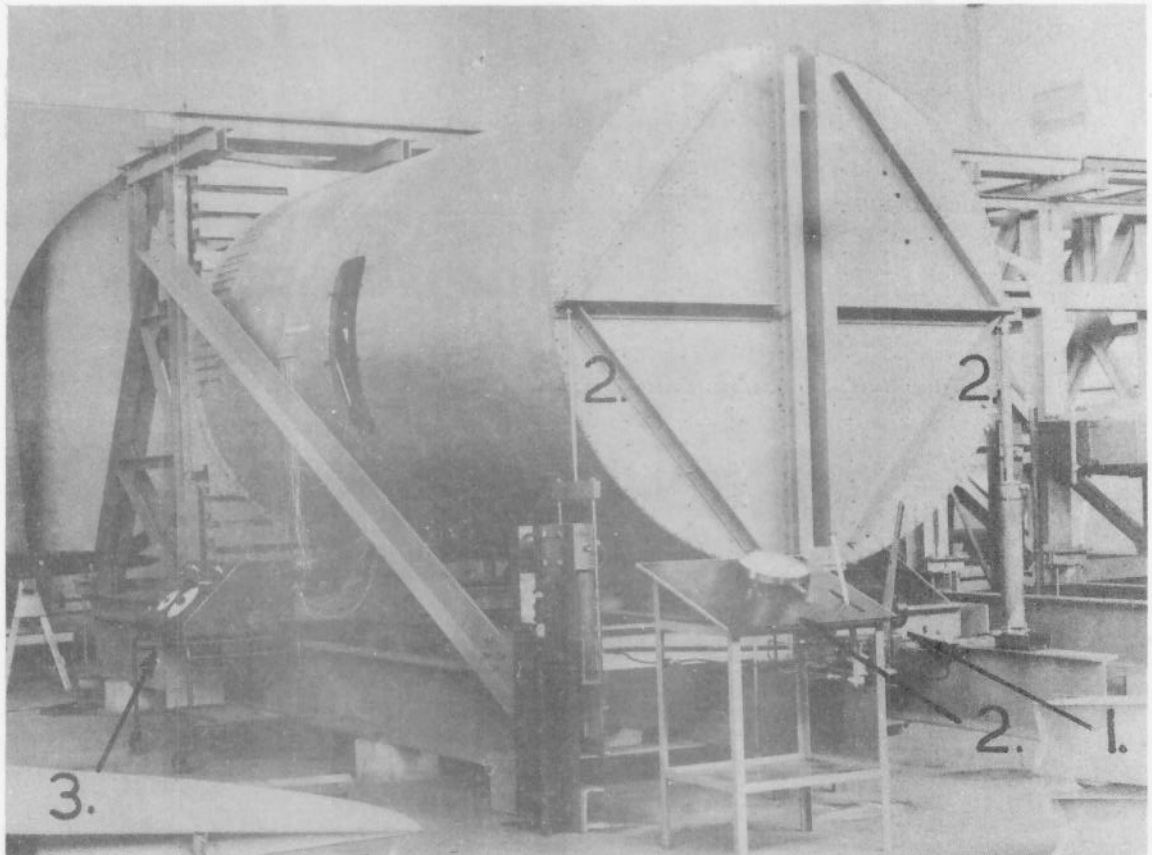
FIG. 1.

1. DIRECT SHEAR: HYDRAULIC LOADING RIG AND JACK.
JACK MOUNTED ON ROLLERS.
2. TORQUE: HYDRAULIC LOADING RIG AND JACK.
3. SAVAGE AND PARSONS TYPE STRAIN RECORDER.

TEST RIG AND SPECIMEN.

A simple 'A Frame' was strengthened, and a calibrated hydraulic torque and direct shear loading rig added. Ram bending and friction effects were reduced as far as possible. The specimen was locally strengthened and bolted to a rigid backplate of steel I beams, Figure 1. 90 ohm strain gauges (H. Tinsley and Co. Ltd.) were cemented to the specimen in shear and tension groups. Compensation for temperature changes was provided, and, where both sides of the material were accessible, also for buckling. In the few cases where buckling compensation was required but could not be provided, results have been neglected.

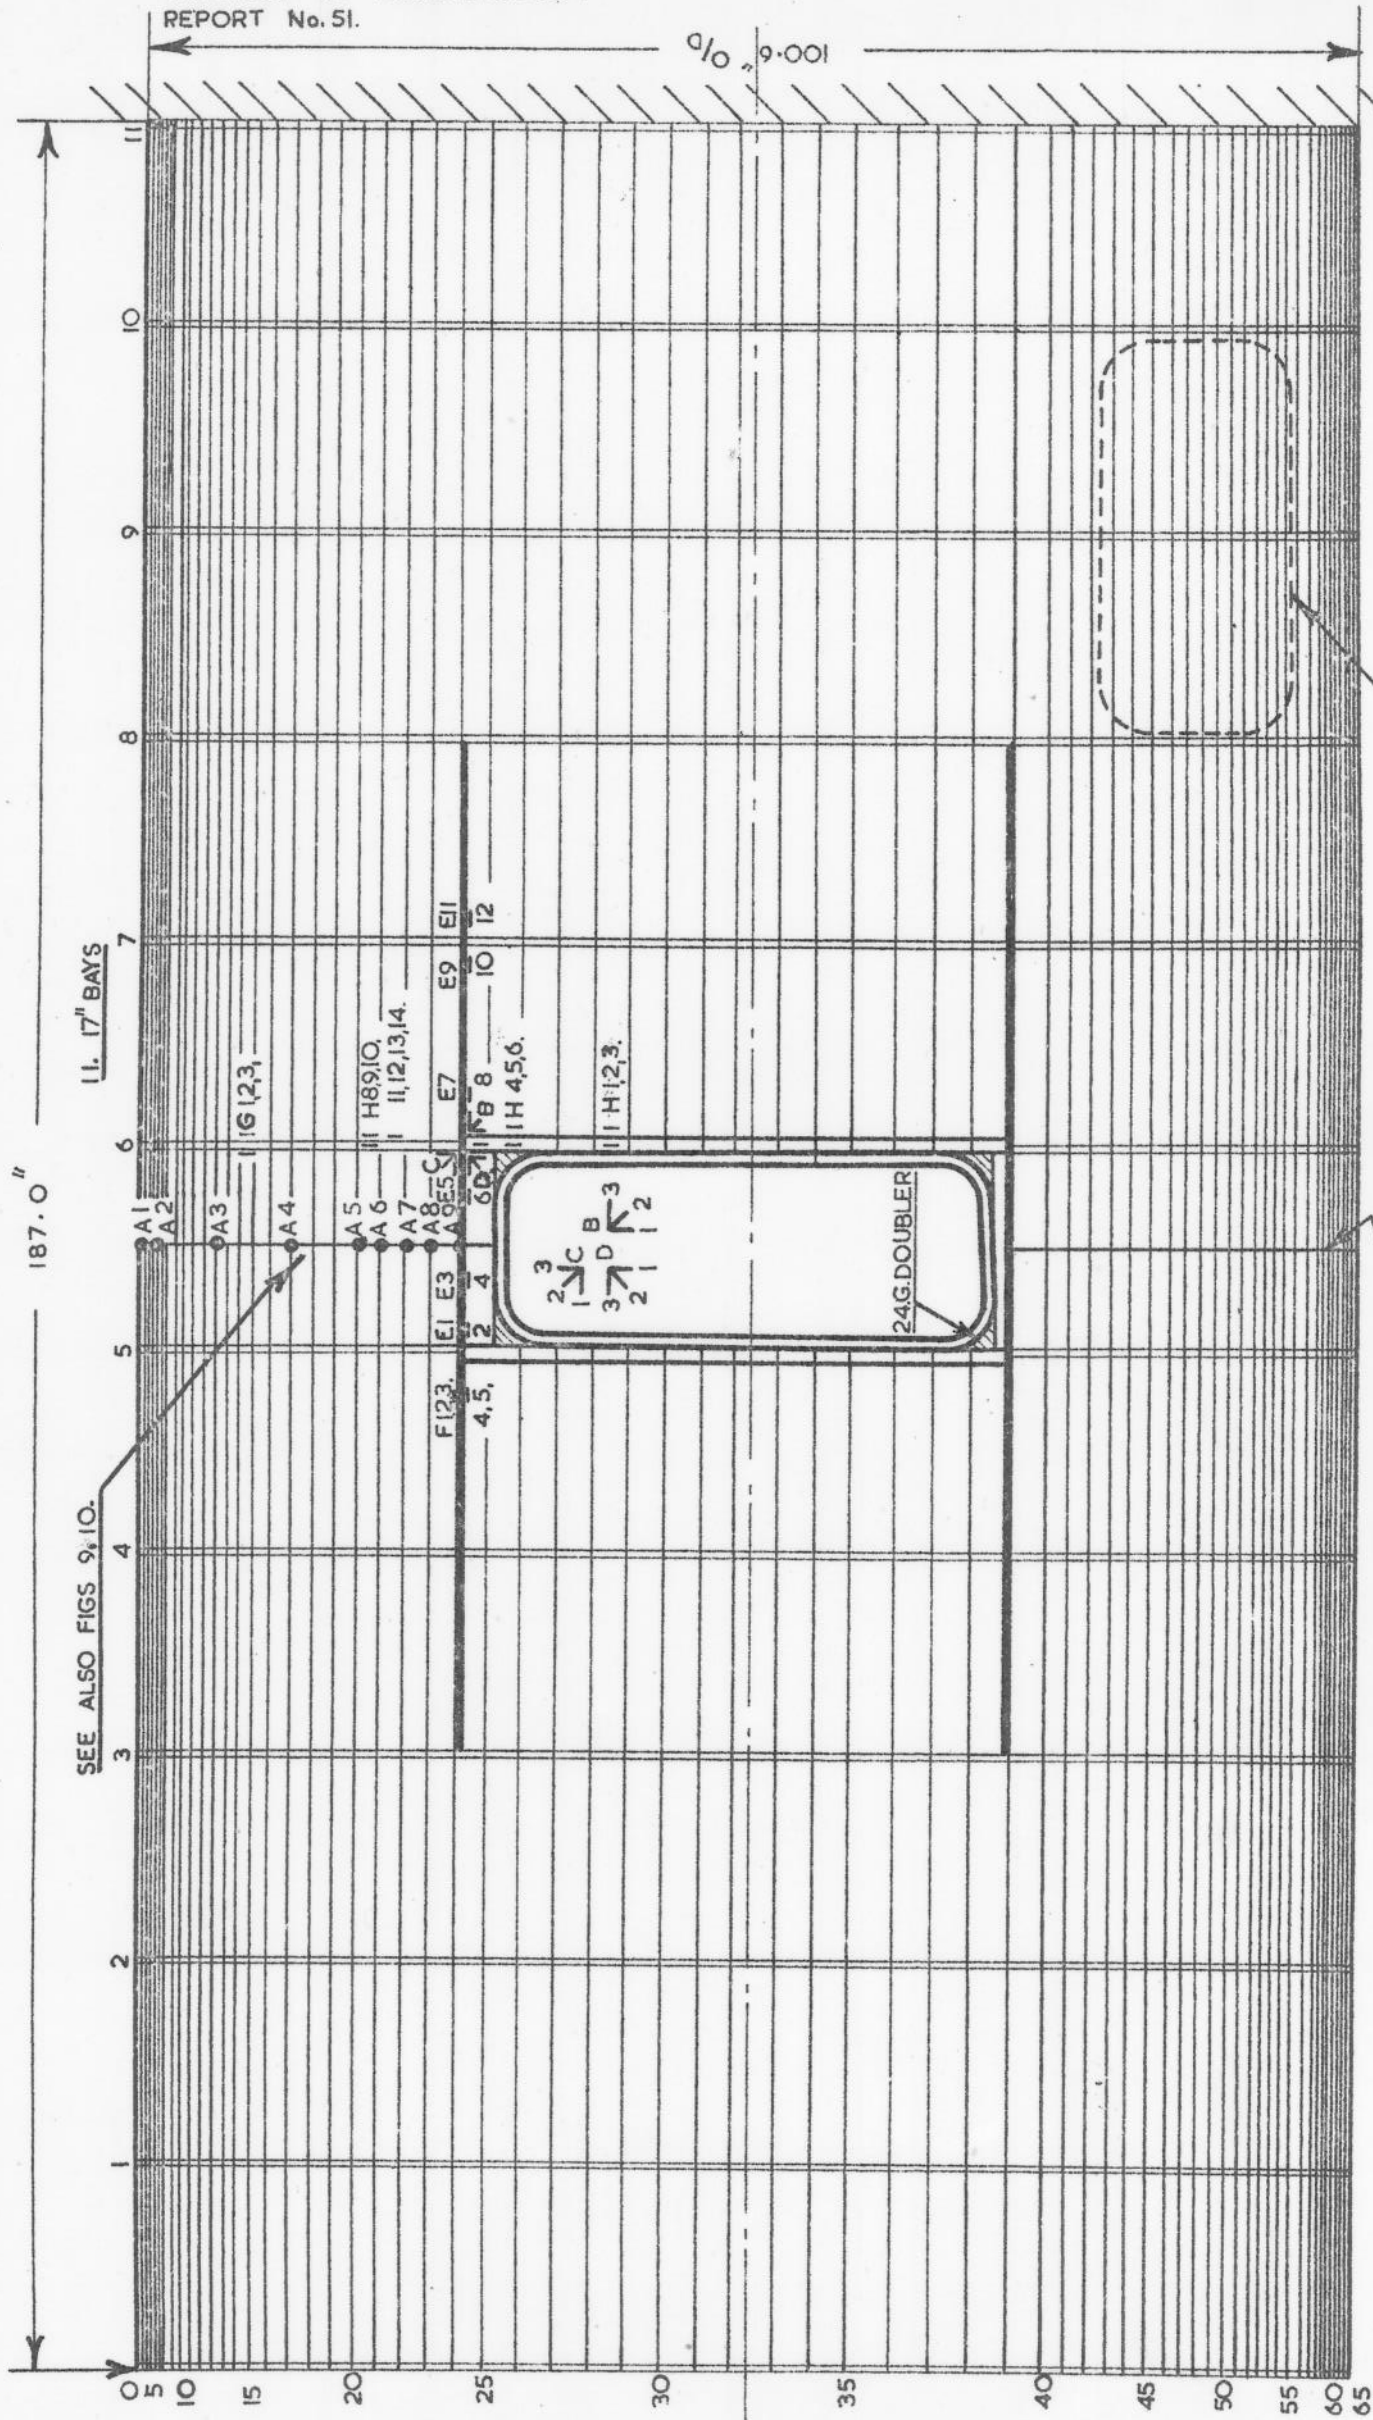
FIG. 2.

AS FIG. 10. LINE OF SKIN SHEAR GAUGES
ARRANGEMENT OF STRAIN GAUGES.

SYMMETRIC ABOUT VERT ϕ

It was repaired and simplified by removing floor beams and filling a third cut-out, to leave the structure given in Table I and Figures 2, 3, 6 and 7. This comparatively simple structure was expected to be more amenable to calculation, and by comparison with previous tests, to indicate floor beam effects.

DIMENSIONS OF TEST SPECIMEN - See Figure 2

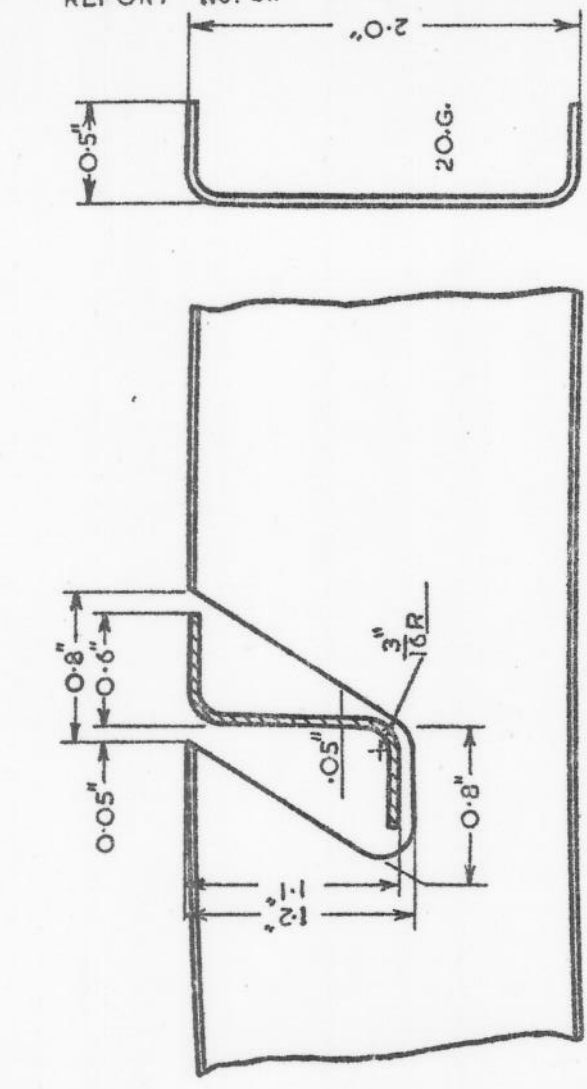
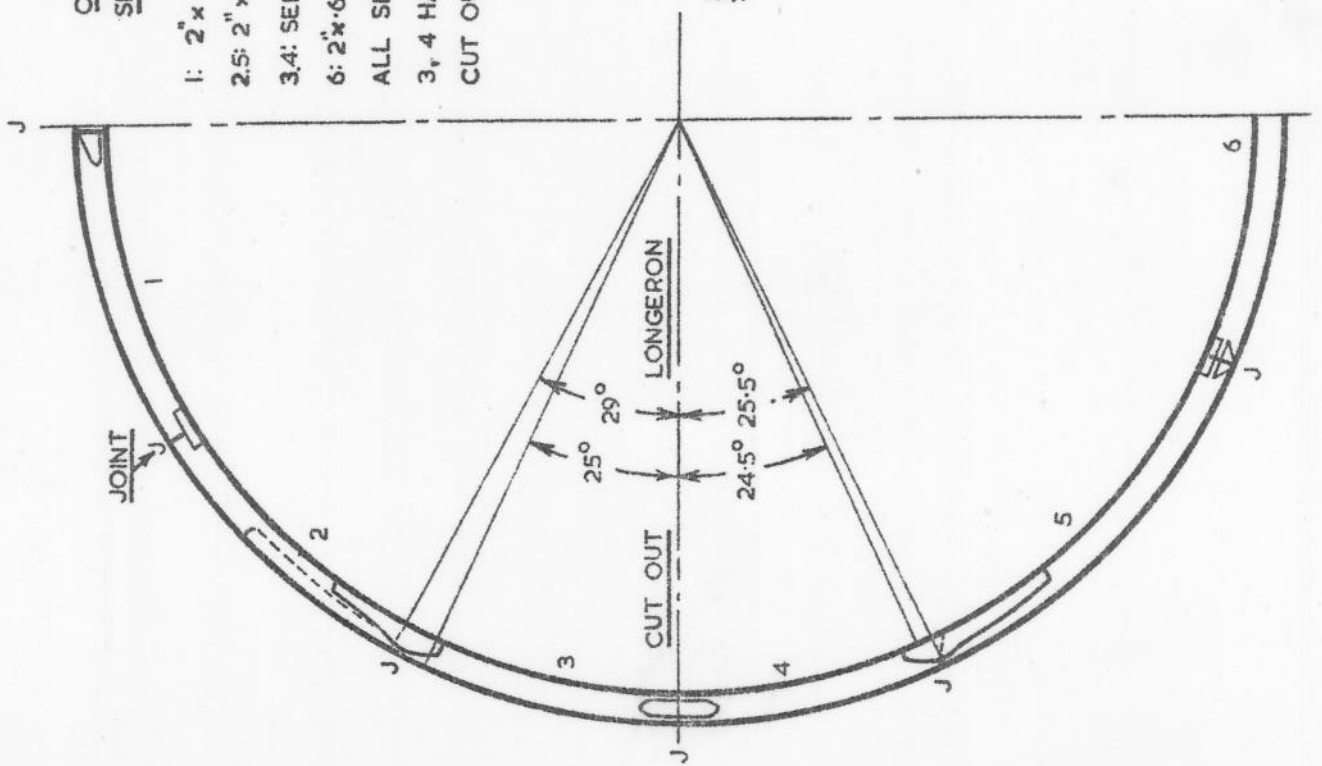
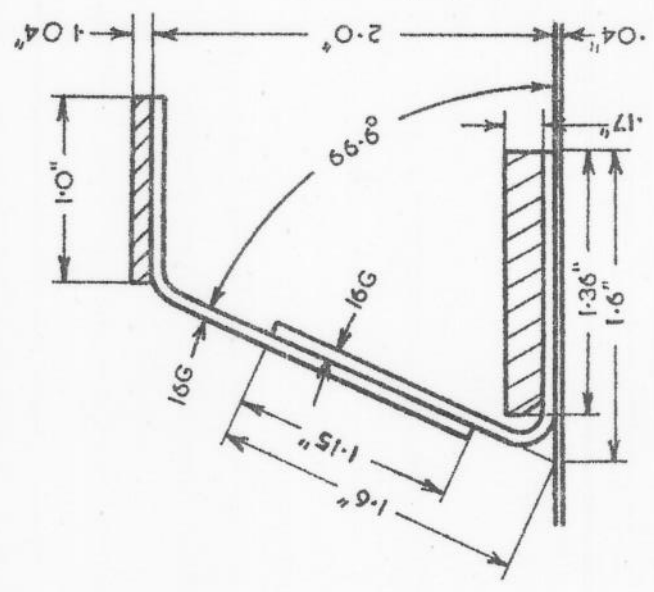
FIG. 3. DETAIL OF STRUCTURE.

STANDARD FRAME
SCALE: FULL SIZE

CHANNEL SECTIONS

- 1: 2" x .45" 19G
- 2,5: 2" x .70" 16G
- 3,4: SEE FIG. 6.
- 6: 2" x .60" 18G

ALL SECTIONS EXCEPT 3, 4 HAVE STRINGER CUT OUTS.

DOOR FRAME

REINFORCED FLOOR LONGERON

SCALE: FULL SIZE
LONGERON REINFORCED WHEN FLOOR BEAMS REMOVED: NOT STRAIN GAUGED.

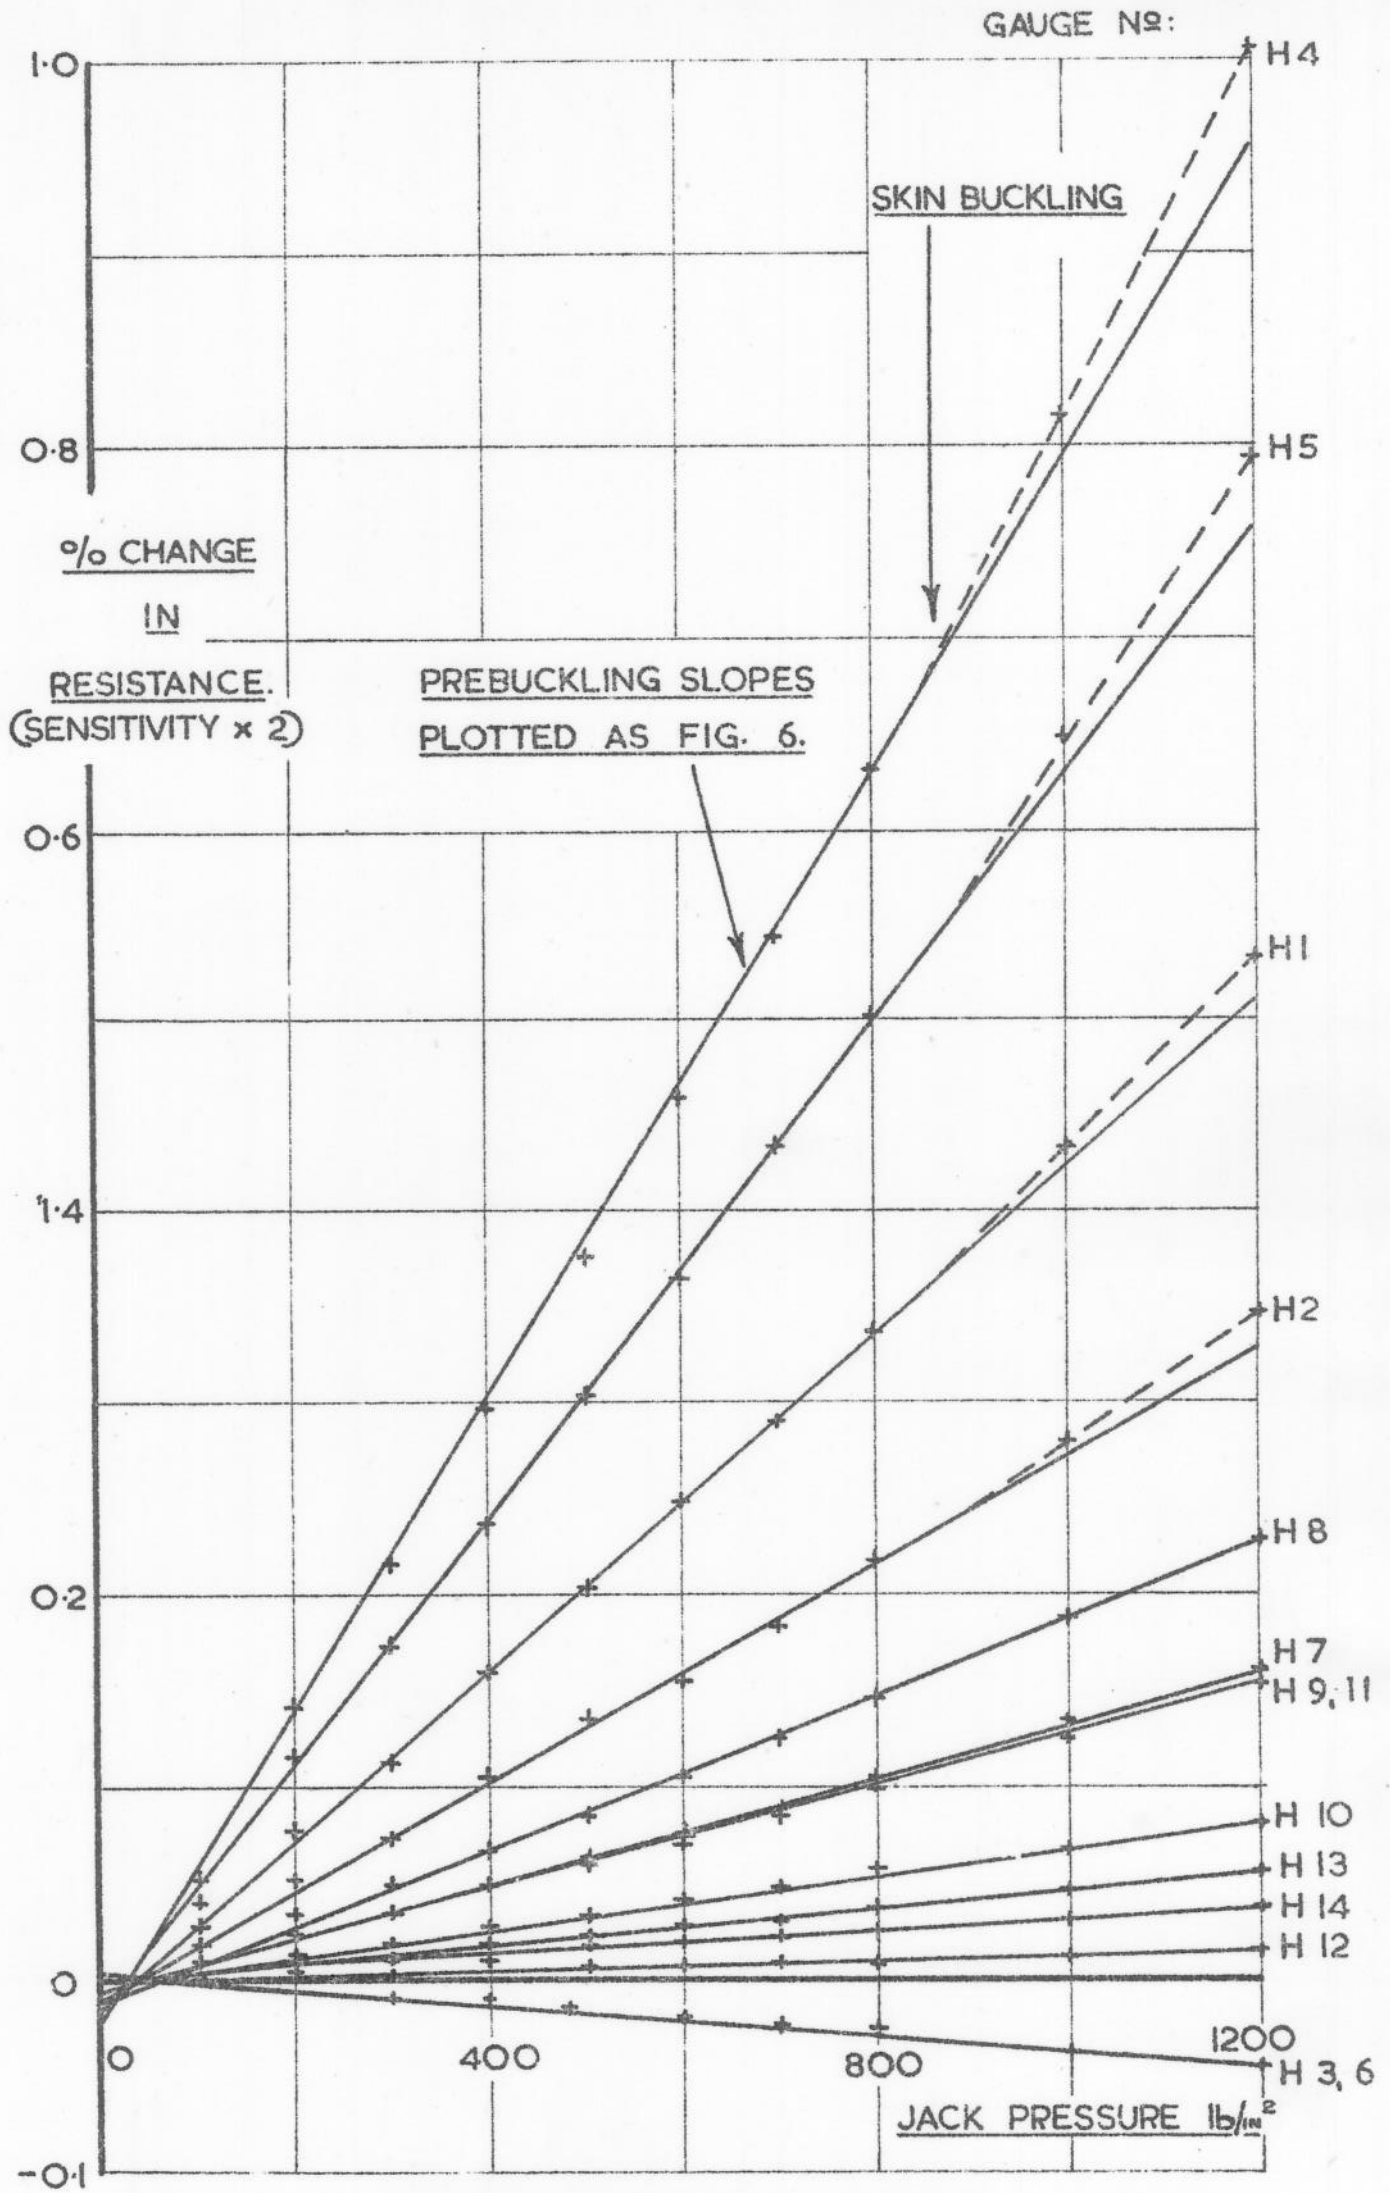
FIG. 4.

FRAME TENSION GROUPS.

EXAMPLE OF:

STRAIN GAUGE READING — JACK PRESSURE.

Load was applied in increments and percentage change of resistance noted. These were plotted and show very good linearity. Typical plots are Figures 4 and 5. It will be seen that for direct shear loading, jack pressure was plotted directly since pressure-load calibration followed a straight line law. In some cases a change of slope occurred with skin buckling. Slopes of these plots were recorded giving percentage resistance change due to load increments of direct shear (ΔW) or torque (ΔT).

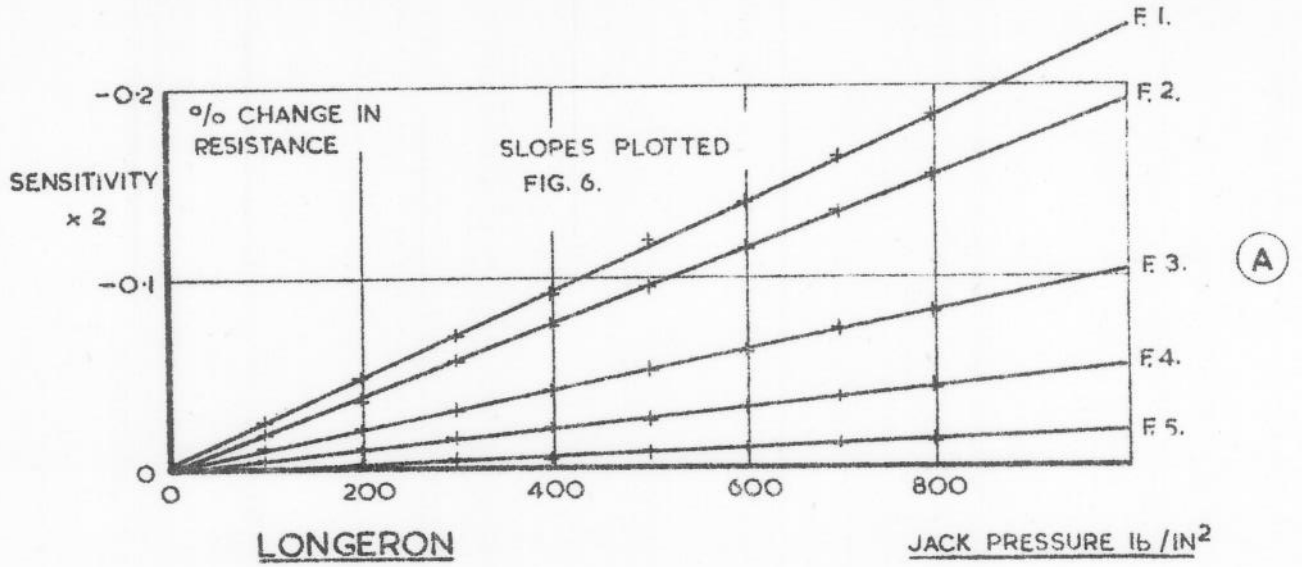
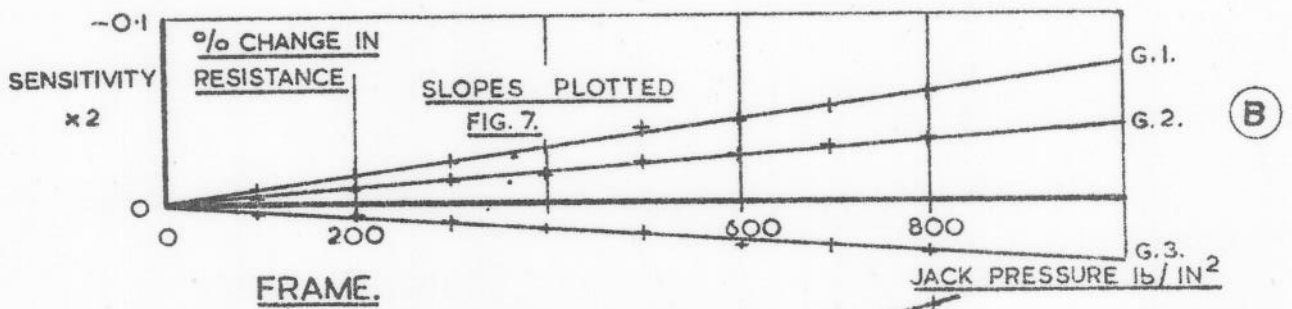
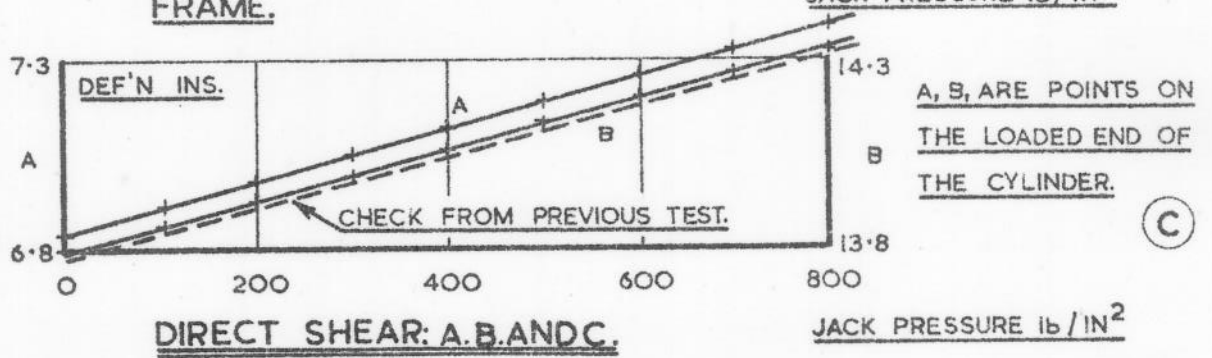
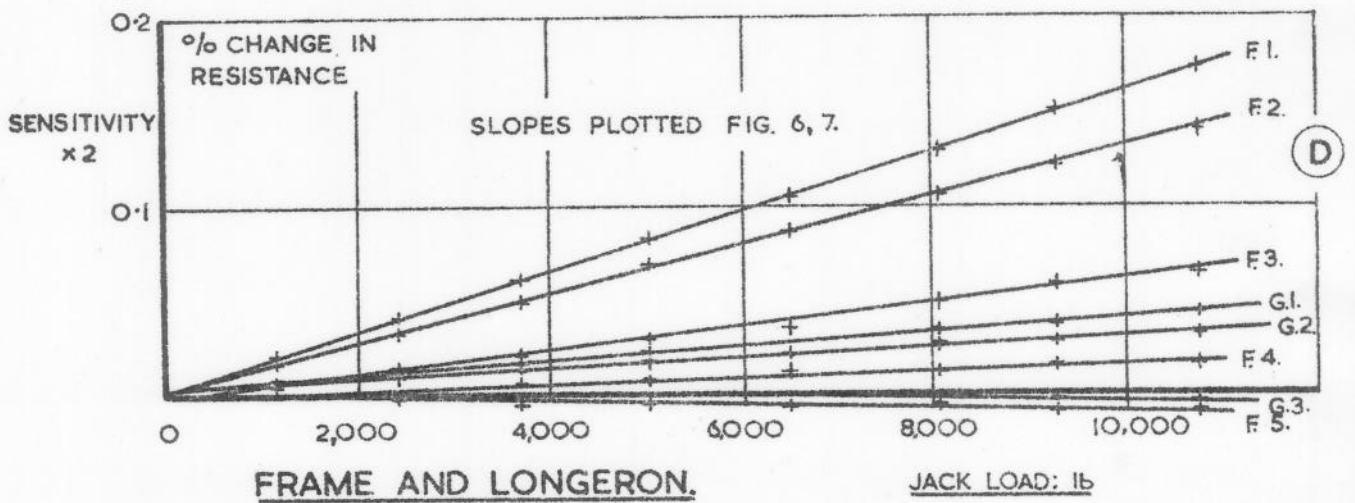
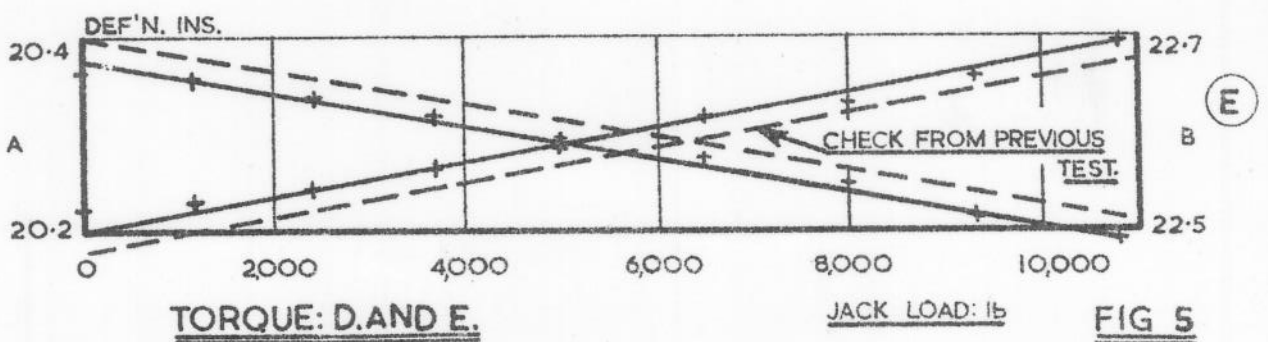
EXAMPLE OF: STRAIN GAUGE READING AND DEF'N — JACK LOAD

% GAUGE RESISTANCE CHANGE FOR: ΔT AND ΔW .

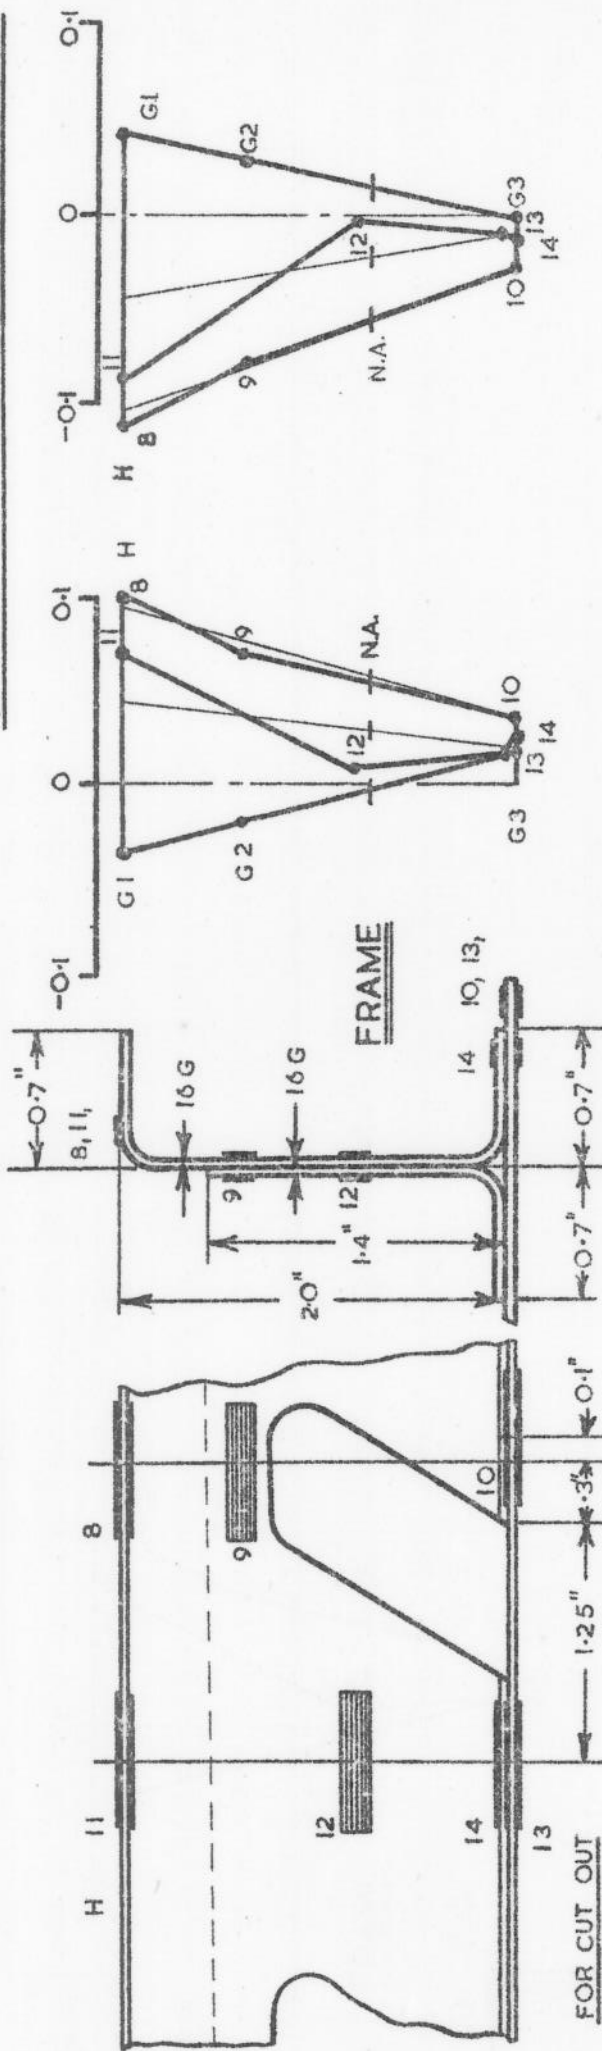
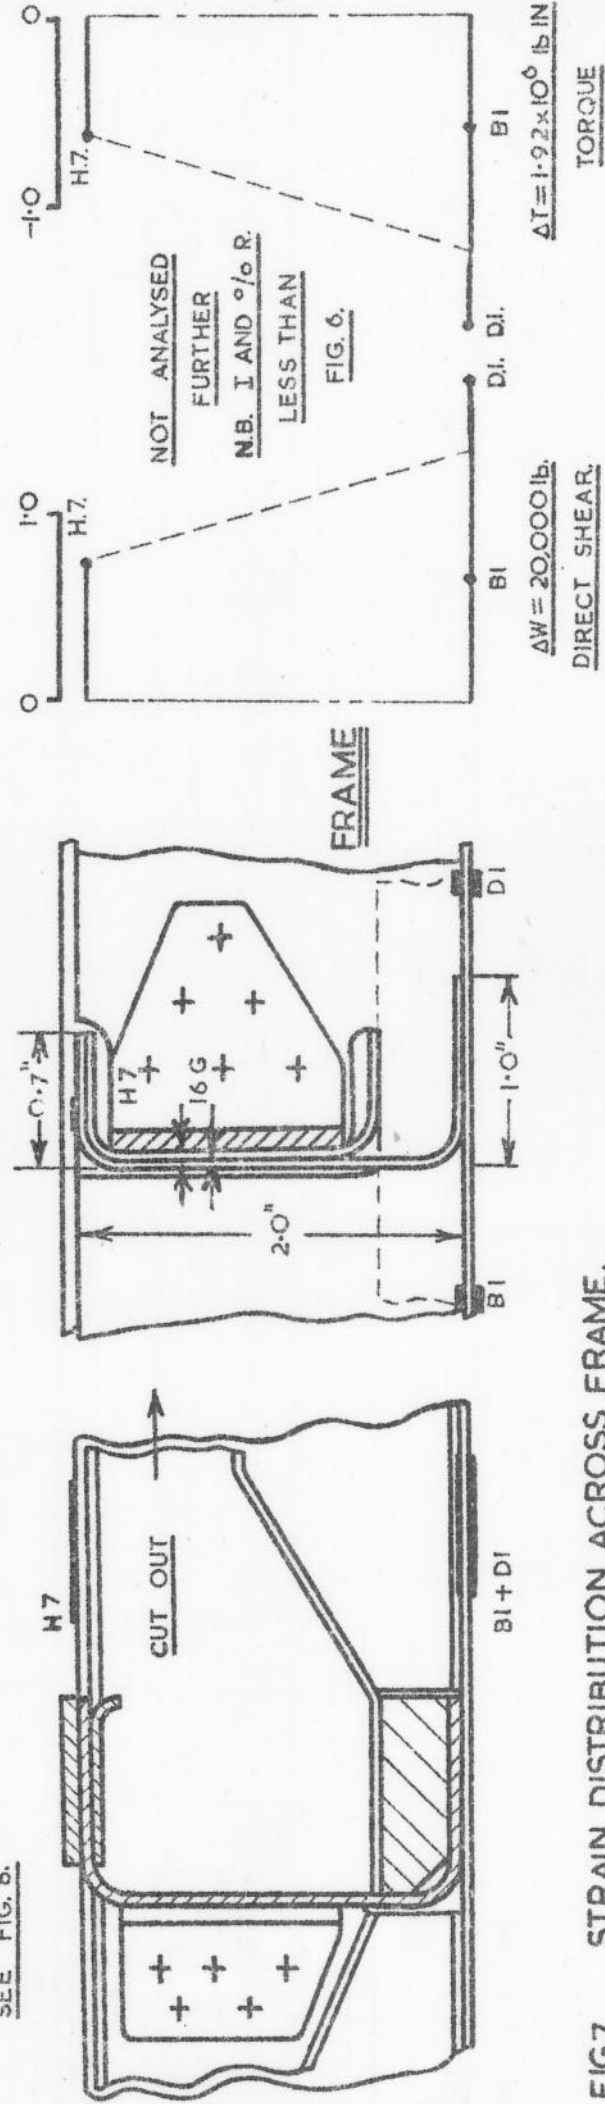
FIG. 7 STRAIN DISTRIBUTION ACROSS FRAME.

FOR CUT OUT
 SEE FIG. 8.

After checking results for linearity of strain across the section of a member, Figure 6, load increments in a member by more than one method etc. (figures 8, 12 and 13), it is felt that these results give fair indication of the stress distribution at the corner of the cut-out investigated.

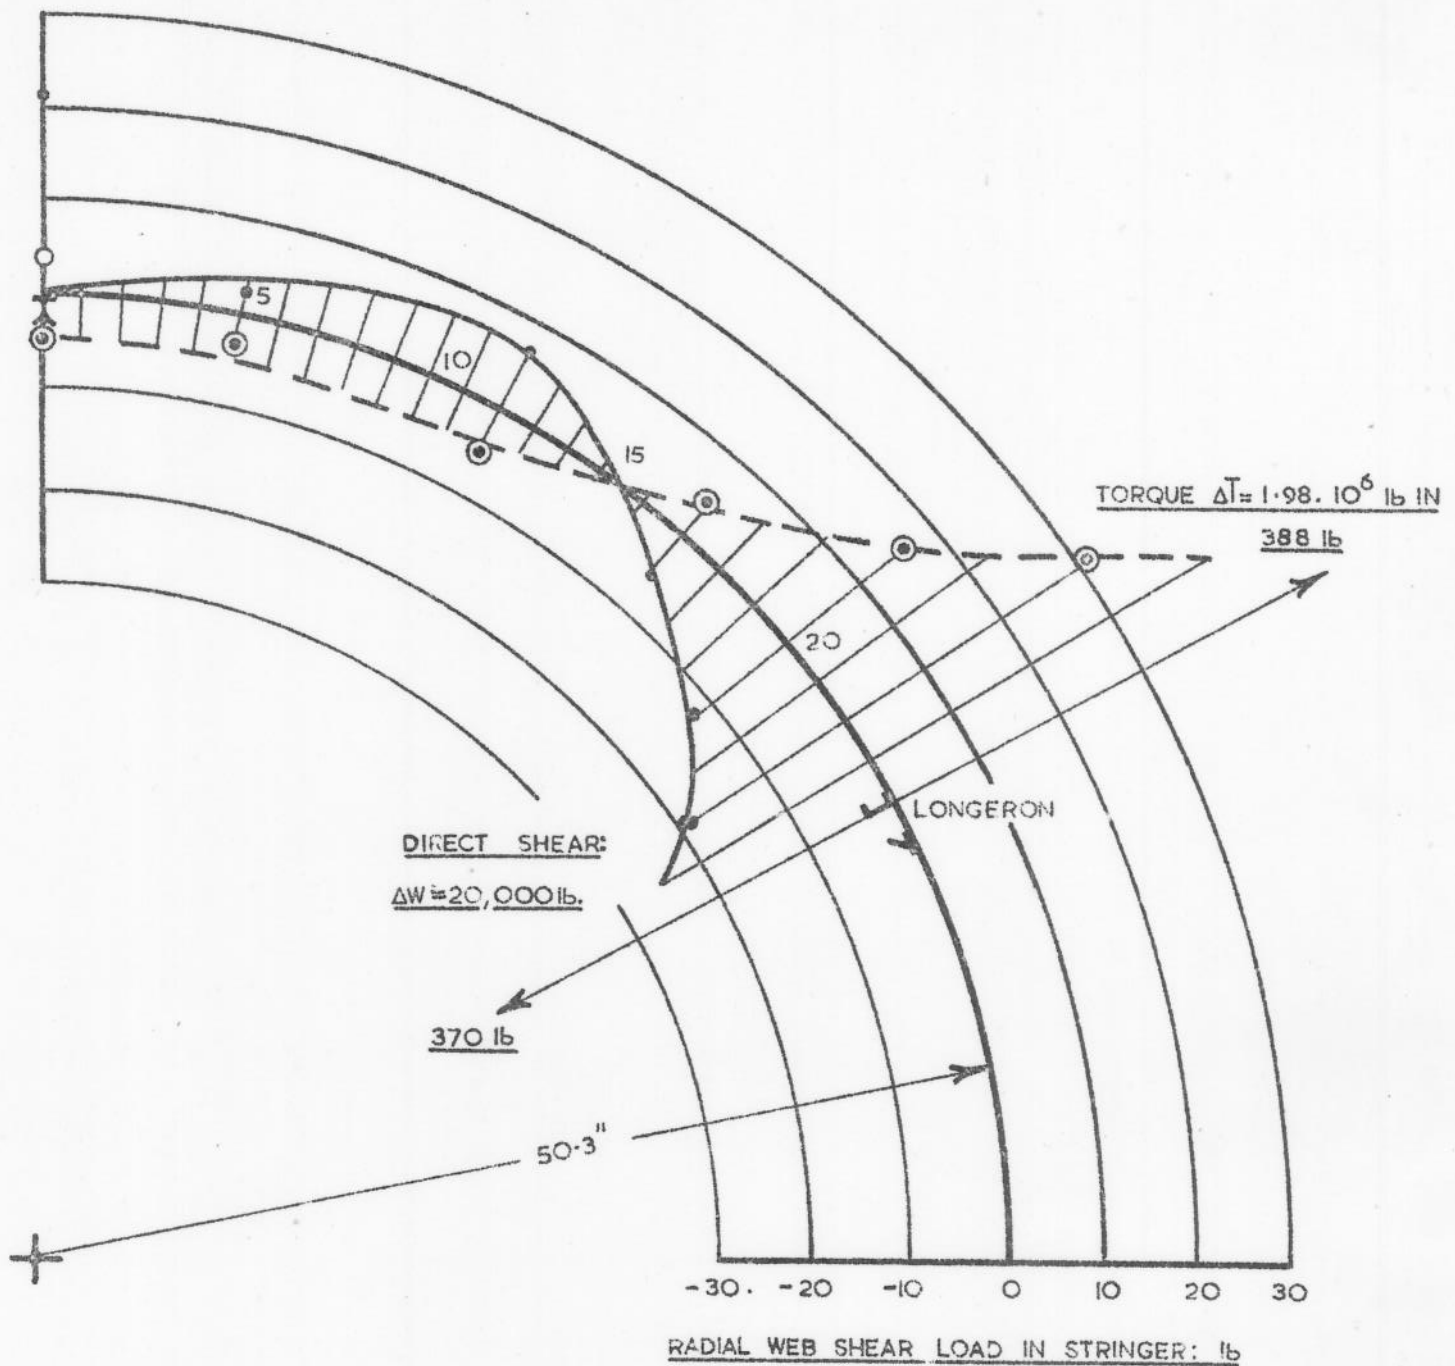
FIG 8

CHECKS:

$$\left. \begin{array}{l} 2^{\text{ND}} \text{ MOMENT OF AREA OF Z STRINGER} + 2'' \text{ SKIN} = 0.036 \text{ IN}^4 \\ \text{LONGERON} = 0.310 \text{ IN}^4 \end{array} \right\} \text{RATIO: } 8.6$$

$$\left. \begin{array}{l} \text{COMPARE MEAN EQUIVALENT RADIAL WEB LOADS.} \\ \text{STRINGER: } 45 \text{ lb.} \\ \text{LONGERON: } 378 \text{ lb.} \end{array} \right\} \text{RATIO: } 8.4$$

ALSO FROM FIG. 12, LOCAL SLOPE OF LONGERON BM. DIAG = .014 lb/lb.

(E. LONGERON SF APPROX 280 lb ($\Delta W = 20,000$ lb))

IN SECTION TESTED:

TOTAL OF COMPONENTS OF WEB LOADS ASSISTING SKIN TO
RESIST DIRECT SHEAR LOAD OF 20 000 lb; APPROX: = 250 lb.

I.E. TOTAL IS 5% OF ΔW .

STRINGER AND LONGERON WEB LOADS AT CENTRE OF BAY WITH CUT

Since resistance to ΔW was 87 per cent while resistance to ΔT was 98 per cent of applied load, further tests included investigation of stringer and longeron web loads in one quadrant of the cylinder, Figure 8. In fact, 5 per cent of the resistance to ΔW proved to come from stringer and longeron webs in shear (of course, these could not resist ΔT). Frame and longeron axial strains were also found.

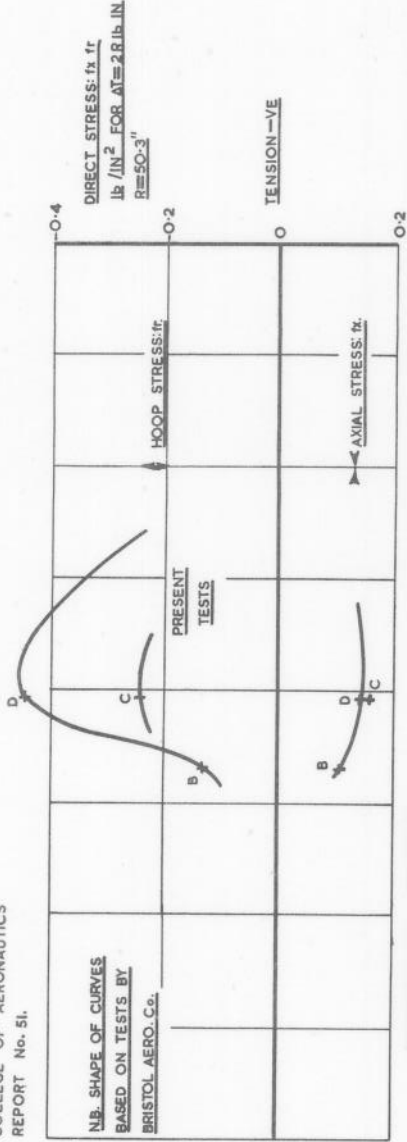
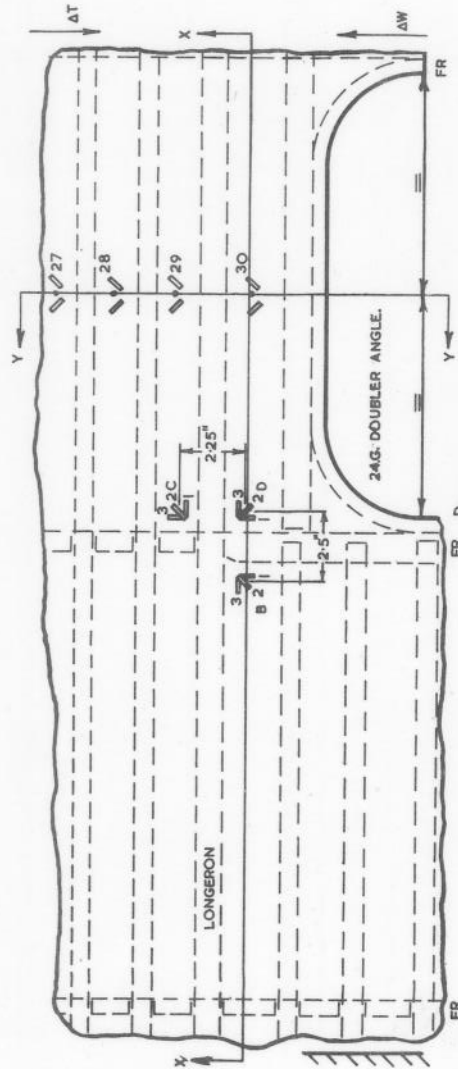
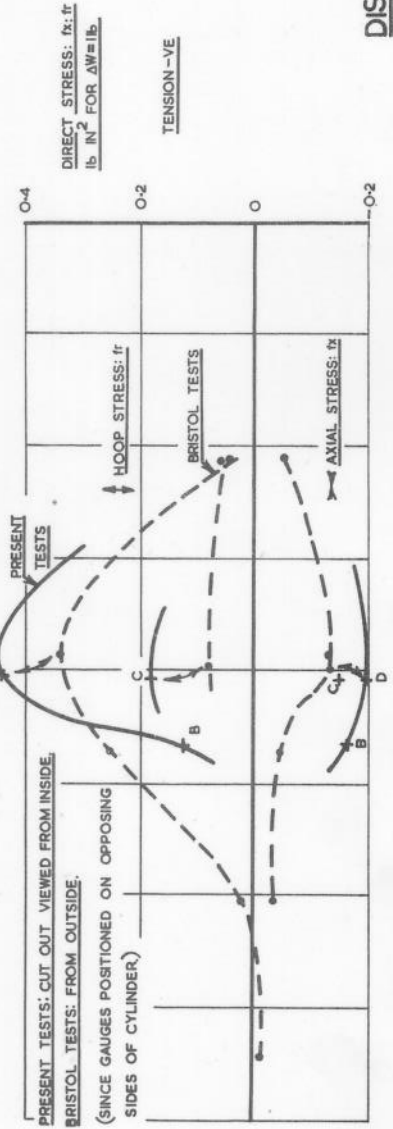
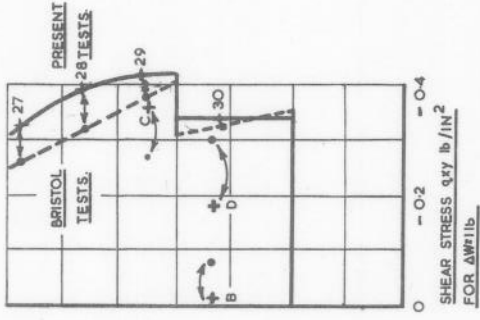
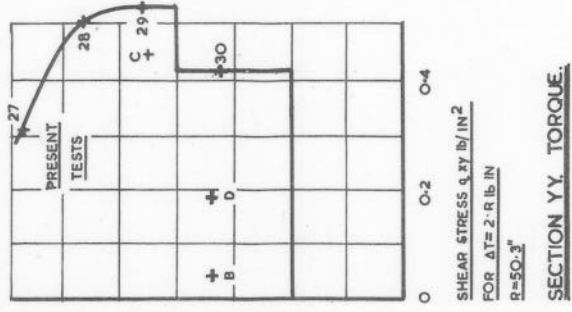
FIG. 11.

SECTION XX. TORQUE.

SECTION XX. DIRECT SHEAR

SECTION YY. DIRECT SHEAR.

DISTRIBUTION OF DIRECT
AND SHEAR STRESSES

Also of doubtful value is the distribution of direct stress near the cut-out (Figure 11). This is due to the poor skin riveting and resultant skin buckling even in unloaded condition. These gauges were compensated for buckling, but rate of acceptance of load was affected.

4. Skin Hoop Stress reached a high value (Figure 11).

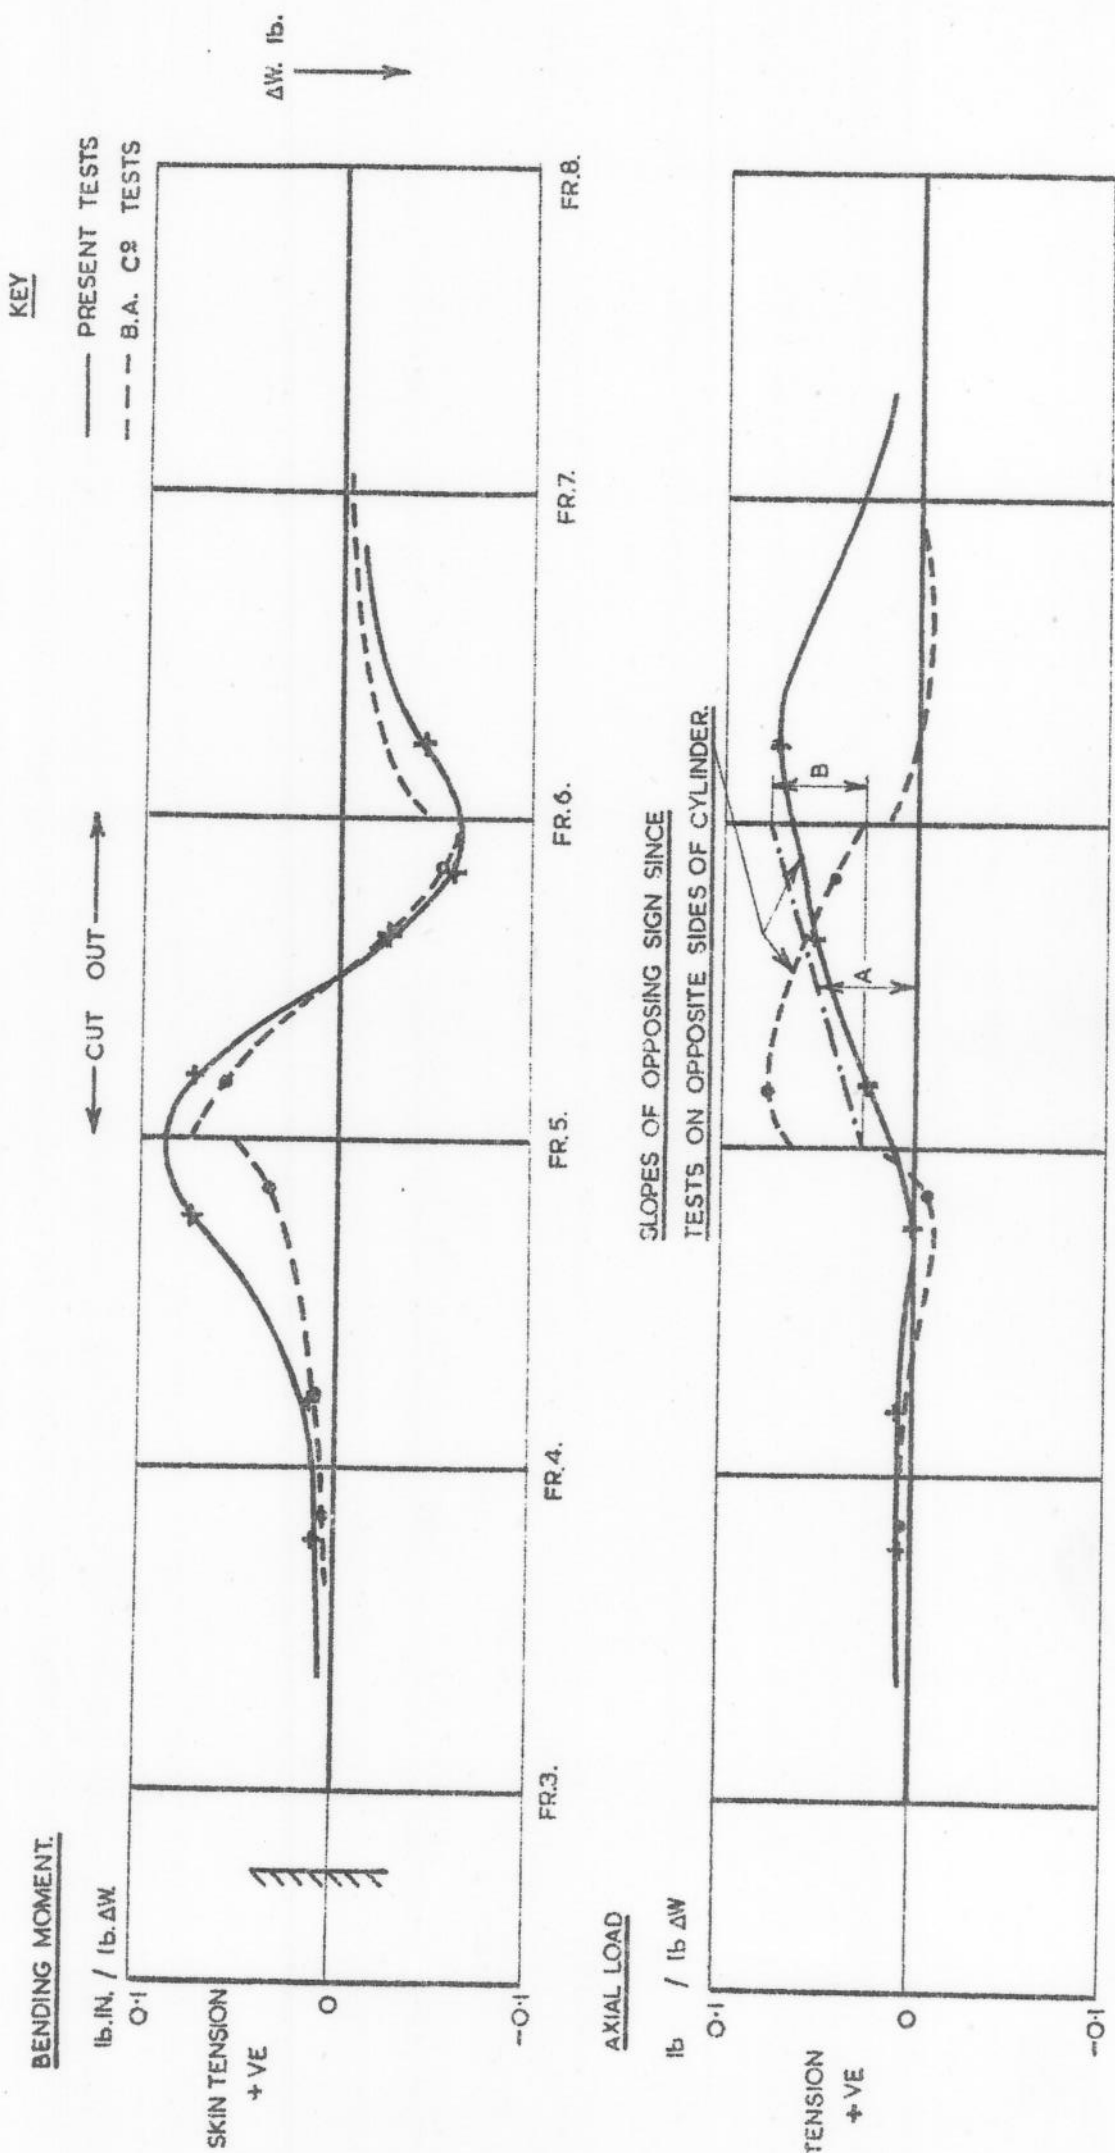
LONGERON LOADS: DUE TO ΔW (DERIVED FROM FIG. 6)
FIG. 12

A : AXIAL LOAD IN LONGERON DUE TO BENDING (THEORY.)
B : EQUIVALENT AXIAL LOAD INCREMENT TO DISCONTINUITY IN SHEAR STRESS DISTRIBUTION FIG. 9.

NOTE: STRESS DUE TO BM. APPROX 5 TIMES STRESSES DUE TO A.L.

Stress due to axial load was small (20 per cent of the stress due to BM). Both BM and axial load were a maximum at the edge of the cut-out and died away exponentially. BM was of the same magnitude as that in the frame.
