REPORT NO. 51

THE COLLEGE OF AERONAUTICS

Stress Distribution near a Rectangular Cut-out
in a Reinforced Circular Cylinder due to Direct
Shear Loading and Torque

Part I: Test Results

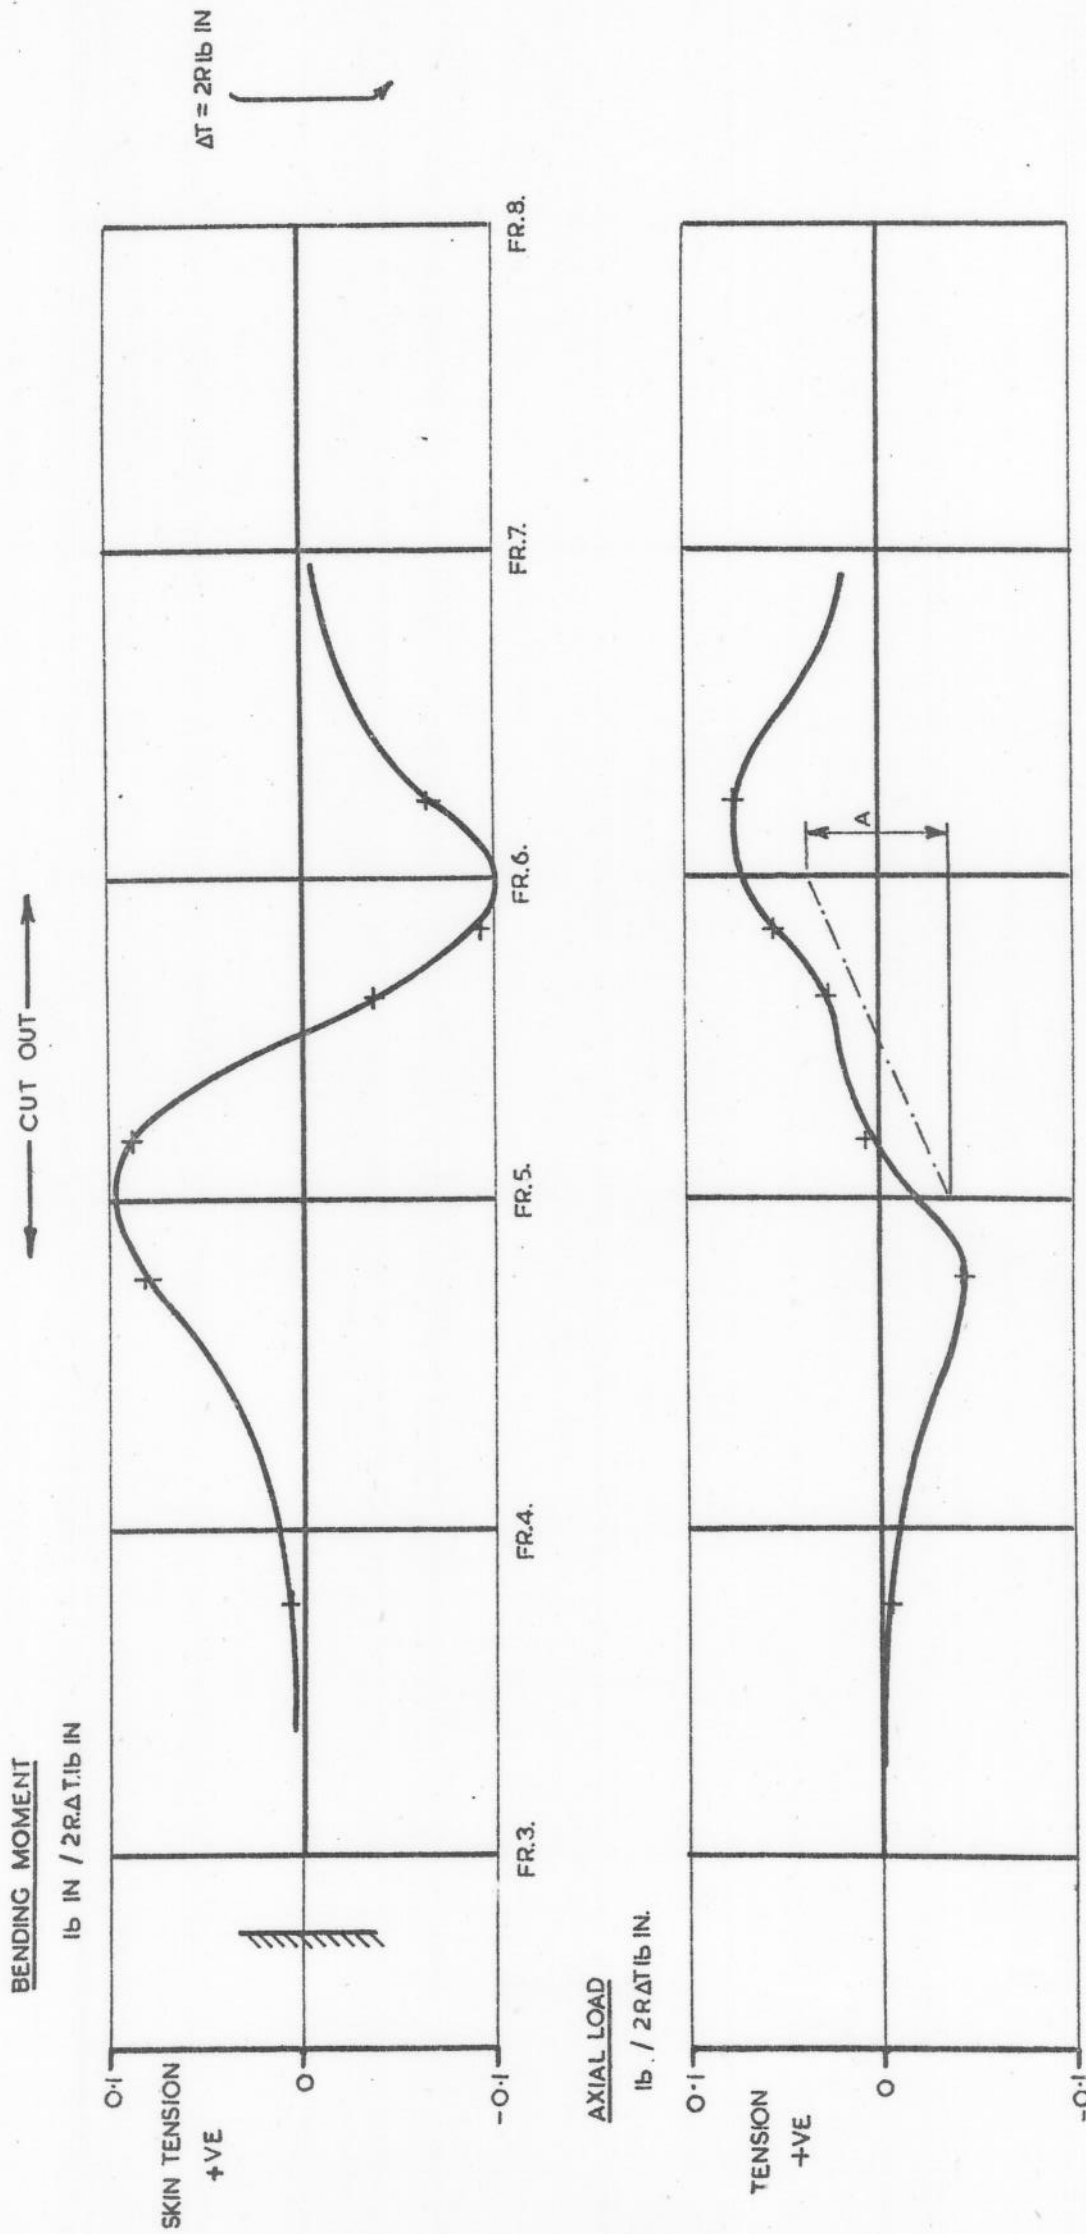
LONGERON LOADS: DUE TO Δt (DERIVED FROM FIG. 6.)

NOTE: STRESS DUE TO BM APPROX.
5 TIMES STRESS DUE TO A.L.

A: EQUIVALENT AXIAL LOAD INCREMENT TO DISCONTINUITY
IN SHEAR STRESS DISTRIBUTION. FIG. 10.

After checking results for linearity of strain across the section of a member, Figure 6, load increments in a member by more than one method etc. (figures 8, 12 and 13), it is felt that these results give fair indication of the stress distribution at the corner of the cut-out investigated.

The discontinuity in skin shear stress distribution occurring at the longeron (Figure 10) indicates an axial load increment in the longeron of the order found (Figure 13).

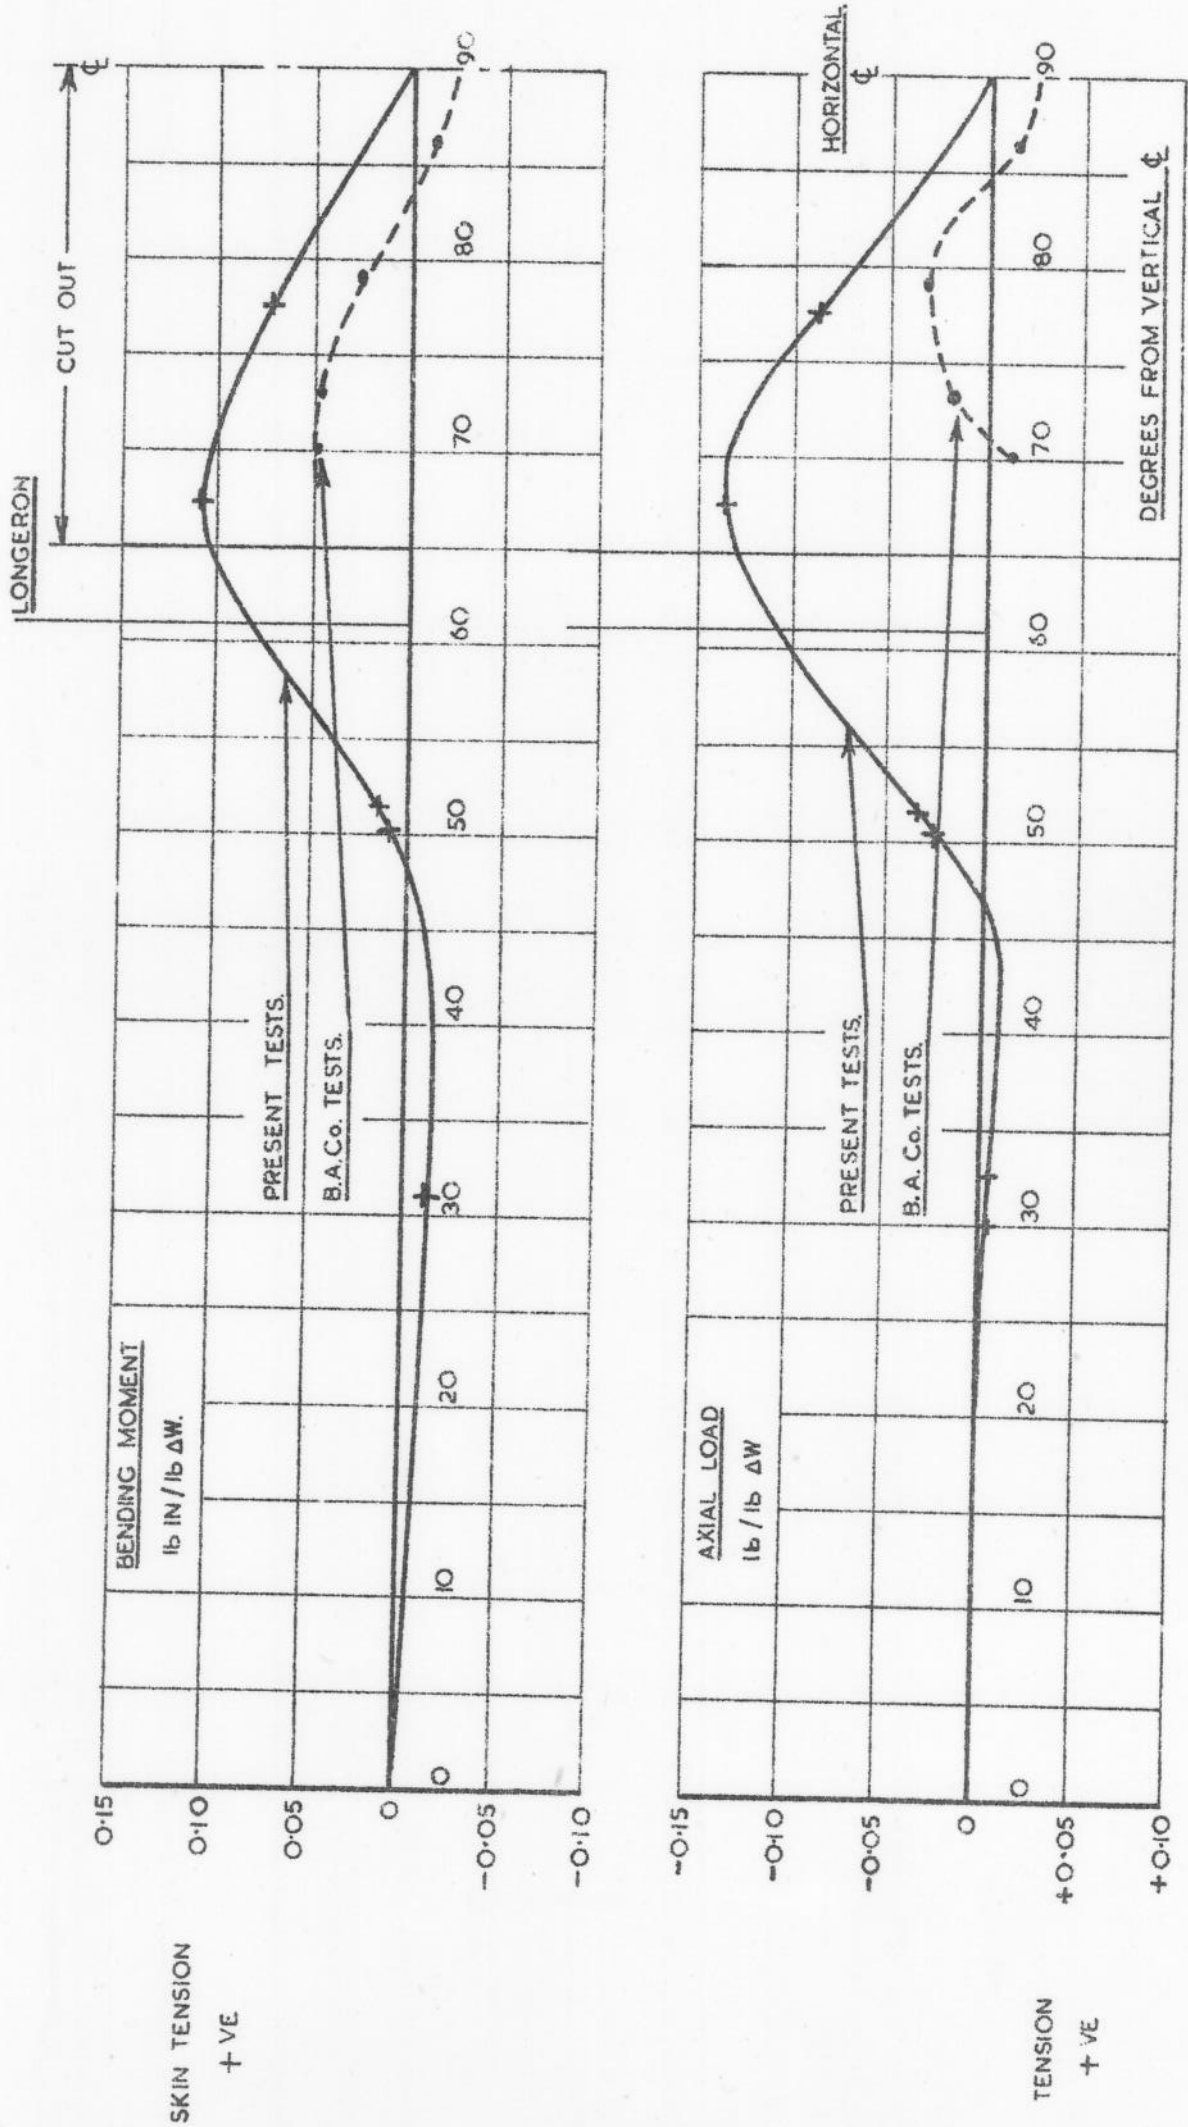
FIG. 14.

FRAME LOADS: DUE TO ΔW (DERIVED FROM FIG. 6 AND 7.)

Both BM and axial load were a maximum at the edge of the cut-out and thereafter very rapidly became negligible.

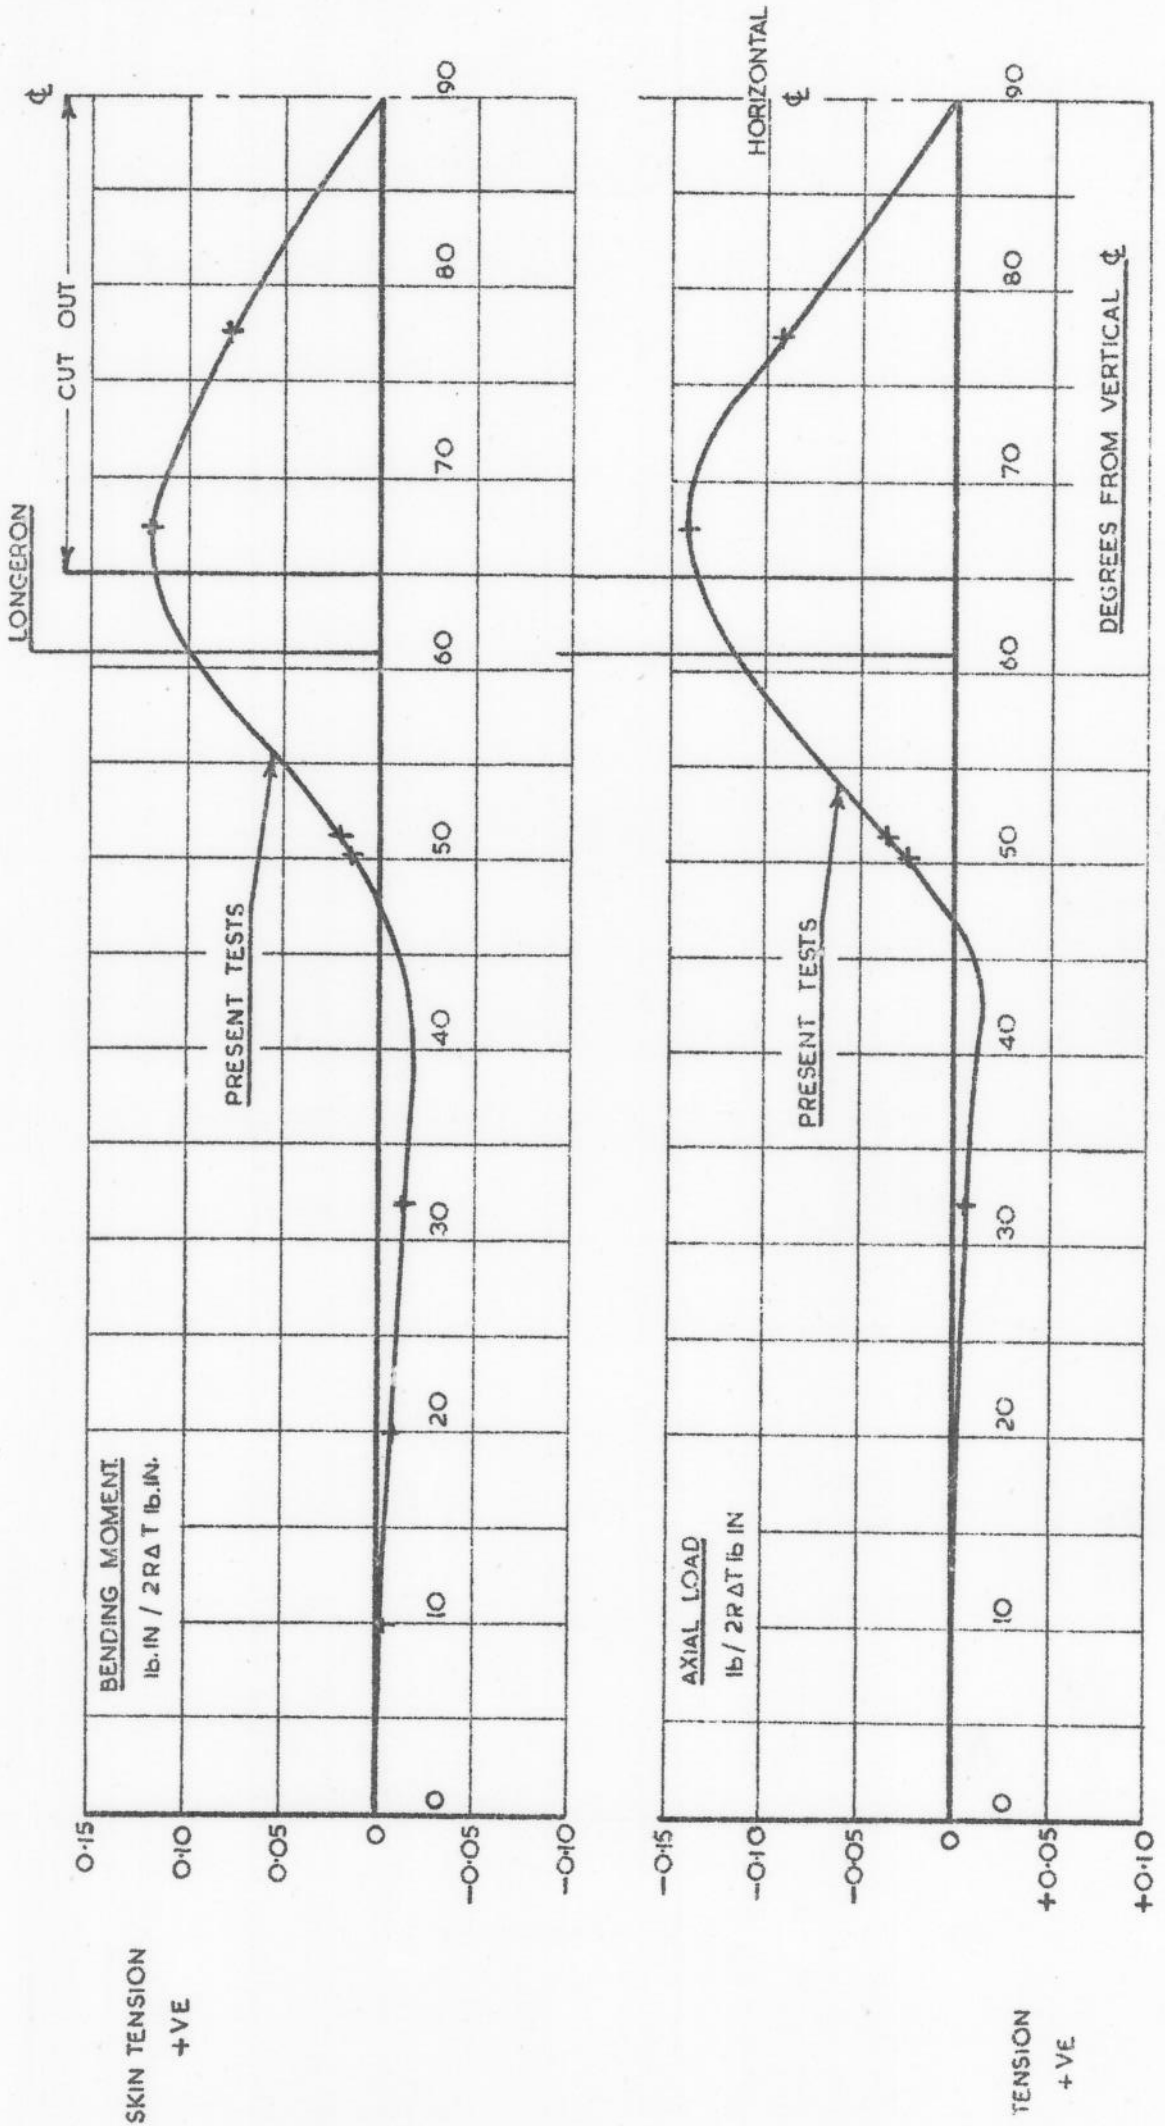
FIG. 15.

FRAME LOADS: DUE TO ΔT (DERIVED FROM FIG. 6 AND 7.)

Maximum frame loads occur at Y (Figure 15). This leads to frame stresses three times those found in the longeron and twice those elsewhere in the frame.
