Review

# Review of Current Guided Wave Ultrasonic Testing (GWUT) Limitations and Future Directions

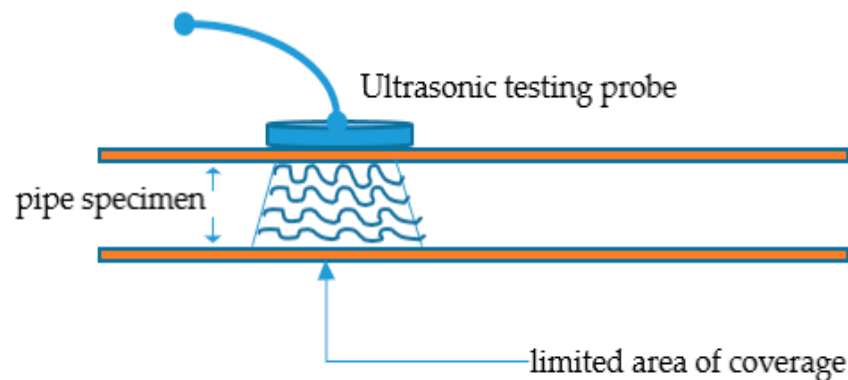
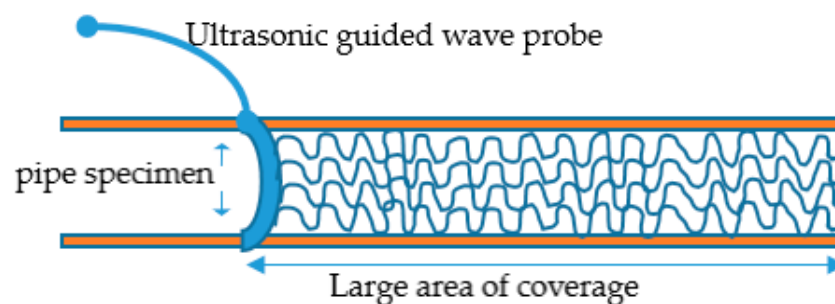
**Figure 1.** Difference between (a) ultrasonic testing, UT; and (b) guided wave ultrasonic testing, GWUT.

The conventional ultrasonic testing (UT) whose frequency is dependent on the thickness of the inspecting structure is different from GWUT of frequency range 20 kHz through 15 MHz or more in rare cases [12,13]. The UT is a high-frequency pulse-echo inspection technique for deep penetration into structural thickness [14]. It covers a limited area of the structure, unlike the GWUT that propagates a long-distance structure, as shown in Figure 1a,b.

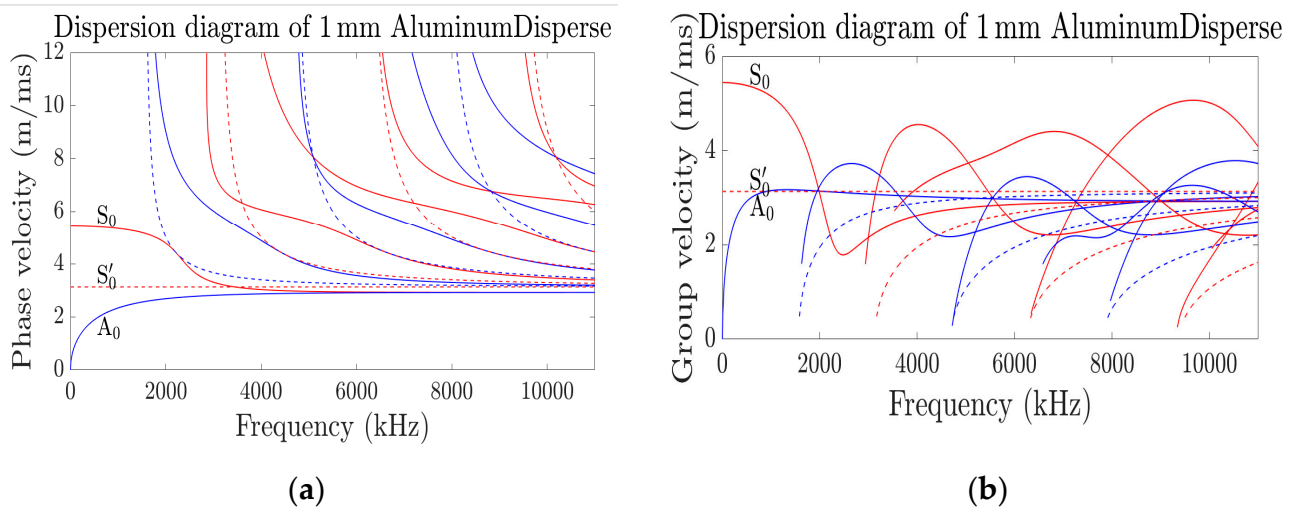
**Figure 2.** (a,b) Dispersive curve of 1 mm thickness of Al obtained using DC [77].

Similarly, in 2016 Armin Huber of the Lightweight Production Technology of the German Aerospace Center developed 'Dispersion Calculator' (DC) [75,77]. DC is more intuitive and interacting than the famous disperse software [76,77]. The calculator uses the stiffness matrix method formulated by S. I. Rokhlin and L. Wang [78–80] to compute the dispersion curve of longitudinal and shear waves in an anisotropic plate and multilayered transversely isotropic composites. Figure 2 is the guided wave phase velocity, and group velocity dispersive curves of 1 mm aluminum plate thickness generated using the DC. It could be deduced from the dispersive curve of phase velocity that  $S_0$  mode is relatively nondispersive up to 200 kHz with  $C_p$  of about 5430 m/s when compared with other

modes. Therefore, it is suitable to monitor the health condition of the plate using  $S_0$  mode as the generated excitation signal. However, excitability and sensitivity of the modes, especially with regards to thickness reduction due to corrosion was not accounted for. In [73], an optimized dispersion curve that relies on the excitability and sensitivity in addition to the group velocity of the mode was developed. This was named goodness dispersion curve, and it offers an informed mode suitable for damage detection but limited to material thickness reduction due to general corrosion. It was revealed that sensitivity of guided wave varies with wave frequency and at low frequency, the wave is insensitive to small thickness variation of the metal. Interestingly, the fundamental symmetric,  $S_0$ , and asymmetric,  $A_0$ , modes were recorded as insensitive.

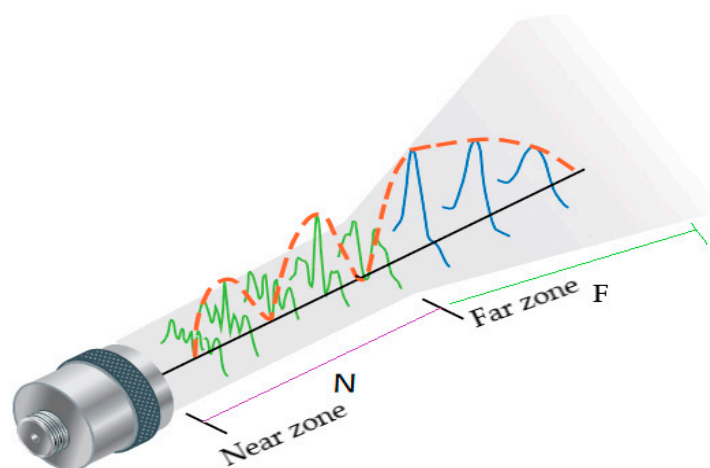
Figure 3. Transducer wave zones [84].

The transducer pressure wave is of two-zone formation [83]: the near zone and far zone, as shown in Figure 3. At the near zone, the wave pressure amplitude varies spuriously with many high and low echoes. However, beyond the near zone distance  $N$ , the wave gradually attenuates in the amplitude. The multiple echoes at the near zone make it challenging to detect structural damage between the near zone and transducer. This is a blind spot of the

transducer where damage detection through signal amplitude analysis is ineffective. Hence, damage detection is effective beyond the near zone distance and within the far zone. The near zone distance is defined as in Equation (12).  $D$  is the transducer diameter,  $f$  is the pressure wave frequency,  $\lambda$  is the wavelength,  $v$  is the velocity.

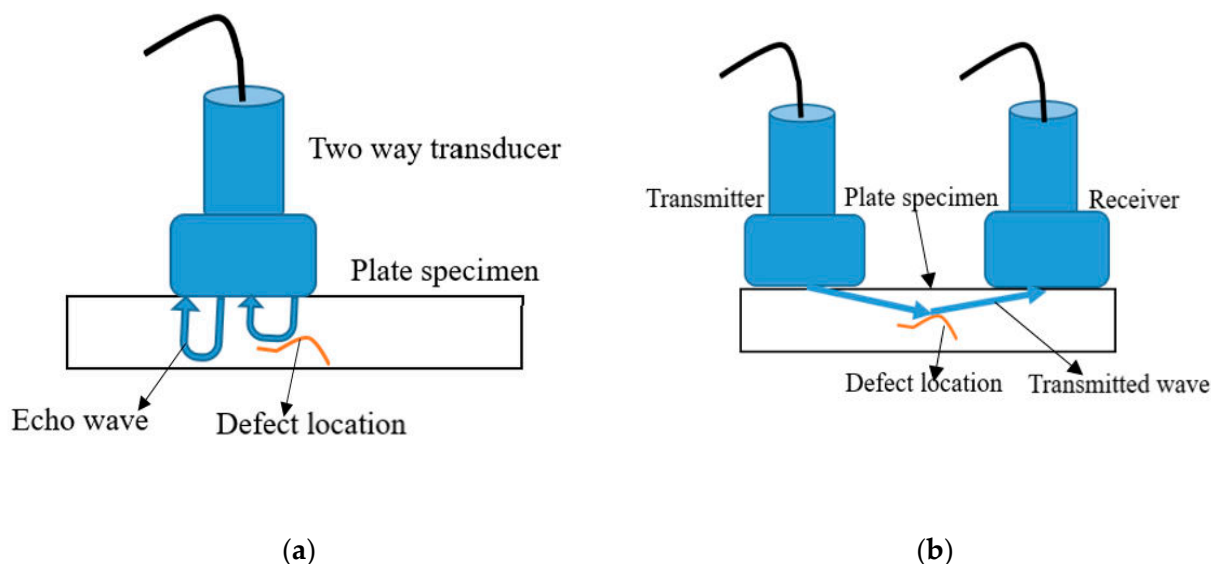
**Figure 4.** (a) Pulse—echo method with a transducer; (b) Pitch—catch method with two transducers (R) [86].

The configuration topology of the transducer is majorly either pulse-echo (P-E) or pitch-catch (P-C) depending on the geometry of the inspecting structure, targeted defect of interest and the needed data [34]. The typical examples of the methods are shown in Figure 4. In P-E, a single or two transducer(s) is used, and the reflected echo signal, time-of-flight (ToF) alongside the propagation velocity are used to determine defect, deterioration, discontinuity, or thickness of the material structure [70,85]. A minimum of two transducers is required in P-C and spaced sufficiently to generate defect interrogating wave and receive it after interrogation with the structural defect. This configuration is often applied to detect

or monitor defects that are not sufficient to cause reflection somewhat further transmission of the wave though attenuated. Unlike the P–E method, the P–C measurement is the amplitude of the damage signal or the received damage signal's shape. P–C is an excellent choice to make when the intention is to cover a long-range structure [86].

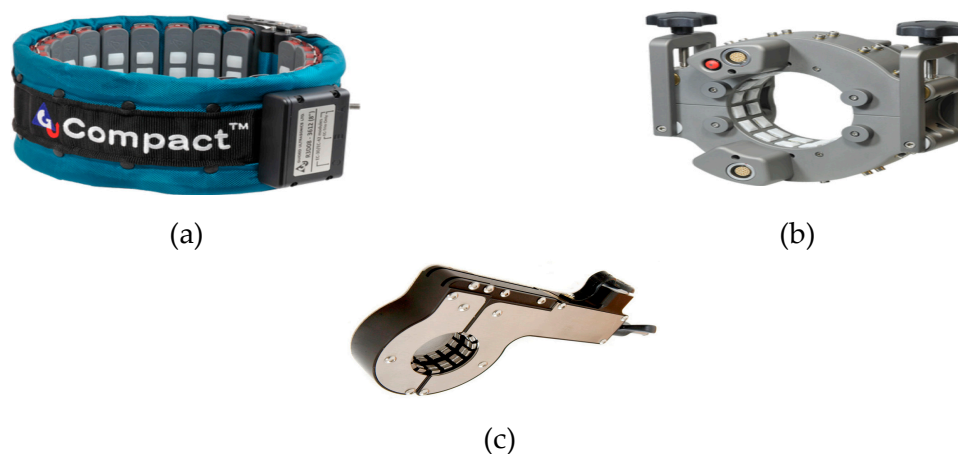
**Figure 5.** (a) Compact ring transducer; (b) Solid ring transducer; (c) Claw transducer [87].

In pipeline inspection, piezoelectric transducers are distributed and interconnected in parallel to form a ring of an array around the pipeline's circumference [44–46]. This technique of inspecting the pipeline is devoid of surface preparation unlike other types of inspecting technique; hence, saves time and encourages more length inspection in a day. However, hopping the device from one point to another is laborious, coupled with its weight, installation, and uninstallation time at distances of interest. Some of the available collar ring transducers in the market for a specific inspection challenge are shown in Figure 5. The compact ring is designed for a wide range of inspection with a 30–35% weight reduction. The solid ring transducer type is for standard inspection of 2–8 inches pipes while the claw transducer type is designed to inspect a closely spaced pipeline that cannot allow the fitting of the conventional ring [87]. A typical transducer ring array contains 2–24 transducers depending on the diameter of the pipe [28,88,89].

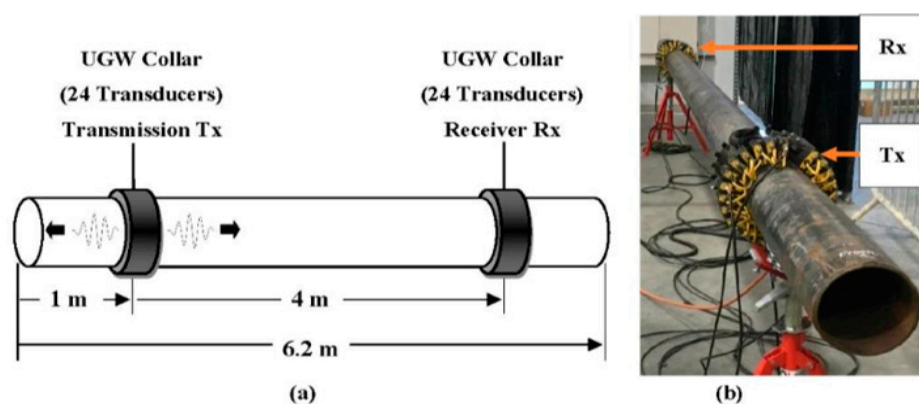
**Figure 6.** (a) Schematic and (b) setting-up of the UGW collar arrangement for pitch-catch configuration topology [89].

Therefore, about 48 transducers must form two rings of circumferential inspection array of a sizeable guided wave. The high number of transducers per ring adds to the high cost of inspecting structures. The networking together of such a large number of transducers could pose a challenge in determining when a transducer has failed. Although it offers merit in full inspection coverage of the structure, it increases the system inspection power [71]. Also, the large size of the collar transducers does not encourage in-service inspection of structure which demands permanent installation of the device [90]. In Figure 6, two 24-transducers collars were configured in pitch-catch topology and used to inspect internal corrosion activities in a pipeline [89]. In [28], multiple ring arrays of 24 transducers were used to study the guided wave's unidirectional excitation function. Fundamental Torsional (0,1) wave mode was generated and conditioned to propagate only in a forward direction. This approach reduces complexity in the signal collection and interpretation, and it saves computational cost.

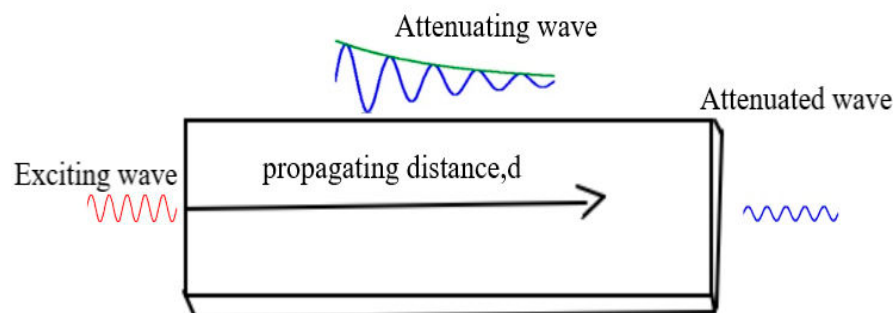
**Figure 7.** Signal attenuation in a medium.

Attenuation reduces signal level, either in amplitude or energy as it propagates through a medium [81]. Figure 7 is a typical demonstration of wave attenuation in a medium. The diminishing of the propagating signal amplitude often follows an exponential decay pattern expressed in Equation (13) while variation in the signal intensity is described in Equation (14).

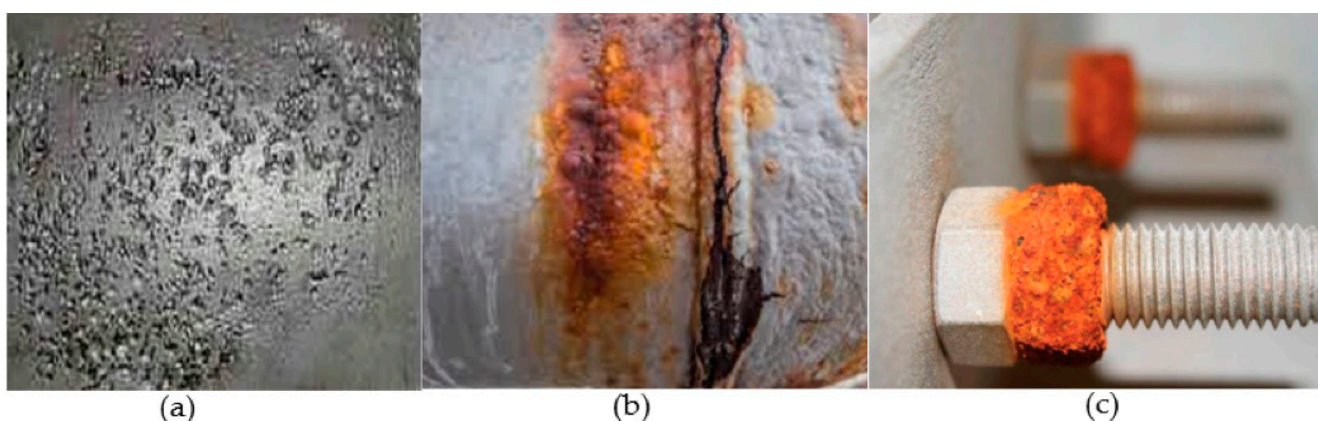
**Figure 8.** (a) Pitting corrosion in carbon steel [109]; (b) stress crack corrosion on carbon steel [110]; (c) crevice corrosion on a bolt [111].

Corrosion activity is an inevitable effect on metallic structures. It is one of the significant issues of safety in industries and results in corrosion failure of structures. It is instigated mostly through metal interaction with immediate environmental variables (oxygen in the air, hydrogen, chlorine, ambient temperature, humidity, and presence of microbial) or stress on the metallic structure as in the case of stress corrosion cracking [102–104]. The result of corrosion activity would be reddish rust if it happened in the presence of oxygen or greenish rust in the chlorine-dominated environment [105,106]. Some corrosion forms are pitting, crevice, and stress corrosion cracking with their peculiarities [107,108] as shown in Figure 8.

The pitting corrosion is caused by unevenness in the metal structure or breakdown of the metal surface's protective coating, thereby exposing it to electron loss. It is not easy to predict and detect. Hence, it has the capability of causing corrosion failure and remain undetected. Crevice corrosion occurs due to an imbalance in ion concentration between the activity areas of the metal structure. It could happen in an oxygen-limited area such as under washers or bolts [111]. The growth of crack on ductile metal due to corrosive surroundings and applied cyclic stress is referred to as stress corrosion cracking (SCC) [112]. Corrosion rate on the material is estimated using Faraday's law [113] of metal's electrochemical reaction as in Equation (16).

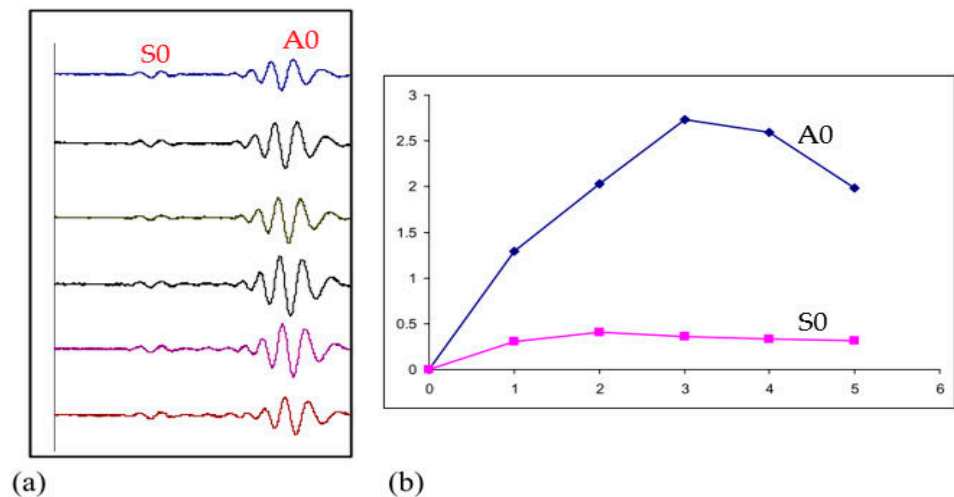
**Figure 9.** DI analysis on pitch-catch signals for corrosion detection. (a) Received signal at PWAS 4 when PWAS 0 sent at 120 kHz; (b) DI curves of both  $A_0$  and  $S_0$  wave packets at 120 kHz of path 0–4 [117].

High-frequency GWUT has been extensively used in monitoring corrosion activity in structures [63,114,115] although low-frequency monitoring was demonstrated in [116] using 64 PZT sensors. In [117], Victor Giurgiutiu et al. leveraged on piezoelectric wafer active sensor (PWAS's) cheap cost, and networked multiples of it for corrosion detection and localization in plates and pipelines. Fundamental lamb wave modes  $S_0$  and  $A_0$  at high frequency (120 KHz) were generated and used. It was revealed that  $A_0$  is more sensitive than  $S_0$  in detecting corrosion both in plate and pipe although  $S_0$  travels faster but less sensitive to the metal thickness changes. This is depicted in Figure 9.

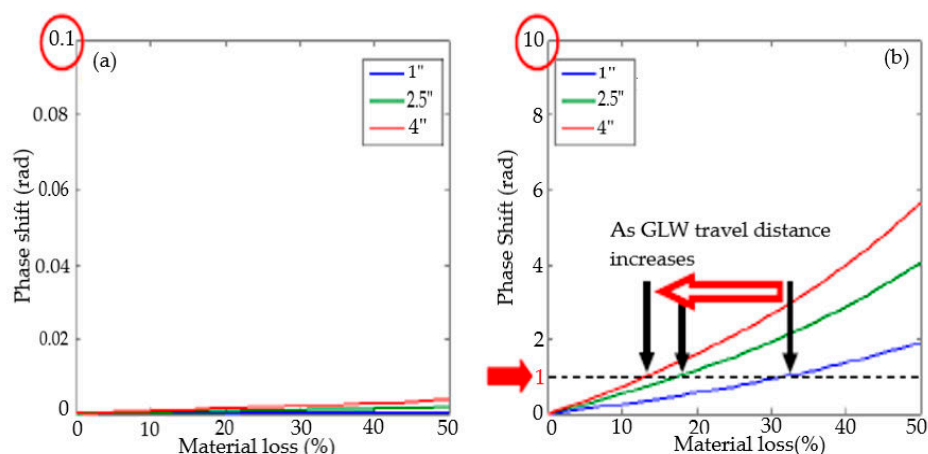
**Figure 10.** Phase shift estimation according to three-wave propagation distance (60 kHz excitation) (a) S0 mode (b) A0 mode of GLWAdpted with permission from [59]. Copyright 2012, ASME.

In [118], accelerated corrosion activity on a steel bar in concrete was successfully monitored using high frequency (200 KHz) lamb wave. The study revealed that corrosion in this nature could be detected using the FFT signal's amplitude response. In [59], corrosion activity was experimentally monitored and quantified using a damage index profile map and  $A_0$  phase shift of the sensor signal. The  $A_0$  group velocity was observed to vary accordingly with the material loss from 0–50% of the thickness. The obtained result suggested that the phase shift of the fundamental antisymmetrical lamb wave  $A_0$  mode can be used to quantify early corrosion activity in structures, as shown in Figure 10.

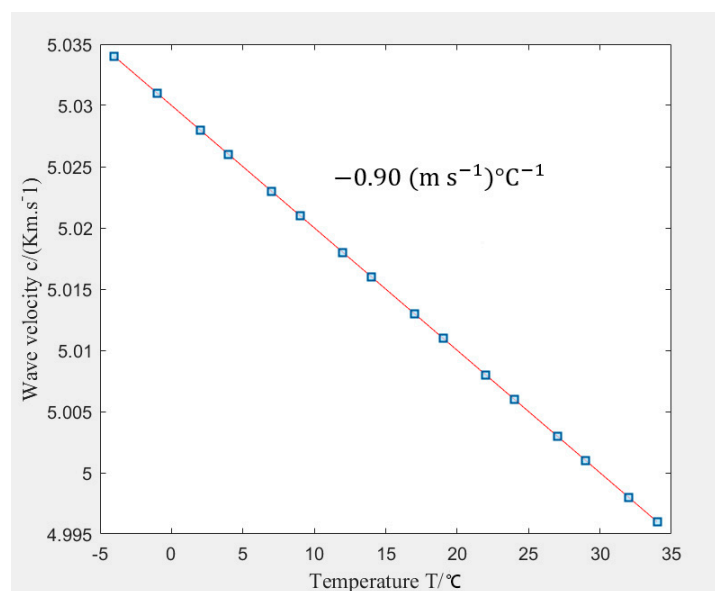
**Figure 11.** Temperature effect on Lamb wave velocity (R) [124].

Environmental factors vary uncontrollably and interact with installed asset structures. This interaction results in guided wave parameter variation, especially during thermal expansivity [122]. Since metallic structures are an excellent medium for propagating the inspecting wave and serve as host for the sensors, the effect of environmental variation on the metal could be transferred on the sensor directly or indirectly hence causing variation in the parametric features of the sensor signals. These variations mostly result in masking damage signals, thereby allowing failure to occur. Studies have been carried out to investigate the ambient temperature variation on the ultrasonic guided wave (host) and the transducers (actuator and sensor). In [123], Cawley made a comparison study of crack formation effect on the resonant frequency and impact of the beam's length on the resonant frequency. The result showed that the change caused by 2% depth cut of the crack was 40 times smaller than that caused by a 2% increase in the beam's length. The effect of temperature on UGW has been widely studied. In [124], Lui Zenghua et al. investigated the effect of temperature ( $-4\text{ }^{\circ}\text{C}$  to  $34\text{ }^{\circ}\text{C}$ ) on lamb wave, L (0,1) propagating on steel. The wave velocity was reported to vary inversely to increase in temperature, as shown in Figure 11. The retardation rate of the velocity was recorded to be  $0.9\text{ m/s}$  for every degree of increase in temperature.

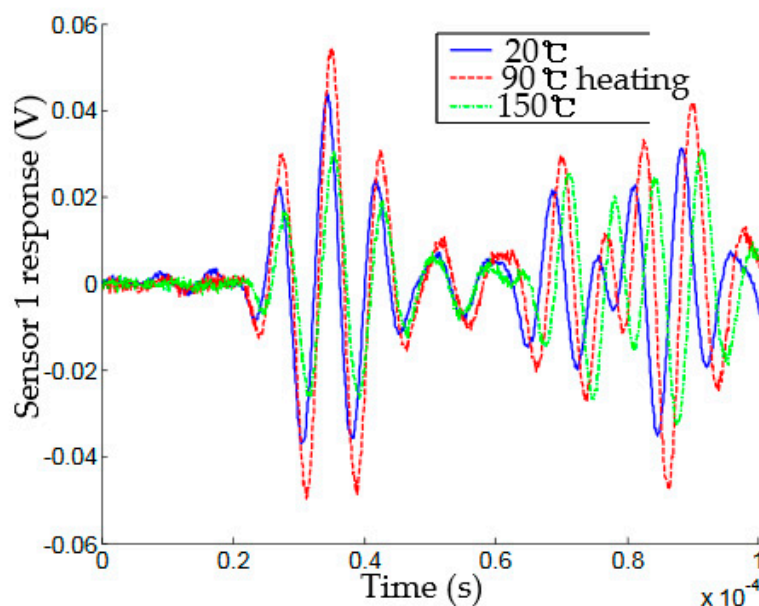
Figure 12. Temperature effect on PZT amplitude [126].

The study on anisotropic plate material carried out by Lanza et al. witnessed similar behaviour but on the wave signal amplitude [3]. It was observed that the wave amplitude increases at the temperature below  $20\text{ }^{\circ}\text{C}$  and decreases at a temperature above  $20\text{ }^{\circ}\text{C}$ . This effect is suggested to be attributed to the competing roles of the PZT coefficients and the dielectric permittivity. When the parameters were isolated, the amplitude response to temperature variation was observed to be proportional. Similar proportionality response was observed when the high-temperature transducer array coupled in an empty pipeline was subjected to a temperature of  $7\text{--}150\text{ }^{\circ}\text{C}$  [125]. In the pitch-catch study of varying temperature ( $20\text{--}150\text{ }^{\circ}\text{C}$ ) effect on guided wave performed by Raghavan and Cesnik in [126], the response was observed to be nonmonotonic in the measured amplitude as shown in Figure 12. The amplitude response signal increased when the temperature is  $20\text{--}90\text{ }^{\circ}\text{C}$  but decreased when it is  $90\text{--}150\text{ }^{\circ}\text{C}$ . This behaviour was subjected to further theoretical and experimental studies. Its behaviour was attributed to the assumption of perfect bonding and constant adhesive layer properties through the temperature range.

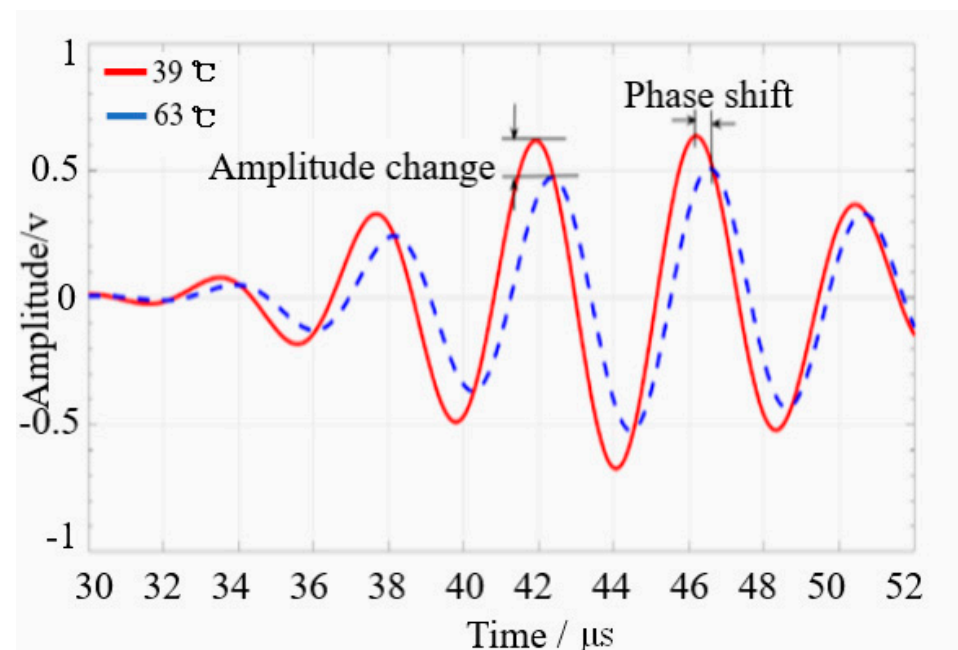
Figure 13. Typical signal differences under different temperatures [5].

Some other research studies on temperature influence on a guided wave and wave inspection parameters can be read in [6–10,129–131]. Figure 13 showed the significant effect of temperature variation that resulted in amplitude distortion and signal phase shift [5].

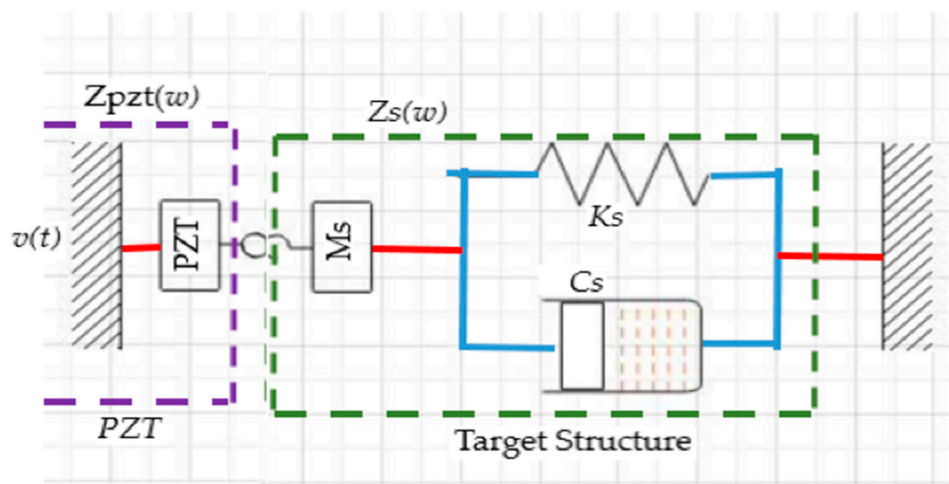
Figure 14. 1-D PZT–target structure interface [143].

It is an acknowledged fact that temperature variation brings about changes in the PZT constant properties, adhesive layer properties between the PZT and the target structure, mechanical properties of the target structure such as young modulus [4,140,141]. Principally, the PZT is bonded to the target structure using an adhesive agent. When an appropriate excitation voltage is applied on the PZT, it would exert acoustic pressure via adhesive layer to the target structure and cause its particles to vibrate in their mean positions. The interaction of the PZT sensor with the target structure in SHM has been modelled in different ways. The essence is to understand their behaviour when there is an existence of damage in the target structure. Among these models are the static and the dynamic finite element models that used the static properties of PZT and structural stiffness to determine the output characteristics of the PZT sensor. The impedance-based-model coupled electro-mechanical system has been more interesting and advantageous than the other two models [142,143]. However, these models are of one degree of freedom (1-DOF) because they considered only the interface between the PZT and the host structure. The physical model of the system is shown in Figure 14 and its simplified model equation for impedance coupling,  $Z(\omega)$  the PZT and the target structure are given in Equation (21) while Equation's structural impedance is Equation (22). For brevity, the equation terms are defined in Table 6.

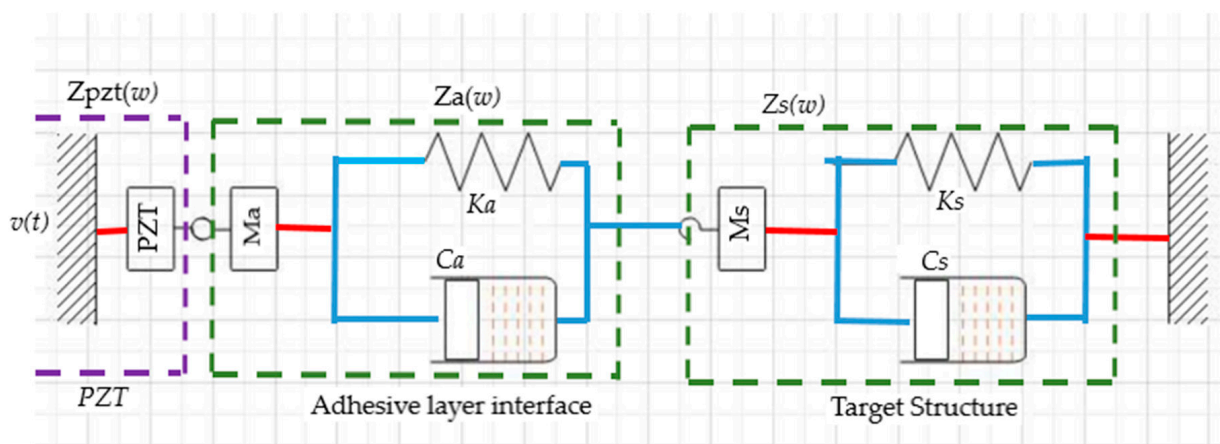
**Figure 15.** Modified PZT–host structure interface [142].

In this model, the output characteristics of PZT is determined via its dynamic properties and structural impedance. By varying the stiffness of the model depicts changes in the target structure.
