Laser array spots thermography for detection of cracks in curved structures

Abstract. The laser array spot thermography (LAST) is a fully non-contact and non-destructive method for the inspection of surface cracks with high efficiency. In this study, the detection capability of this method for the inspection of surface cracks in structures with curved surfaces is experimentally studied. The influence of the inspection angle on the crack imaging results is also investigated. The experiment results show that cracks in surface of the pipes with different diameters can be detected and imaged by LAST.

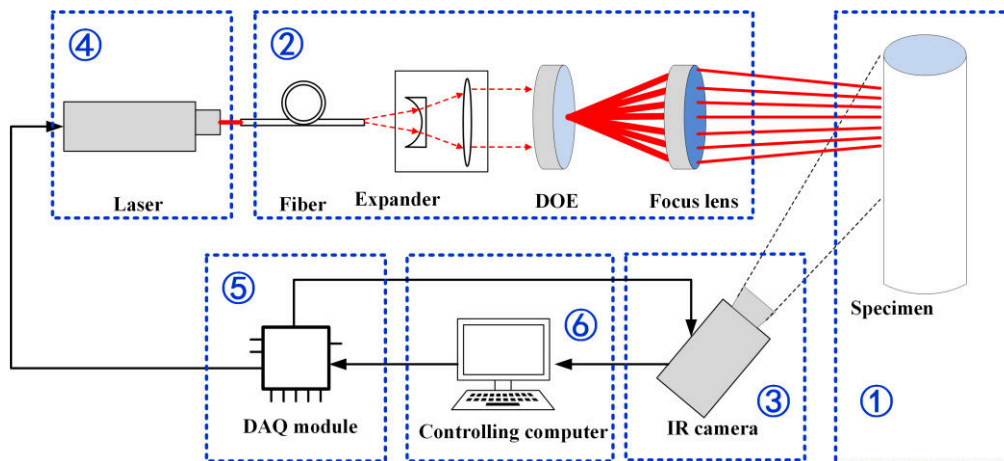
Fig. 1. Picture of laser array spot thermography experiment system. The system contains (1) specimen and holder; (2) optical components, comprise of a laser expander, a DOE and a PCL; (3) IR camera; (4) continuous-wave laser; (5) DAQ model; (6) controlling computer.

The established LAST system for inspection of surface cracks is shown in Fig. 1. The experimental setup includes a continuous heat source, an infrared camera, a data acquisition (DAQ) module and a set of optical components. The heat source is a continuous-wave (CW) laser with 1064 nm wavelength and maximum power of 100W. The thermal images were acquired by a mid-wave infrared thermal camera with a resolution of 512×640 pixel and frame frequency of 60Hz. The laser output power and duration are controlled by a DAQ module of ARM, which also output camera trigger signal to synchronize the capture of infrared images and laser turn on. The optical components contain a diffractive optical element (DOE) and a plano-convex lens (PCL) laser to split the single point laser beam into a 9×9 laser array.

The working principle of the system is as follows. First, the controlling computer sends out a trigger signal to the DAQ module to activate the inspection procedure. Then, a periodic voltage signal is generated by DAQ module and transmit to laser driver. This voltage signal is amplified and then drive the laser to generate laser beam. At the same time, another periodic voltage signal generated by the DAQ module is also transmitted to the IR camera to synchronize data acquisition with the laser excitation. Once generated, the initial single laser beam is split into a laser beam array by the optical components. Finally, the laser spots array is exerted onto the target surface of interest, generating thermal waves and finally reveal the surface cracks. The technical specifications of equipment and details of the optical components designing have been carefully discussed in [7].

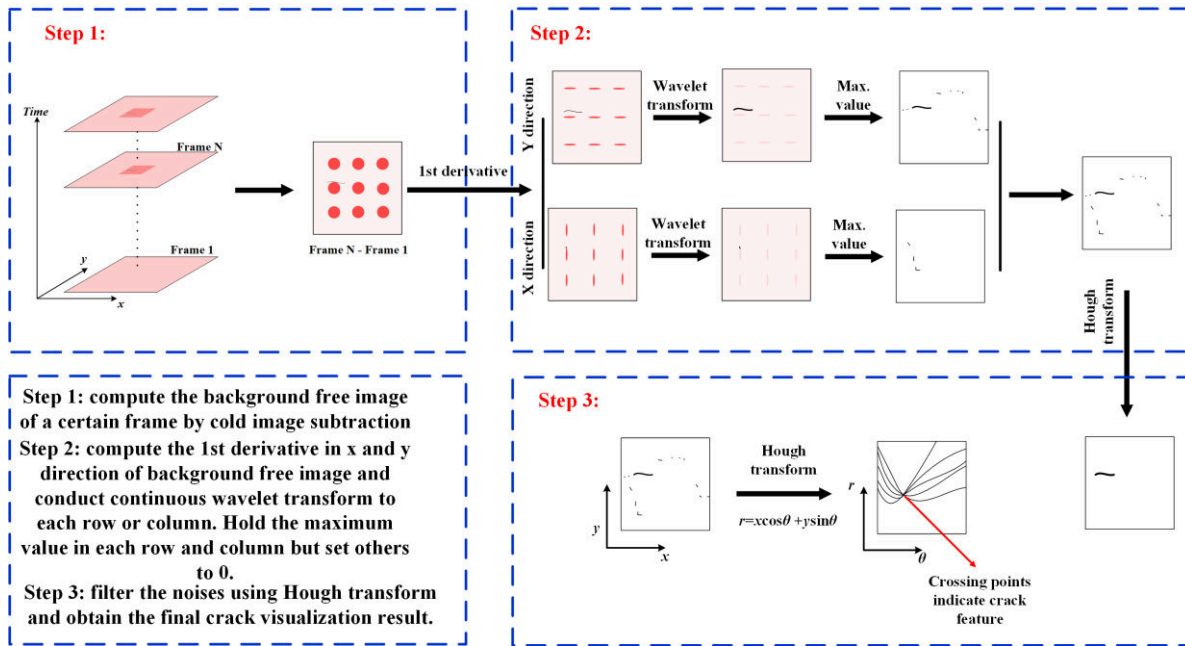
Fig. 3. Crack imaging procedure

In this section, a crack imaging algorithm combined with wavelet transform and Hough transform is developed to automatically identify and quantify a crack from the thermal images obtained by the LAST system. The derivative image is widely used in processing thermal signals to enhance edges and other important information while suppressing the noise. In LST, the thermal wave propagation along the surface will be blocked by a crack and cause local irregularity of images. In a similar manner, the presence of spatial discontinuities in thermal image caused by the presence of crack can be detected by the wavelet transform [8]. After that the peak values are extracted to isolate crack information from the thermal images. The Hough transform is a powerful tool in image processing field for the detection of features such as lines and circles [9]. So it can be adopted to automatically distinguish crack features and noises after the peak value filtering. Finally, the crack visualization result can be obtained. The algorithm is composed of three steps and the details of each step are outlined in Fig. 3.

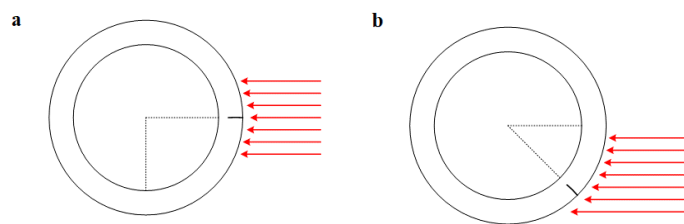
Fig. 4 laser excitation modes: (a) vertical mode, the crack direction is parallel to the laser direction. (b) angular mode, the angle of the crack direction towards the laser direction is a certain angle.

region directly. Although the application of guiding fiber or reflection lens can solve the reachability problem to a certain extent, the vertical incidence of laser is not always achievable. Thus it's also significant to investigate the influence of inspection angle to the capability of crack imaging from the point of view of practical inspection. Therefore, two kinds of laser excitation modes are considered in this work: vertical mode and angular mode (see in Fig. 4), which respectively represents the laser is heated near the crack region vertically and with a certain angle. In this work, inspection experiments under the heating angle of 30° , 45° and 60° are conducted. In experiments, the laser array is respectively generated onto the regions near the crack in the way shown in Fig. 4 to detect these defects. The laser induced on the specimen is a 4-s square pulse with 2-s heating and 2-s cooling. The power of initial laser is 80 W which means the power of each element spot in the laser array is around 1 W.

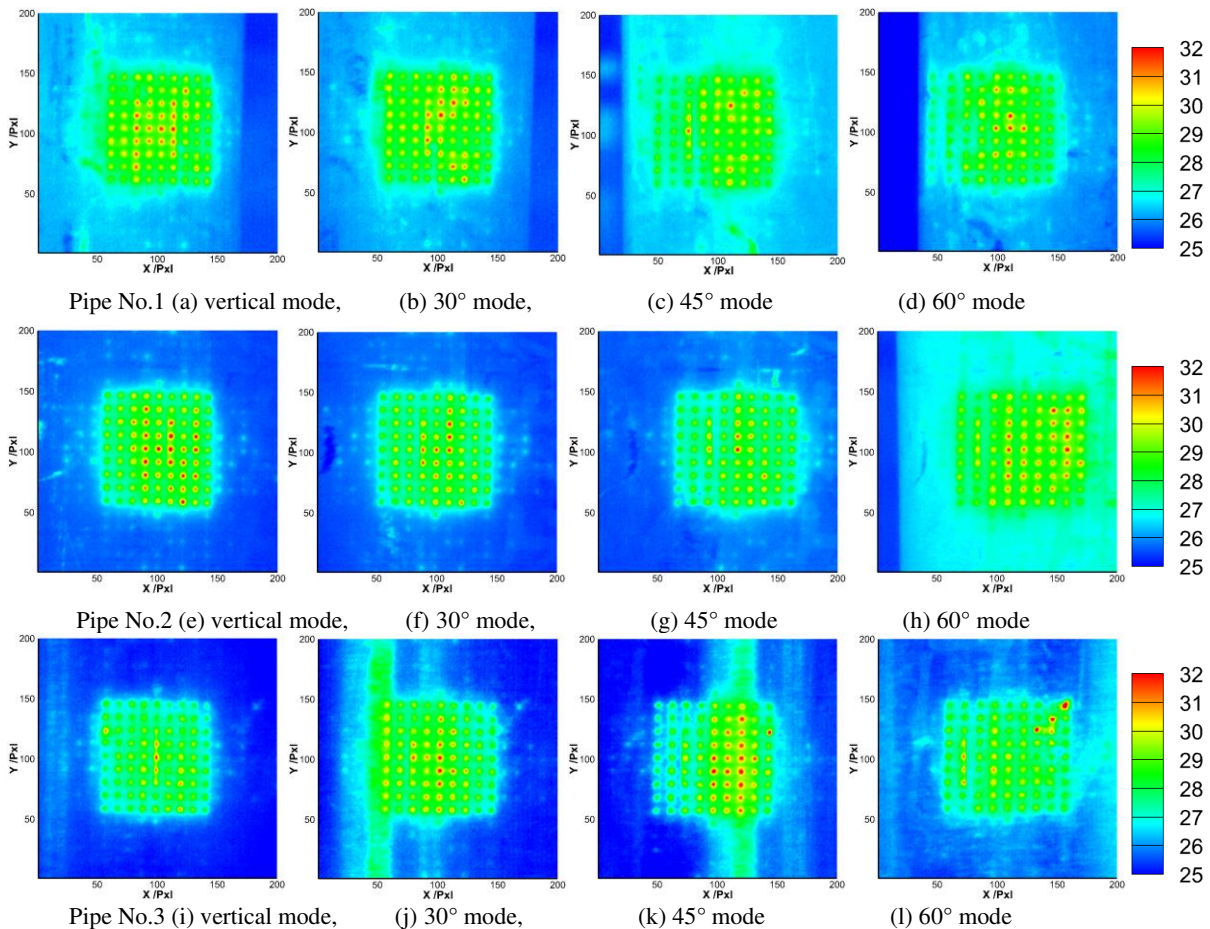
Fig. 5 Representative thermal images of pipes obtained at 2s

Fig. 5 shows the measured temperature distribution on the pipe surface after irradiated by the 9×9 laser spots array after 2 s. Although the resolution of full image is 512×640 pixels only a 200×200 pixels region near the laser source heating area is selected as the region of interest (ROI). The results show that the unsymmetrical distribution of surface temperature caused by the crack can be witnessed although the curved surface reflects parts of the laser energy and cause the uneven heating effect on the surface. With the increase of laser heating angle, the crack become less clearly in original thermal images. Then the image processing procedure discussed in section 3 is applied to the raw images. Fig. 6 illustrates the results of main steps in the image processing of ROI in Fig. 5a. Final results of all the six images are shown in Fig. 7. As we expected the laser heating patterns are greatly eliminated and all the cracks are clearly revealed. Finally, the crack length is evaluated by counting the amount of pixels that visualized the crack (1 pixel sees 0.22mm).

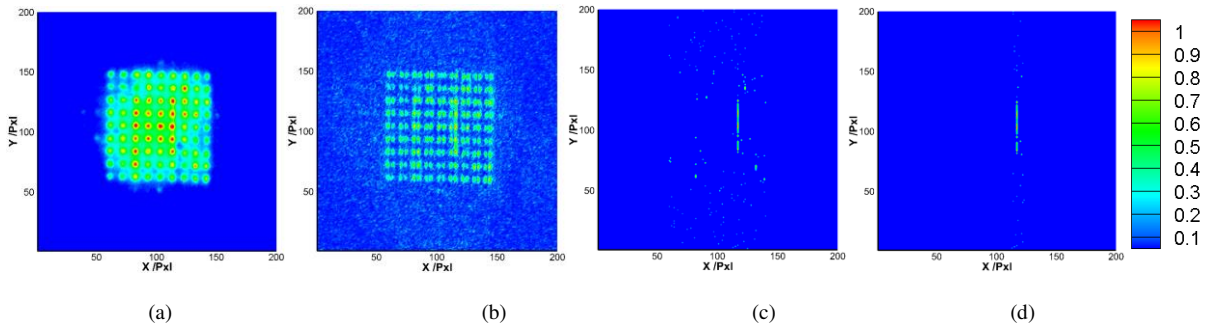
Fig. 6 Image processing procedure: (a) cold image subtraction result; (b) 1st derivative image; (c) peak value extraction result; (d) crack extraction result by Hough transform.
